**DIRECTORATE GENERAL OF CIVIL AVIATION**

**FINAL INVESTIGATION REPORT ON THE GROUND INCIDENT OF WING TIP STRIKE  
BETWEEN VT-ISS OF M/S INDIGO AND VT-TGG OF M/S AIR INDIA EXPRESS DURING  
TAXING AT KOLKATA ON 27.03.2024.**

**O/o Dy. Director General of Civil Aviation (ER)**

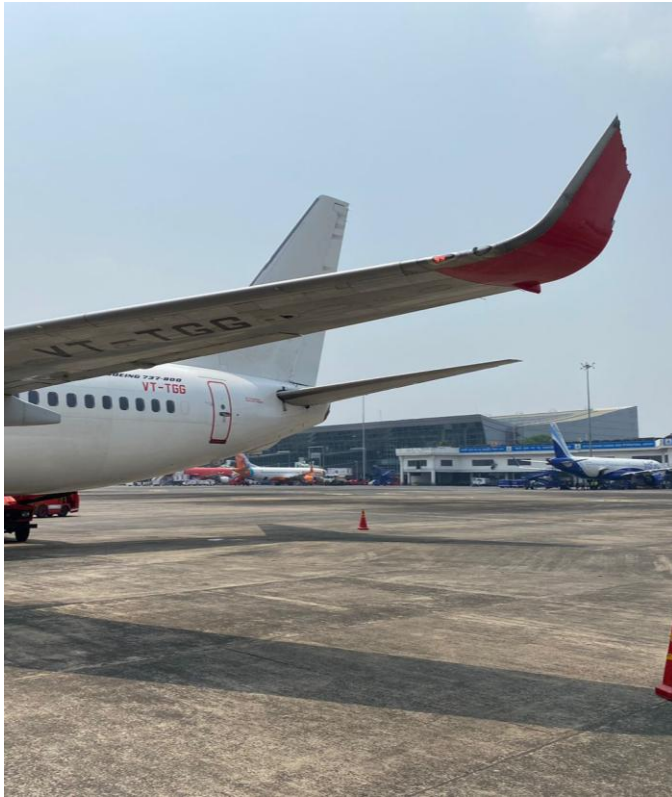
On M/s Air India Express Aircraft VT-TGG, it was seen that a portion left wing tip (winglet) was broken off and the honeycomb structure of the winglet was exposed. Winglet replacement was carried out by M/s AIESL as per AMM on 29.03.2024. CRS for VT-TGG was issued on 29.03.2024.

Damage to VT-TGG winglet

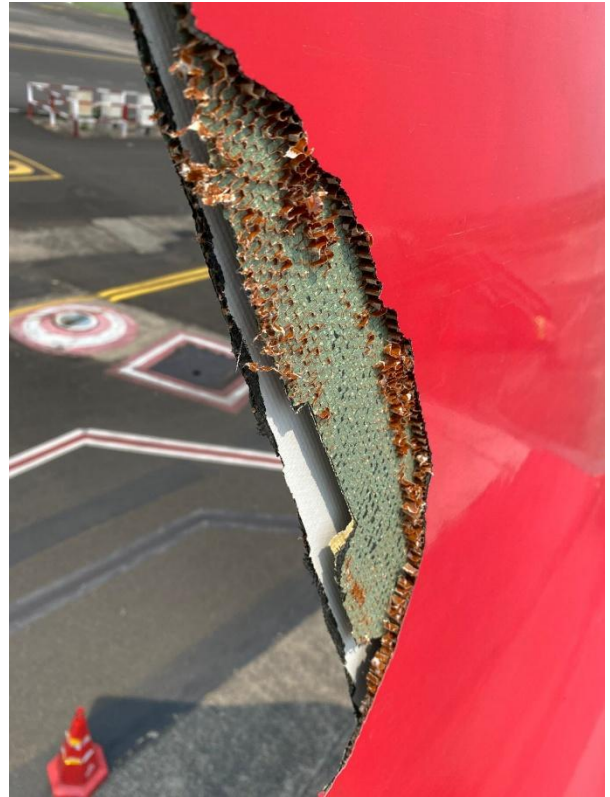
Close-up of damage to VT-TGG

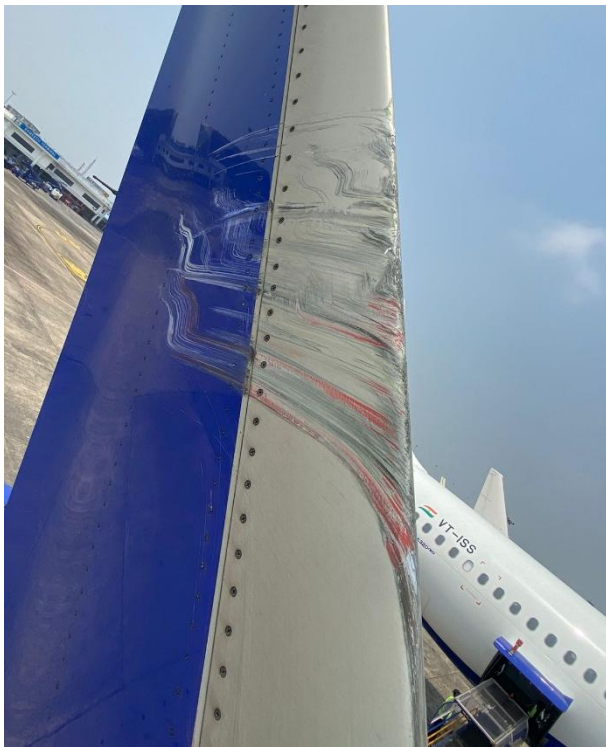
M/s Indigo aircraft VT-ISS had damages on its RH wing leading edge sharklet and after inspection as per AMM, the damage was found out of SRM limit. After removal, a new RH sharklet assembly was installed on VT-ISS.

Damage to VT-ISS winglet

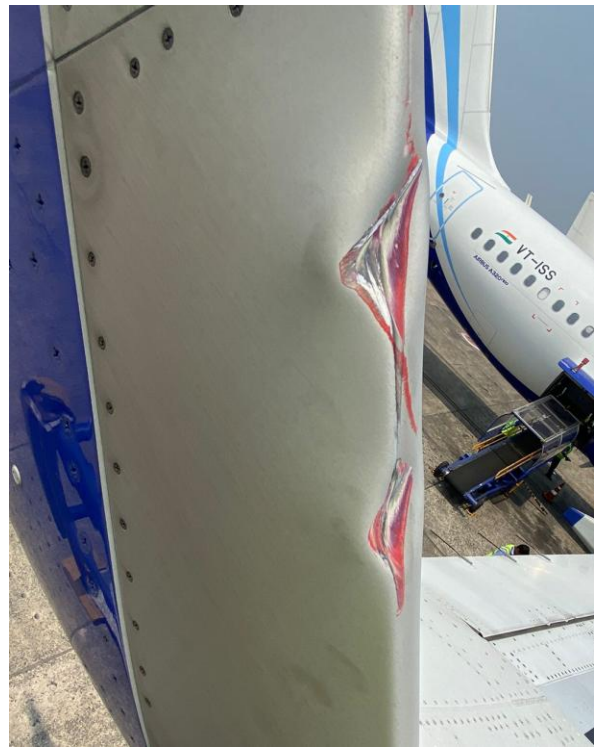
Close-up of damage to VT-ISS

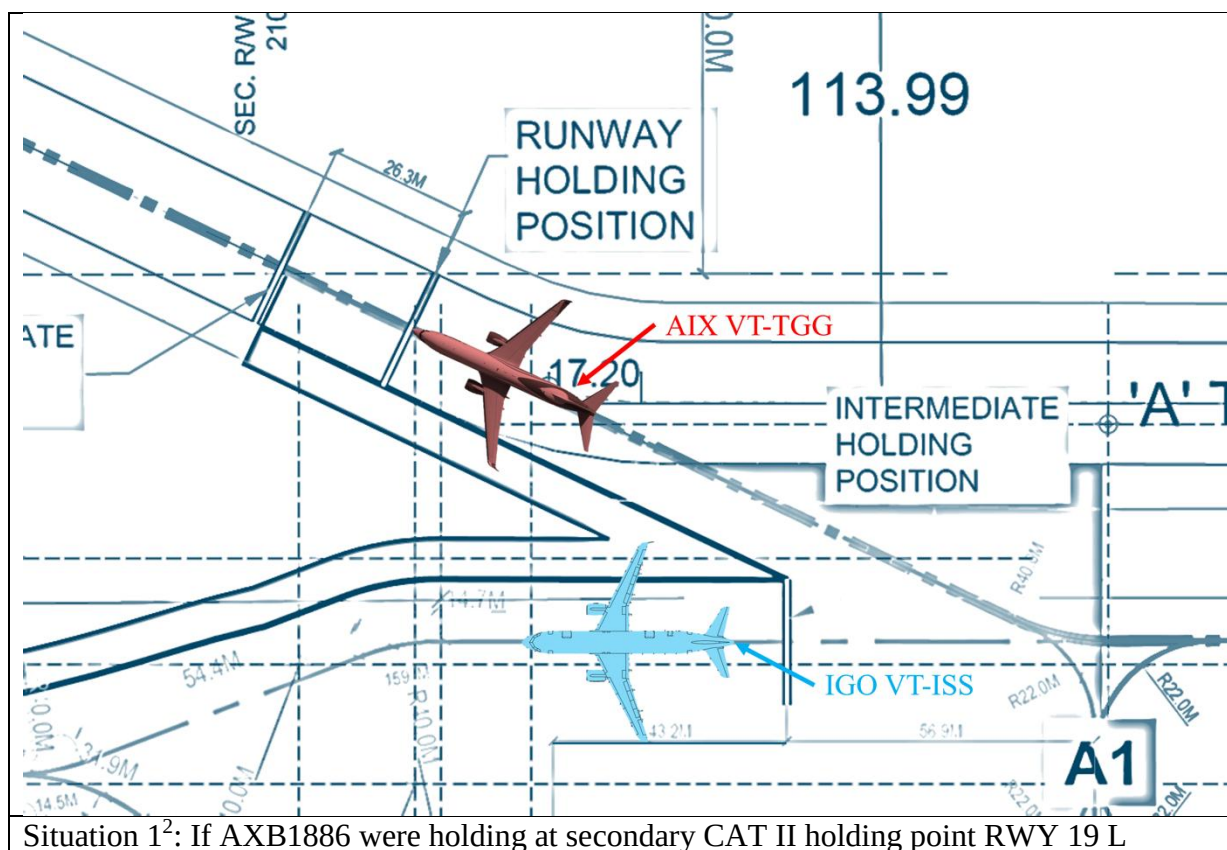
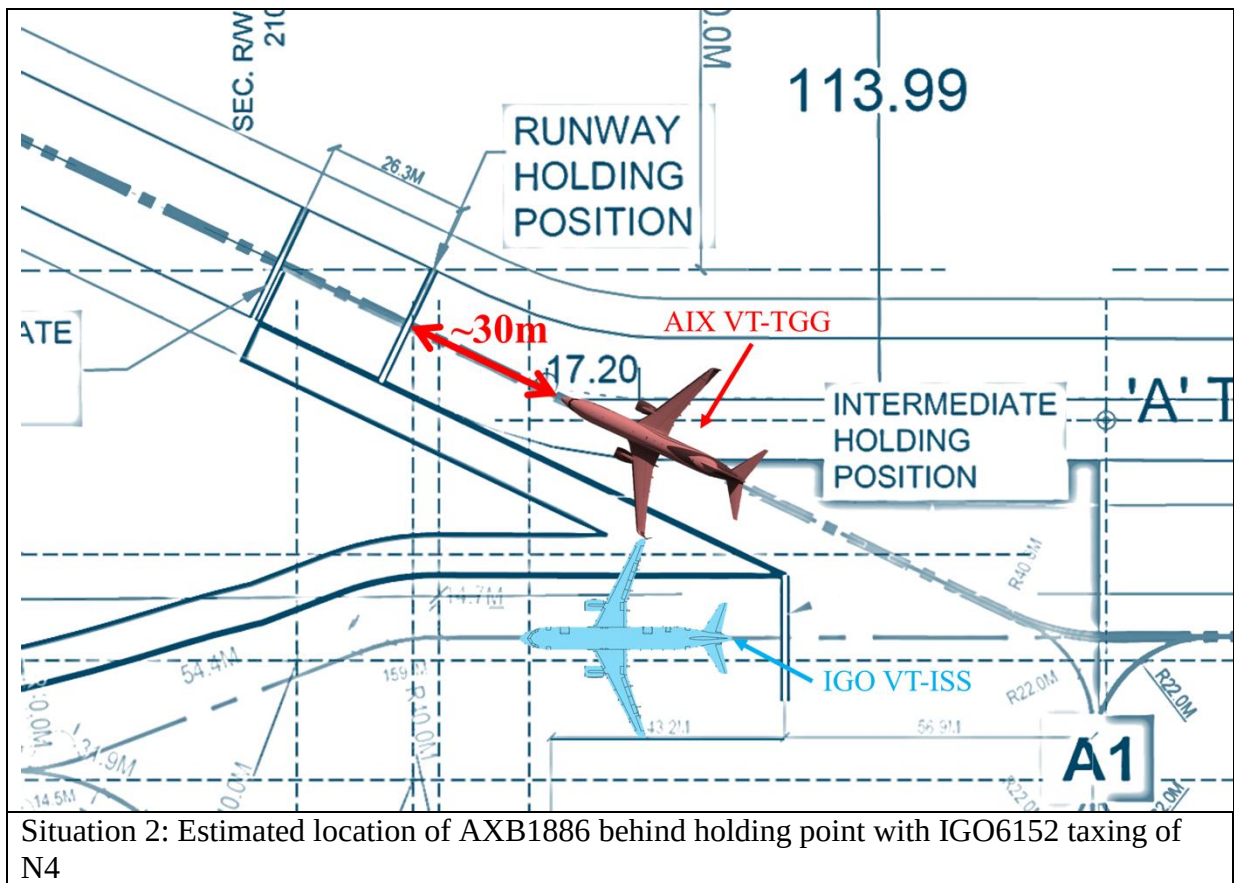
### 1.19.1. Location of AXB1886 & IGO6152 near point of collision:

From situation 1 pictorial representation, it is seen that if AXB1886 were at its assigned holding point A RWY 19R (CAT I), IGO6152 while crossing it on taxiway N4 would have ample clearance from the stationary aircraft AXB1886. From the situation 2 representation where IGO6152 wing tip comes in contact with AXB1886, the aircraft AXB1886 would have to be approximately 30 metres behind the CAT II holding point of RWY 19L. It is also seen AXB1886 is positioned at an angle to the passing Indigo flight IGO6152. Visually, the angle seems to be approximately  $40^{\circ} - 45^{\circ}$ .

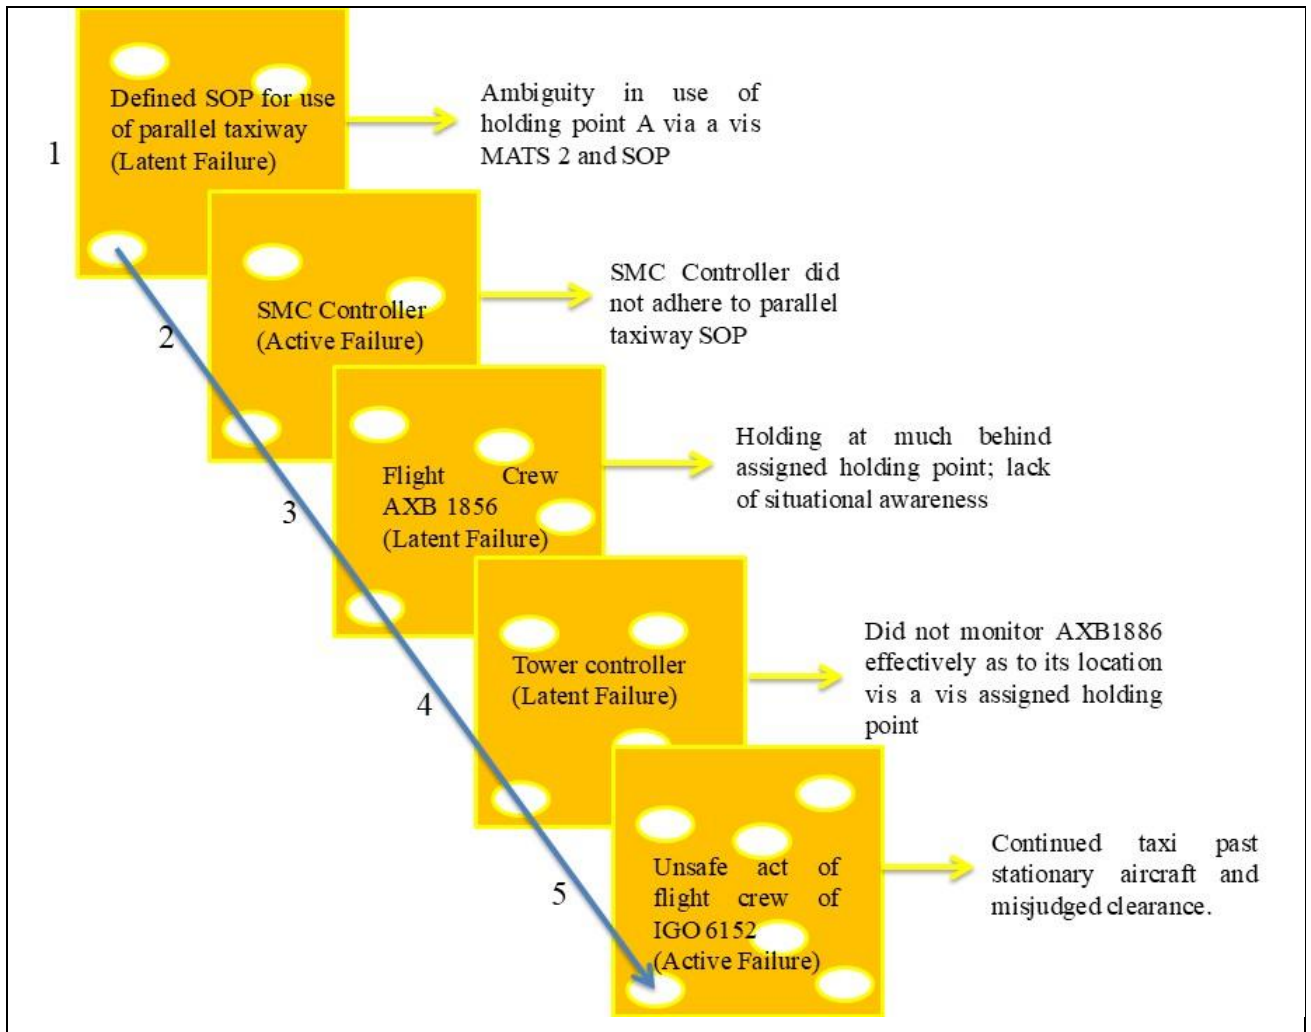
This is also diagrammatically depicted by the Swiss Cheese Model<sup>4</sup> in the figure below wherein the various imperfections in the defensive layers (SOPs and systems) aligned perfectly to culminate in the ground incident. The latent conditions in the form of SOP, procedures, decision making and oversight by key monitoring personnel are all contributory factors to the ground incident with the active failure of judgement error by flight crew of IGO6152 during taxiing being the probable cause of the incident.
