# Investigation report on Incident of AIRPROX between IGO2306 and IGO273J at Delhi Approach on 10.05.2024

DIRECTORATE GENERAL OF CIVIL AVIATION

Type: A320-214,	Type: A320-251N,
Nationality: Malta,	Nationality: Indian,
Registration: 9H-SLE	Registration: VT-IQY
Call sign: IGO2306	Call sign: IGO273J
M/s Inter Globe Enterprises	M/s Inter Globe Enterprises
Pvt. Ltd (Indigo)	Pvt. Ltd (Indigo)
License: ATPL,	License: ATPL,
Nationality: Ukraine,	Nationality: Indian,
Extent of Injury: Nil	Extent of Injury: Nil
License: ATPL,	License: CPL,
Nationality: Namibia,	Nationality: Indian,
Extent of Injury: Nil	Extent of Injury: Nil
04,	04,
Extent of Injury: Nil	Extent of Injury: Nil
168,	177,
Extent of Injury: Nil	Extent of Injury: Nil
10th May, 2024, 12:35 UTC	10th May, 2024, 12:35 UTC
Agartala	Patna
Delhi	Delhi
Delhi	Delhi
Approach	Approach
AIRPROX (Infringement of	AIRPROX (Infringement of
Separation Minima)	Separation Minima)
	Nationality: Malta, Registration: 9H-SLE Call sign: IGO2306 M/s Inter Globe Enterprises Pvt. Ltd (Indigo) License: ATPL, Nationality: Ukraine, Extent of Injury: Nil License: ATPL, Nationality: Namibia, Extent of Injury: Nil 04, Extent of Injury: Nil 168, Extent of Injury

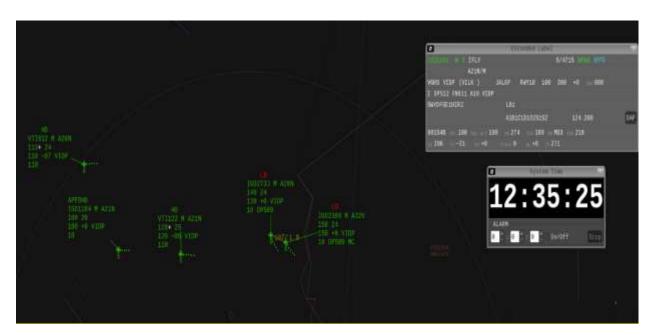
At 12:35 UTC, APAA Controller instructed IGO273J to descend to FL130. IGO273J didn't read back the instruction, instead IGO2306 captured this transmission and read back the instruction and commenced descend from FL150. The APAA controller also could not detect that the descend instruction meant for IGO273J has been read back by IGO2306. Thereafter, the controller got occupied in handling other traffic. At 12:35:25, Level bust Alert (LB) appeared in the data Block of both IGO273J & IGO2306 (Fig 1).

Fig 1: Level bust Alert (LB) appeared at 12:35:25 UTC

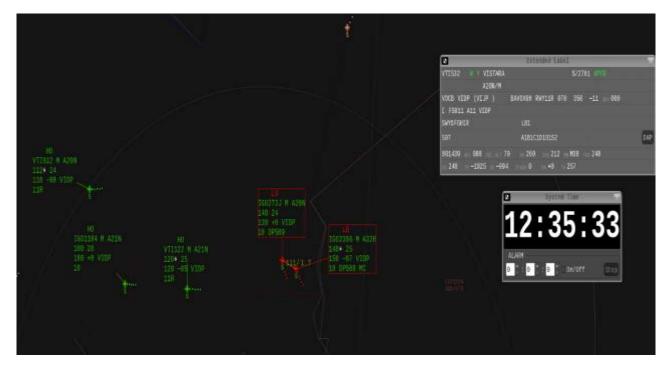
At time 12:35:33 UTC, Separation Breach between IGO2306 and IGO273J occurred and Automation System generated Current Conflict Alert (Fig 2).

Fig 2: Current Conflict Alert appeared at 12:35:33 UTC

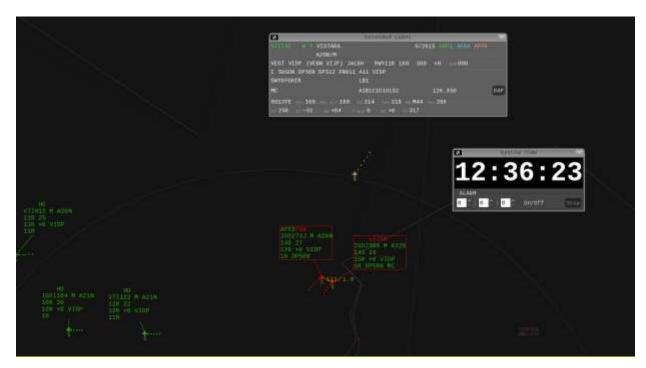
The APAA Controller immediately instructed IGO2306 to maintain FL150, while it was passing FL148. The APAA Controller also immediately instructed IGO273J to descend to FL130. But none of the aircraft read back the instructions. APAA Controller further instructed IGO2306 to maintain FL145 multiple times, which was not read back by the crew. IGO273J was still maintaining FL140 and IGO2306 continued its descent. IGO273J reported that an aircraft 400 feet above, was in the descending phase. The APAA controller responded affirmatively and again instructed IGO2306 to maintain FL145 but IGO2306 didn't respond. The APAA Controller instructed IGO273J to descend to FL130, and IGO273J read back the instructions. Meanwhile IGO2306 continued to descend up to FL143. The APAA Controller again instructed IGO2306 to maintain FL145. This time IGO2306 read back the instruction and stopped descending at FL143. At time 12:36:23 UTC, TCAS RA Alert appeared in the data block of IGO2306 and IGO273J (Fig 3).

Fig 3: TCAS RA Alert appeared at 12:36:23 UTC

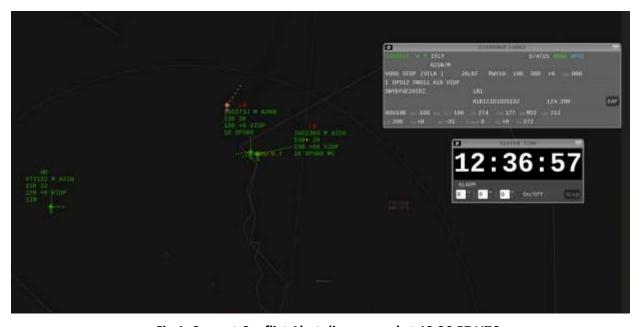
Later, APAA Controller instructed IGO273J to descend to FL120 but IGO273J didn't read back. IGO2306 reported getting TCAS RA, APAA Controller acknowledged. IGO2306 was observed commencing climb from FL143 and IGO273J commenced descent from FL140. At 12:36:36 UTC, Standard separation between IGO273J and IGO2306 restored and at 12:36:57 UTC, Current Conflict Alert disappeared from Automation System (Fig 4).

Fig 4: Current Conflict Alert disappeared at 12:36:57 UTC

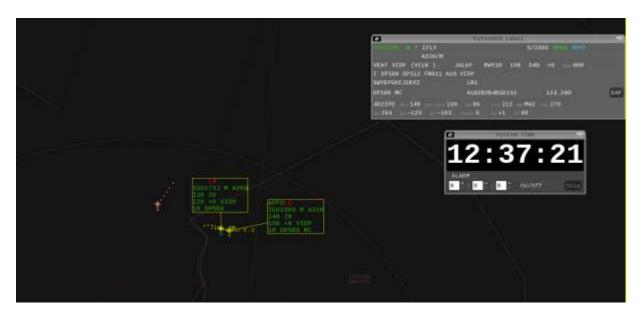
The APAA Controller advised IGO273J to report clear of conflict, IGO273J acknowledged. IGO273J was observed maintaining FL138 and IGO2306 was observed climbing to FL150. At 12:37:05 UTC, IGO273J reported clear of conflict and maintaining FL138. The APAA Controller instructed IGO273J to fly HDG 260, IGO273J read back the instruction. The APAA controller instructed IGO2306 to Fly HDG 270. Meanwhile IGO2306 was observed descending to FL148 again. Automation System generated Predicted Conflict Warning (Fig 5).

Fig 5: Predicted Conflict Warning appeared at 12:37:21 UTC

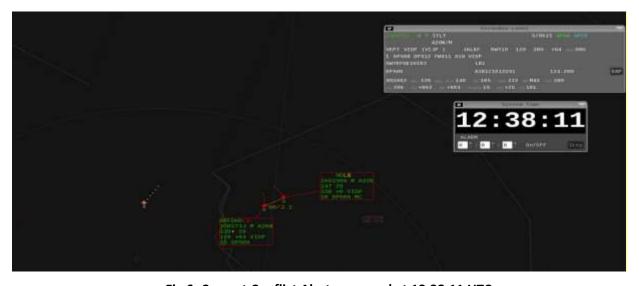
IGO273J confirmed with APAA whether to maintain F140 but APAA Controller was busy handling other traffic, IGO273J commenced climb. At that time IGO2306 was maintaining FL147. Separation breach occurred and Automation System again generated Current Conflict Alert at 12:38:11 UTC (Fig 6).

Fig 6: Current Conflict Alert appeared at 12:38:11 UTC

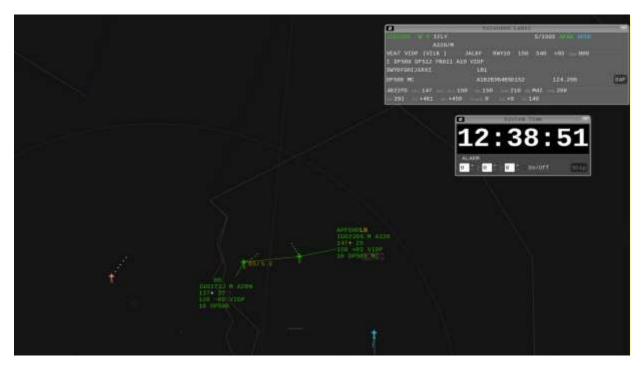
APAA Controller instructed IGO273J to descend to FL120, the same was read back by the crew. APAA Controller instructed IGO2306 again to maintain FL150 and the crew acknowledged the same. At 12:38:48 UTC, Standard separation between IGO273J and IGO2306 restored and Current Conflict Alert disappeared from Automation System at 12:38:51 UTC (Fig 7).

Fig 7: Current Conflict Alert disappeared at 12:38:51 UTC
