**Government of India
Directorate General of Civil Aviation**

**INVESTIGATION REPORT ON AIR TURN BACK INCIDENT OF
M/S AIR INDIA A-319 AIRCRAFT VT-SCJ OPERATING FLIGHT
A1-776 ON 14.07.2023 AT MUMBAI**

On 14/07/2023, M/s Air India A-319-112 aircraft VT-SCJ was involved in an Air turn back incident while operating flight AI-776 sector Mumbai-Kolkata.

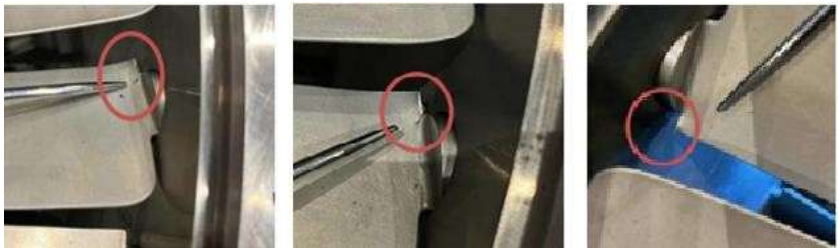
S. No	Description	Quantity	Observation
LPC MODULE			
1	Booster Stage 2 to Stage 5		No damage was observed. Minor corrosion with external deposits observed.
HPC FRONT STATOR ASSEMBLY			
1	Inlet Guide Vanes	03	<ul style="list-style-type: none">Crack observed on Qty 02 vanes outer trailing edge ; not permissible as per ESMNicks on Qty 01 vane trailing edge outer side beyond ESM limits

2	Stage 1		Several blades had damage in the form of tear, missing material, tip curl & bend. Damage was beyond acceptable limits of AMM.
3	Stage 1 VSV (Scallop)	01	Nick and Crack on leading edge beyond ESM limit

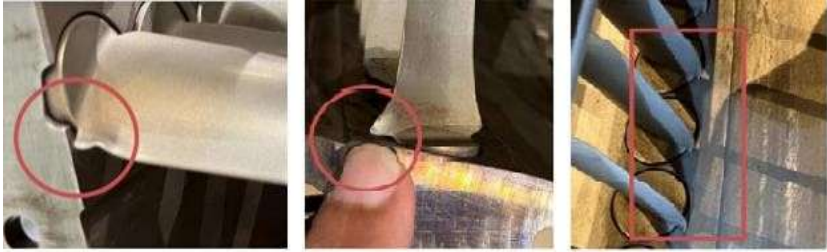
5	Stage 2 VSV (Non-Scallop)	42	<p>Dent/ Bent on trailing edge outer side beyond ESM limits</p>

6	Stage 2 VSV (Scallop)	20	<p>Dent/ Bent on trailing edge outer side beyond ESM limits</p>

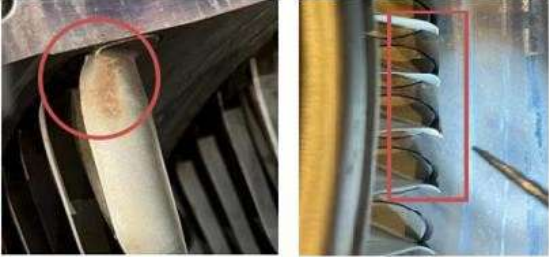
7	Stage 3		<p>Most of the blades had damage in the form of tear, missing material, tip curl, material separation & impact damage. Damage was beyond acceptable limits of AMM.</p>
8	Stage 3 VSV (Non-Scallop)	44	<p>Dent/ Bent on trailing edge outer side beyond ESM limits</p>

9	Stage 3 VSV (Scallop)	17	<p>Dent/ Bent on trailing edge outer side beyond ESM limits</p>

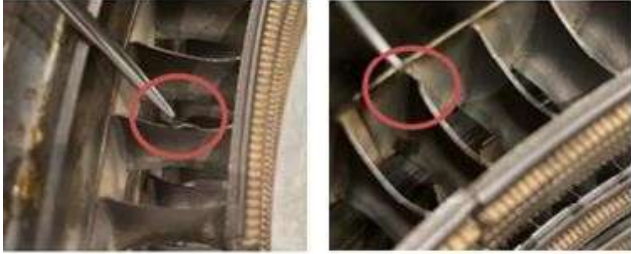
13	Stage 7		Quantity 3 to 4 blades had damage in the form of missing material on tip area, quantity 01 blade found previously blended within acceptable limits of AMM.
14	Stage 8		Quantity 10 to 12 blades had damage in the form of tear, missing material, impact. Damage was beyond acceptable limits of AMM.
HPC REAR STATOR ASSEMBLY			
1	Stage 8 vane cluster assembly	2	Quantity 02 vanes clusters have nicks and dents beyond ESM limits

HPT			
1	HPT Blades	04	No damage observed during the Boroscopic inspection of HPT blades from rear. Notches visible on quantity 04 blades.
LPT			
1	Stage 4 LPT blades		Minor Erosion observed on leading edge of the blades, within acceptable limits of AMM.
Other observations			
Quantity 04 OGV metal strip found liberated. Nicks observed on AFT engine mount LH side link.
