**FINAL INVESTIGATION REPORT ON
INCIDENT TO
M/s. ALLIANCE AIR ATR 72-600 AIRCRAFT, VT-RKM
ON 03.07.2023 IN MUMBAI TMA**

**GOVERNMENT OF INDIA
O/o, DIRECTOR AIR SAFETY, WESTERN REGION,
NEW INTEGRATED OPERATIONAL OFFICE COMPLEX,
SAHAR ROAD, VILE PARLE (EAST), MUMBAI-400099**

FINAL INVESTIGATION REPORT ON INCIDENT TO
M/s. ALLIANCE AIR ATR 72-600 AIRCRAFT, VT-RKM ON 03.07.2023
IN MUMBAI TMA

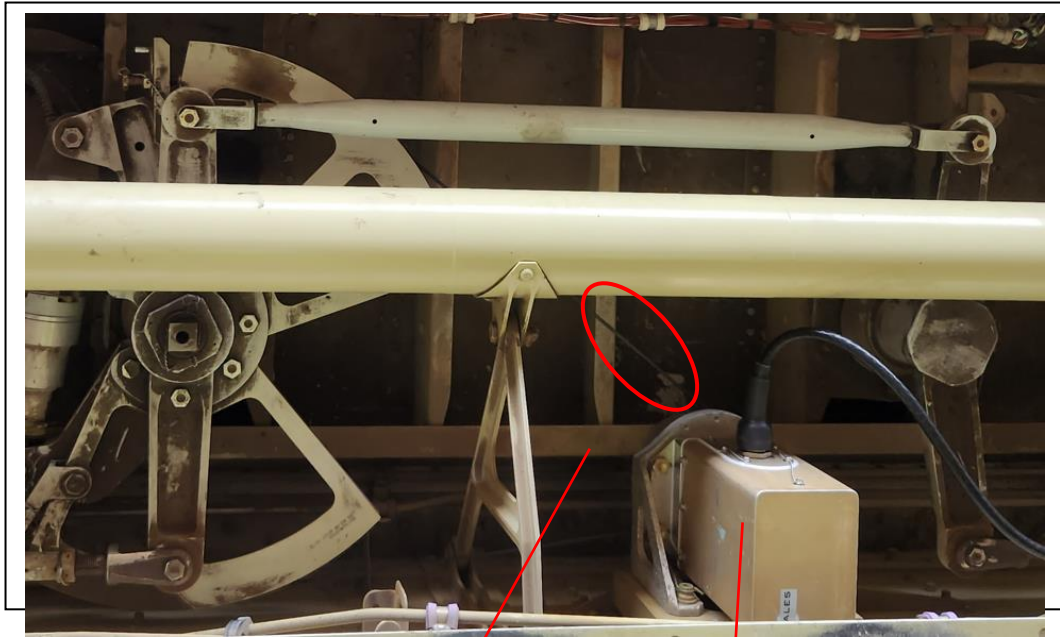
Fig.3: A/P Roll actuator cable connection to the roll quadrant (*picture taken after the rectification action*)

The A/P roll actuator cable tension was checked, however, the tension was found to be approx. 20 lbf which is below the limits mentioned in the maintenance data. As per the maintenance data, the cable tension should be 35.97 ± 4.50 lbf (160 ± 20 N). The zero electrical mark on the actuator was slightly misaligned, however, was within the AMM limits.

The DVI of the roll actuator and the capstan were checked which were satisfactory. The in-situ condition of the A/P roll cable was satisfactory and no damage was observed. The attachment of the cable to the quadrant was fine and the lock nuts were properly wire locked.

It was found during troubleshooting that the tension of A/P roll actuator cable was below the AMM limits. However, the condition of the cable and the capstan was satisfactory including the cable attachment and wire locking of locknuts. The subject cable was last adjusted on 04.06.2020 during the replacement of the servomotor of the A/P Roll actuator and subsequently, no work was carried out in the aft center section of the wing box. Absence of any abnormal in-situ condition and maintenance records implies that the aircraft was operating with the low cable tension in A/P roll actuator cable since its release after the last replacement of servomotor of the A/P Roll actuator. However, vibrations/ controllability issues were not reported on the aircraft by any of the crew previously.

The same roll cable was used for adjusting the tension to the limits specified in the maintenance data as there was no abnormality w.r.t. the roll cable. A duplicate inspection of roll control was also carried out by another certifying staff, which was satisfactory. Subsequently, the servo motor (S/N: 2016) of the A/P roll actuator was replaced with a repaired one (S/N: 1302).

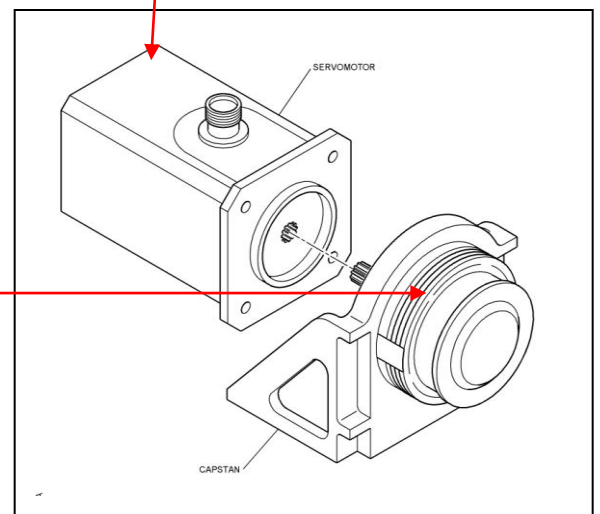
Fig.5: Servomotor and the Capstan

The replaced A/P roll actuator servo motor (S/N: 2016) was sent to an OEM (M/s Thales) workshop for component testing and repair. The visual and functional test on the servo motor revealed the following findings:

- *Jerky running during the bench test*
- *Corroded connector*
- *Continuity out of tolerance*

- The removed Servomotor, during tests, showed some out of tolerances values (connector and cable)
 - > Even not compliant, those items do not affect the functioning of the Servomotor.
- The Servomotor being "jerky" indicates a wear of the potentiometer. The shop findings confirmed this wear at zero position. A sustained zero position is equivalent to the aircraft being wings level (bank angle zero). Outside the zero position, the Servomotor is not jerky anymore.
 - > When the aircraft is flying with a bank angle, this Servomotor, is not jerky and does not create vibration.

- According to the tests and the workshop findings, neither malfunction nor vibration could be suspected by the servomotor at a high bank angle. Consequently, it shall not be linked to the observed high bank phenomenon.

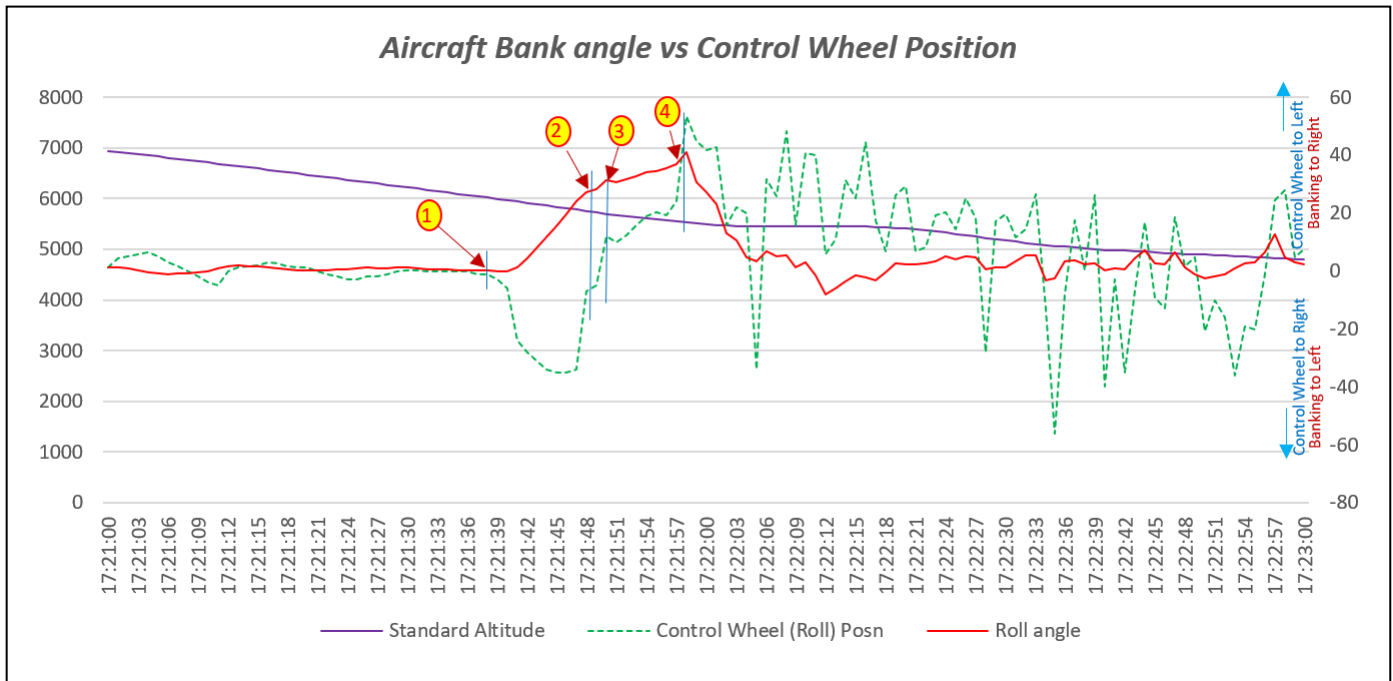
Fig.6: Graph depicting the aircraft bank angle vs the control wheel position

As the control wheel position continued to turn to left and crossed its center position, reaching 11 deg to left, and when the LH ailerons were deflected upwards, the aircraft was banking right reaching approx. 32 deg. As the roll angle reached 39.31 deg, A/P was disengaged at 17:21:57 UTC (4). The roll angle reached approx. 41 deg to the right in a second. P/L#1 was pulled back to flight idle resulting in TQ#2 being ~13% while TQ#1 was ~1%.

After disengaging the A/P, the roll effort input by the PIC on the control wheel parameters showed values of 854N & 1013N. The control wheel position at this moment was approx. 53 deg to the left. The aircraft started rolling towards the left from its maximum attained bank angle of 41 deg to right. By this time, the aircraft had descended up to FL55. The bank angle was brought back to approx. 4.84 deg to right at time 17:22:04 UTC. Power was being adjusted as required.
