FINAL INVESTIGATION REPORT OF INCIDENT TO M/s AIR INDIA, A-320 AIRCRAFT, VT-CIH ON 19.12.2023 AT MUMBAI

GOVERNMENT OF INDIA
OFFICE OF DEPUTY DIRECTOR GENERAL OF CIVIL AVIATION (WR)
INTEGRATED OPERATIONAL OFFICE COMPLEX, SAHAR ROAD,
VILEPARLE (E), MUMBAI – 400099

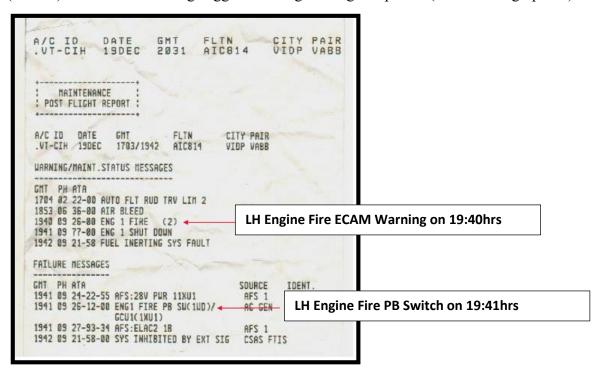
e. Post flight report revealed that the following faults in the aircraft, where LH Engine (ENG 1) fire ECAM warning triggered during landing roll phase. (Refer Photograph# 1)

(Photograph# 1: Post flight report of incident flight)

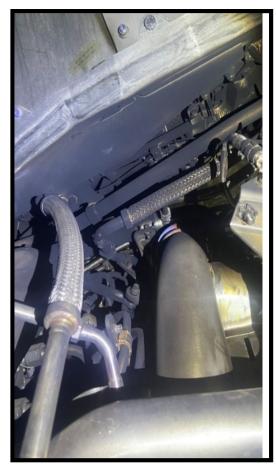
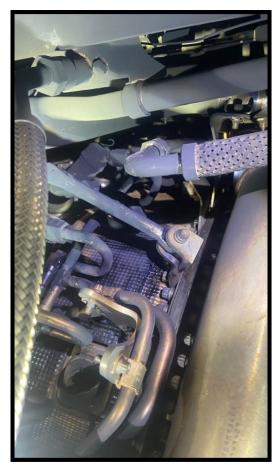
- i. Visual Inspection of each fuel nozzle B-Nut was carried out & no leak observed. Only cocking and Black soot observed on 9'o clock position & 1100-1130 O' Clock position fuel nozzle. (ie, Nozzle no:14,15,16,17,18 & 19).

- ii. Thereafter, all fuel nozzles were inspected for safety cable & found satisfactory & no markings were observed on the fuel nozzle & no leakage was observed from the fuel nozzle. (Refer Photograph 2).

(Photograph# 2: Engine fire signs on LH engine (ESN) 598879)

- n. In addition, as recommended by CFM, multiple tasks were performed. As the source of fuel leak was not detected, the engine was removed for MRO intervention. Thus, LH Engine (ESN: 598879) was replaced with other serviceable engine (Sl No: 598196).

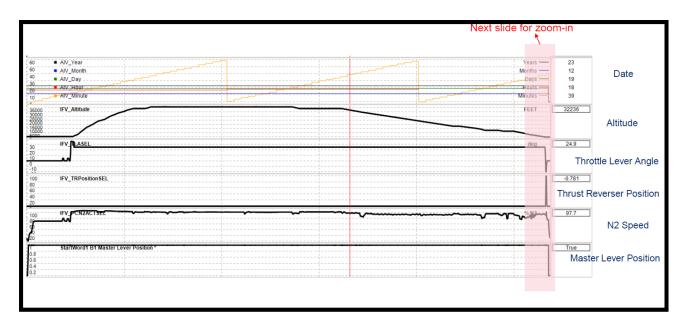
- a. 17:14:22 UTC: Aircraft lift off time
- b. 19:40:05 UTC: Aircraft touch down time
- c. 19:40:07 UTC: Aircraft thrust reversers were deployed for both engines. For LH Engine:
- d. 19:40:24 UTC: (at 61.5 knots ground Speed), Master Caution got triggered & then after 1 second, LH Engine FIRE warning generated.
- e. 19:40:28 UTC: LH Engine EGT started rising from 544 degrees Celsius & rose up to maximum of 653 degree Celsius.
- f. 19:40:52 UTC: LH Engine EGT started decreasing.
- g. 19:41:01 UTC: LH Engine Master was switched off.
- h. 19:41:11 UTC, FIRE PB switch of LH Engine was pulled out & thereafter, LH Engine FIRE Warning got disappeared at 19:41:21 UTC.

(Graph# 1: DFDR Analysis of event flight VT-CIH, where zoom-in referred in Graph# 2)

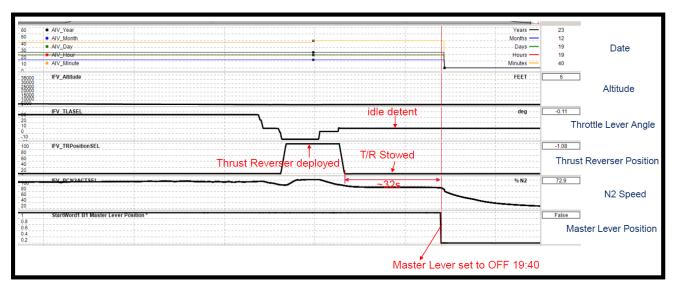
(Graph# 2: DFDR Analysis (zoom-in portion referred in Graph#1) of event flight VT-CIH)

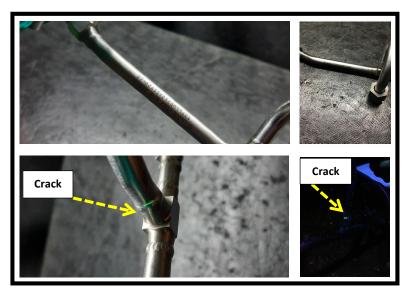
- a. M/s Air India **had reports of fire** on ground related to fuel leaks from cracked LEAP-1A fuel manifold on two engines in their fleet:
 - i. On 19.12.2023, ESN: 598879 of aircraft VT-CIH (subject incident Flight no: AI-814): Crack was found at the weld area of the manifold part number 2525M99G01.
 - ii. On 29.05.2023, ESN: 598655 of aircraft VT-EXK: Fuel Manifold PN 2525M99G01 found with crack at the welding joint near to the Fuel Nozzle location #18.
- b. The shop visit reports from ESN 598879 and ESN 598655 provided by M/s GEES-M (GE Engine Services-Malaysia) both concluded that the cause of the fuel leak that led to the fire was from cracks in the weld of the fuel manifold 2525M99G01 (Refer photograph 2).

(Photograph# 2: Fuel Manifold of ESN 598879 showing crack along with its SEM (Scanning electron microscopy) Image)

The crack in the weld of the fuel manifold of the LH engine caused the fuel leak, which eventually led to the LH Engine fire warning. The root cause of crack in the weld of the fuel manifold is determined as low cycle fatigue.

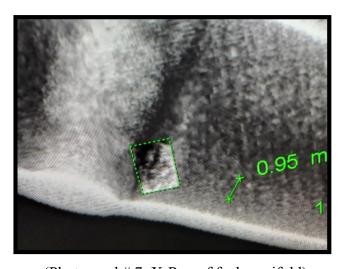
(Photograph# 7: X-Ray of fuel manifold)

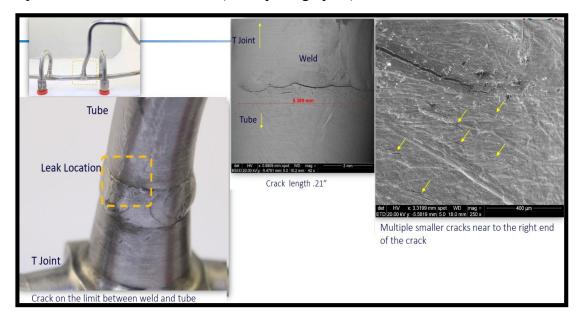
e. Metallographic summary/metallurgical analysis of crack observed in the fuel manifold of engine ESN 598655 for previous similar case of 29.05.2023 on aircraft VT-EXK provided below for reference: (Refer photograph 8).

(Photograph# 8: Specimen diagram for crack developed due to low cycle fatigue failure)

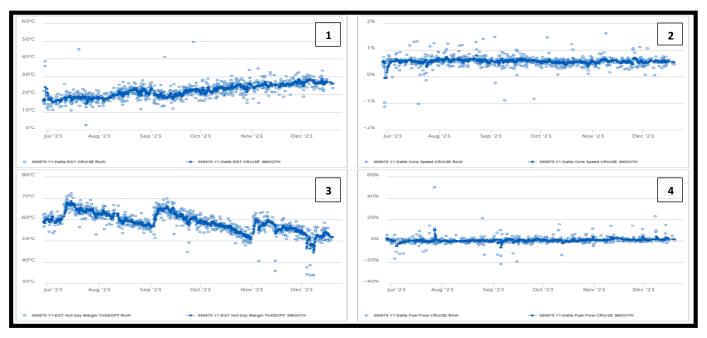
j. As per CEOD analysis report by CFM, there was no significant shift observed in engine performance of ESN 598879 CFM Engine for EHM from 28.06.2023 – 25.12.2023 (i.e. for 180 days). Trend analysis of engine ESN 598879 during the last six months till the incident is provided below: (Refer Graph 3, 4 and 5).

(Graph# 3: Representing trend on Delta EGT during Cruise (1) and Delta core speed during Cruise (2), EGT Hot day margin take-off (3), Delta fuel flow cruise (4))

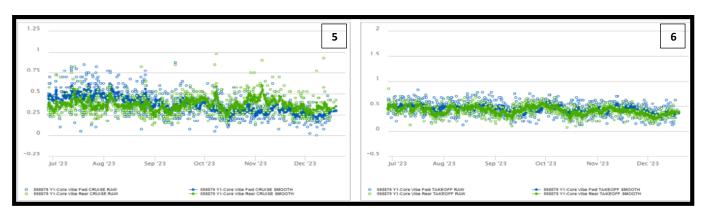
(Graph# 4: Representing trend on Core vibration forward & rear during Cruise (5) and core vibration forward and rear during take-off (6))

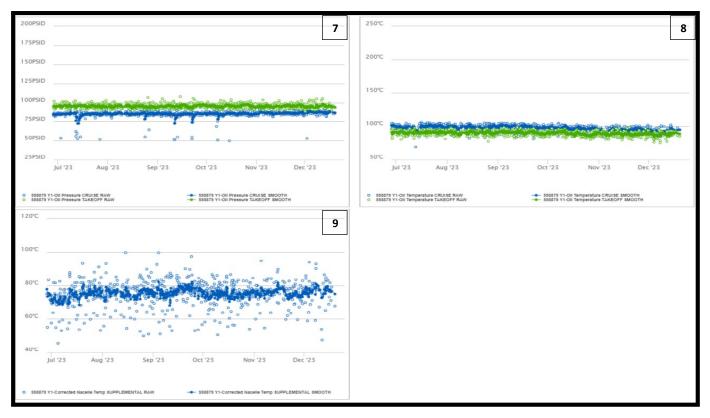
(Graph# 5: Representing trend on Oil pressure during Cruise & take-off (7), Oil temperature during Cruise & take off (8) and corrected nacelle temperature supplemental (9))
