**Investigation Report on Incident to  
M/s Air India Airbus A321 aircraft VT-PPT operating  
flight AI-807 at Delhi on 17.05.2024**

**GOVERNMENT OF INDIA  
DIRECTORATE GENERAL OF CIVIL AVIATION**

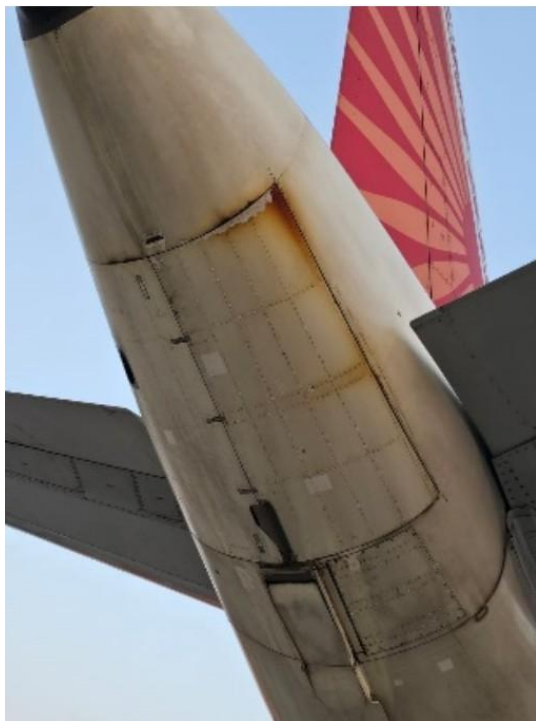
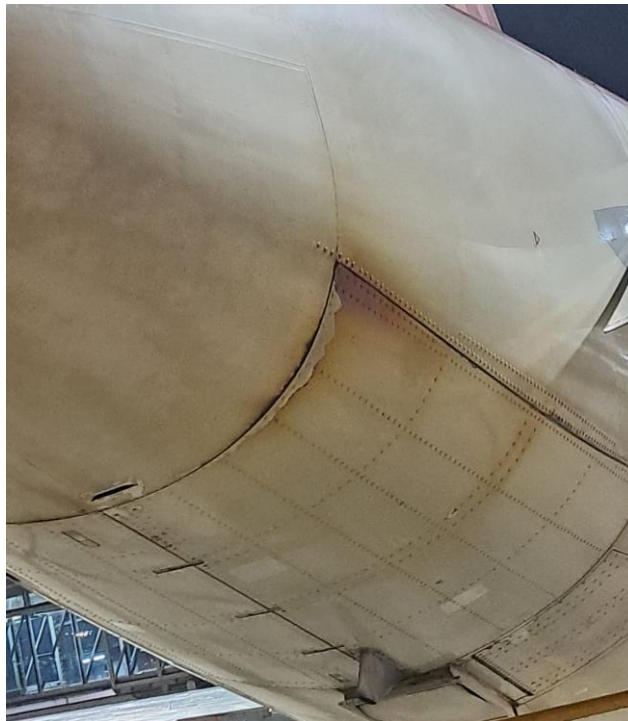
Black soot was observed in the upper portion of the APU compartment. Paint discoloration/ heat damage signs were observed on rear of RH APU cowl door structure. Air inlet diffuser on tapping shows signs of debondings. Exhaust bellow found torn.

**APU compartment (in fuselage tail cone) and access doors on the bottom of the tail cone [Post incident]**

1. The R/H APU door damage was found beyond NTM 51-10-12 limits, the R/H APU door has been replaced.
2. The APU hoist fittings (QTY 3) have been inspected as per NTM 51-10-12, only the lower fitting has been found damaged beyond limits and replaced.

The APU fire loop and Fire extinguisher bottle have been replaced.

The damaged APU (S/N: P4438) has been removed and replaced by a serviceable and fully equipped APU.

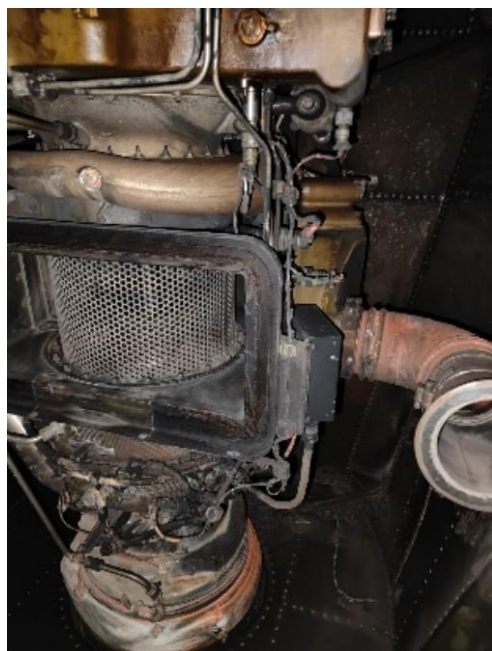
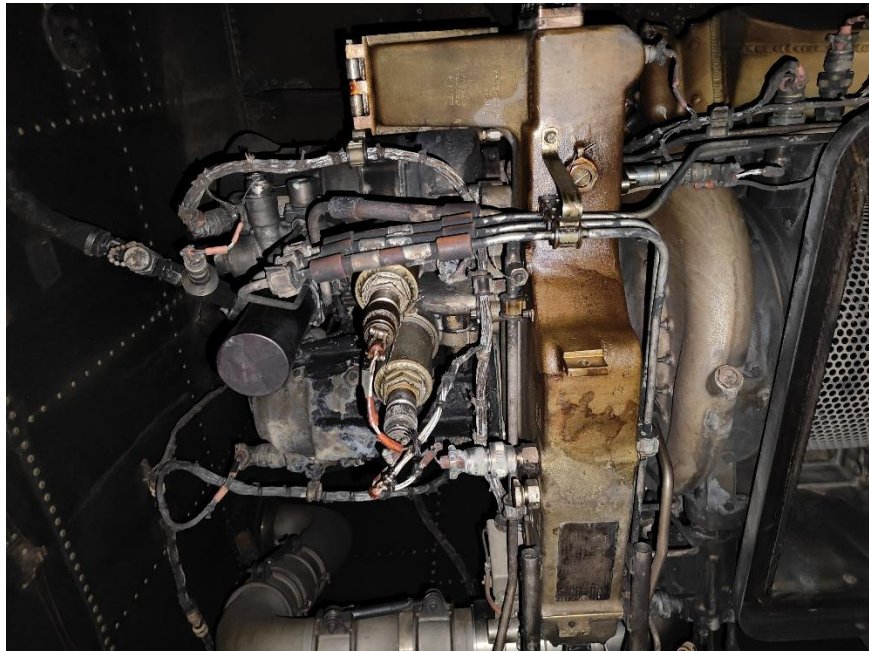
**APU and view inside APU compartment [Post incident]**

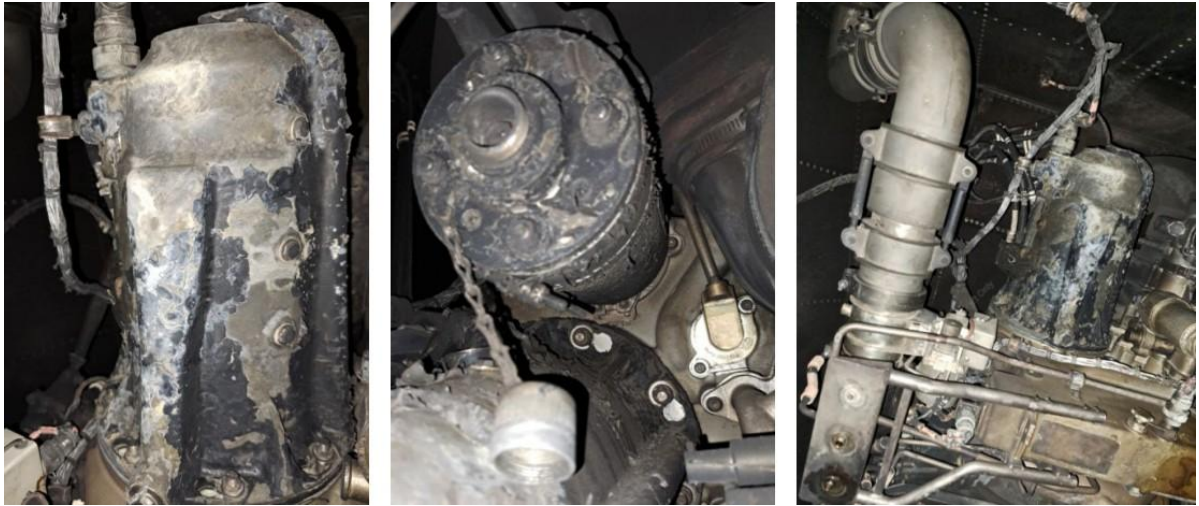
**1. APU GEN and Starter paint damaged**

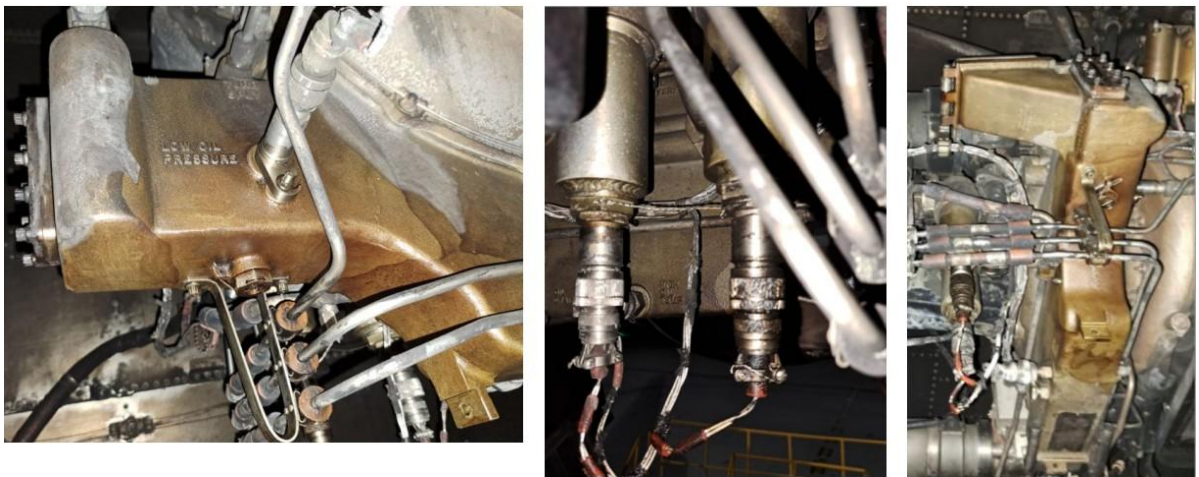
Before starting the APU, the Oil level was checked and it was significantly over the “FULL” mark. The evidences found confirmed that the oil leak occurred with the APU on wing as a result of an APU over servicing

2. Traces of oil found on oil tank, oil LOP Switch and APU Drain Port

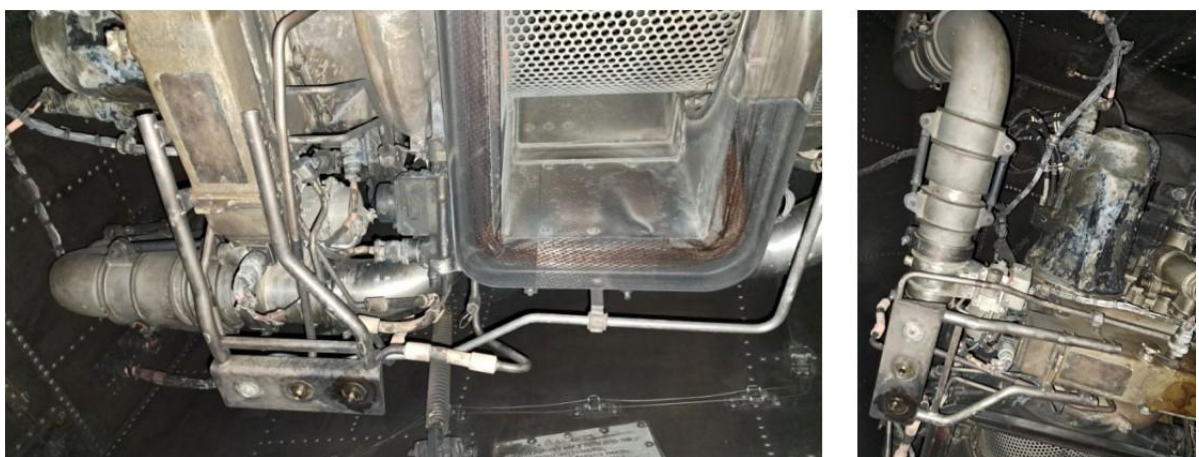
3. APU Rear Drain Oil Traces

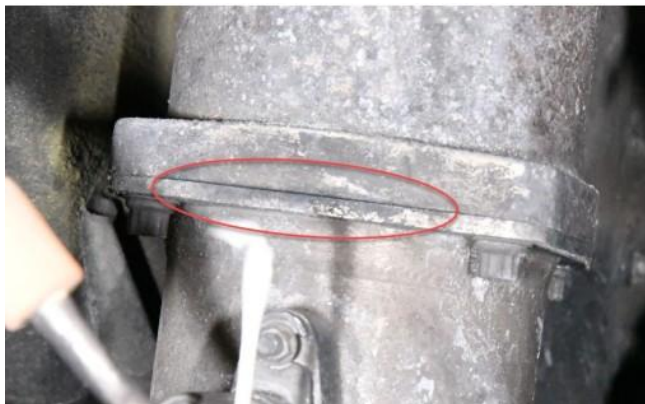
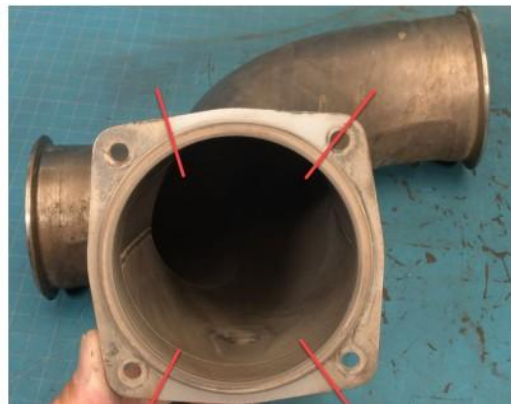
4. Load Compressor Scroll flange hot air leak:
  - a) It was confirmed that the 4 bolts were only hand tightened. It has been further clarified by M/s Honeywell that, during disassembly of the scroll housing and T-duct, a light break away torque of 4-5 in-lb was measured (torque requirement is 120 in-lb).

- b) During the APU operation, with the thermal expansion of the parts, a gap was created between the LC scroll and the T-Duct.
  - c) A significant hot air leak occurred due to this gap.

- d) During the tear down, two different sectors of the flange show evidence of leak
5. Load Control Valve hot air leak
  - a) The valve was removed from the APU and tested separately in the Honeywell lab.

- On the T-Duct as the 4 bolts were only hand tightened.

Load Compressor Scroll flange hot air leak was confirmed because 4 bolts were found to be improperly torqued. During the APU operation, with the thermal expansion of the parts, a gap was created between the LC scroll and the T-Duct resulting in a significant hot air leak.

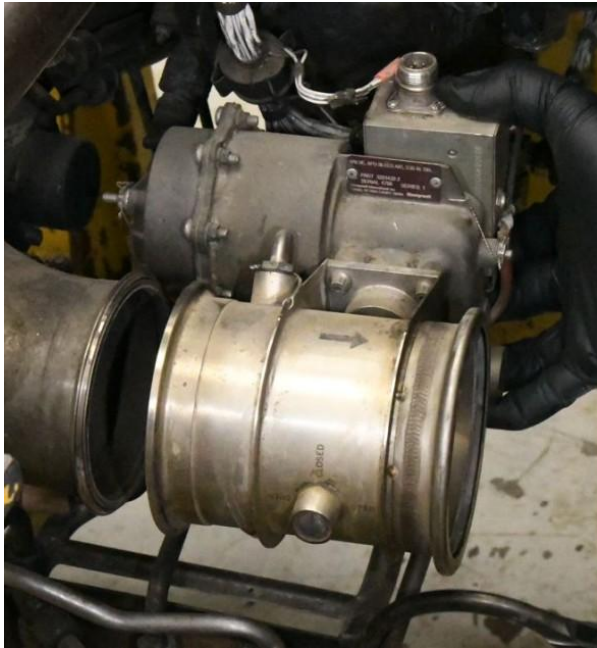
- b) The external hot air leakage detected was through the LCV shaft seal.
  - c) The leakage rate measured was completely out of the acceptance value.

- d) An ATP was performed to the valve and failed in several checks.
6. Oil traces on the lower part of the APU Oil Tank and Low Oil Pressure switches:

- On the LCV due to a failure of the shaft seal.

On separate testing of the Load Control Valve in Honeywell lab, external hot air leakage detected was through the LCV shaft seal, the leakage rate of which was completely out of the acceptable value.

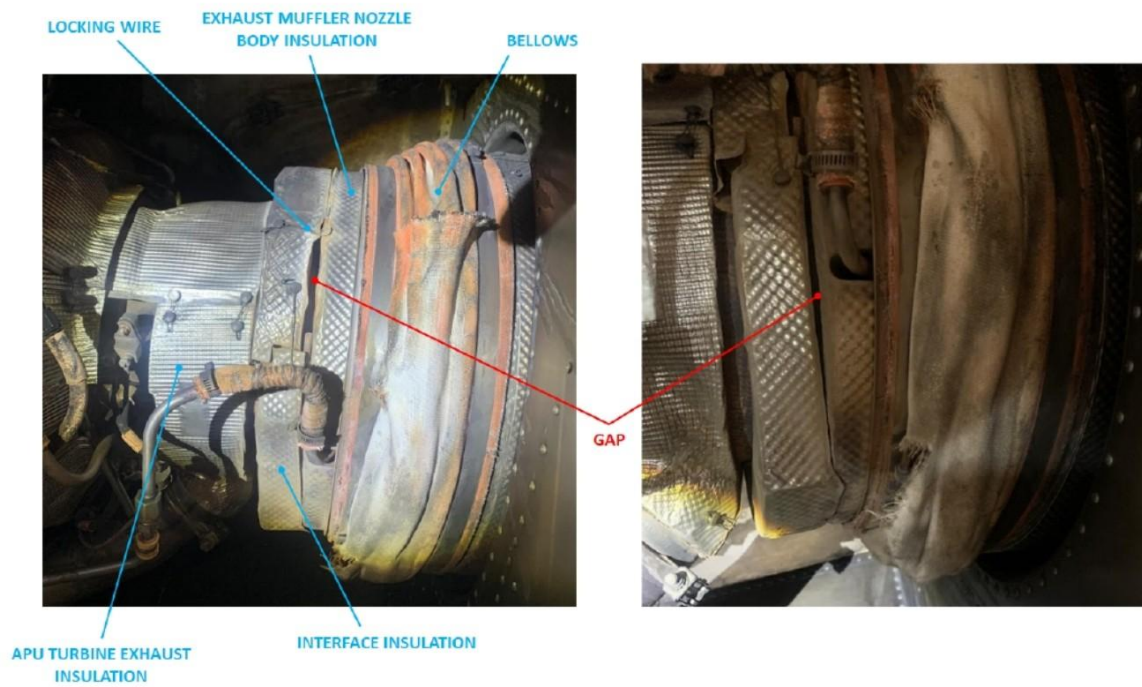
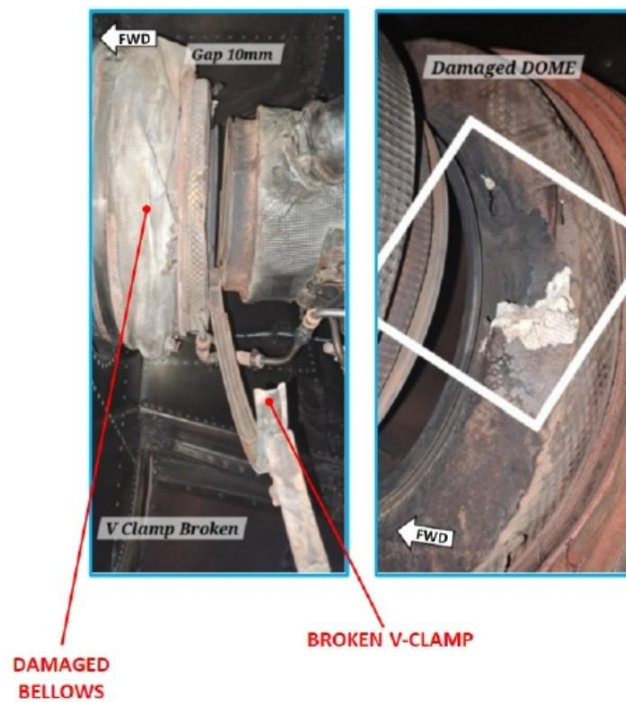
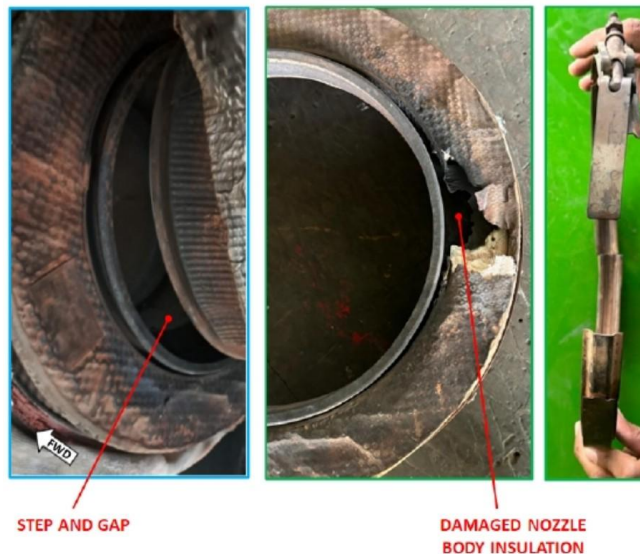
However, During the APU Compartment initial inspection, a gap between the interface thermal blankets and the Nozzle Body thermal blanket was detected. After the removal of the thermal insulation blankets, the APU Exhaust Muffler V-Clamp was found to be broken and displaced. A gap of 10 mm between the APU and the APU Exhaust Muffler was noted. The V-Clamp failure caused not only a gap, but also a step resulting in the misalignment of the APU Engine and APU Muffler centrelines.

Exhaust Muffler interface damages were reported on the APU. During the APU Compartment initial inspection, a gap between the interface thermal blankets and the Nozzle Body thermal blanket was detected. After the removal of the thermal insulation blankets, the APU Exhaust Muffler V-Clamp was found to be broken and displaced. A gap of 10 mm between the APU and the APU Exhaust Muffler was noted. The V-Clamp failure caused a gap and a misalignment of the APU Engine and APU Muffler centrelines.
