Final Investigation Report on Abnormal Runway Contact Incident to M/s. Srilankan Airlines A330-343 aircraft Regn. 4R-ALR at Cochin on 27/05/2018

Model : A330-343

Registration : 4R-ALR

13. Type of incident : Off Centre Landing – (ARC)

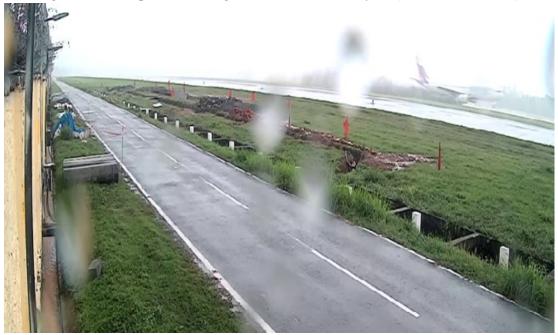
At 0955 UTC, the aircraft carried out landing at Cochin International Airport. However, while landing, Tower controller and SMC controller noticed that the aircraft not landed on the centre of the runway 27 and subsequently the aircraft re-entered the runway. Immediately, fire station was alerted by the Air traffic controller and also the aircraft was contacted for any assistance. Crew reported that the aircraft was under control and no assistance required.

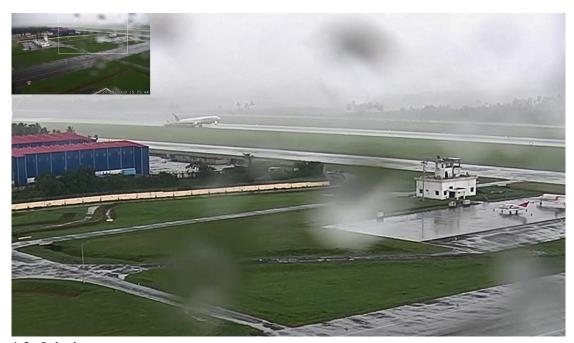
Fig.1B: Aircraft position during touchdown on runway 27. (Another view)

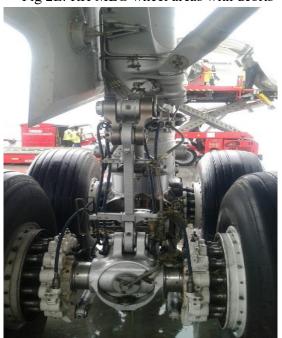
Aircraft sustained minor damages. On visual inspection, RH side MLG tyres received the following damages;

- a. Multiple cuts on # 3, # 4 and # 8 main wheels side wall.
- b. Thread got separated and found hanging on #7 main wheel.

Fig 2E: RH MLG wheel areas with debris

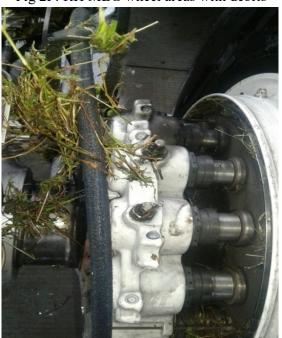
Fig 2F: RH MLG wheel areas with debris

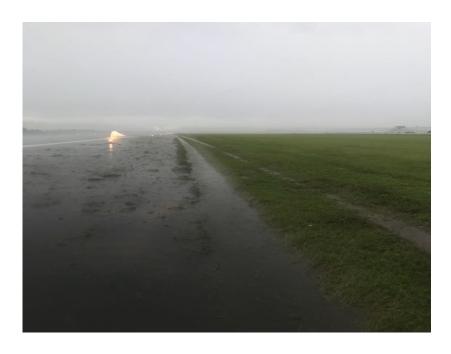
Impact markings indicate that the aircraft's RH MLG made a touch down on the unpaved muddy surface (RH side of the runway 27) and longitudinally around 810 meters from the threshold of runway 27. After rolled out for a distance of approx. 420 metres in the same path, RH MLG entered the runway shoulder pavement area and damaged two runway edge lights (R 1-8 & R 2-8) at the entry point on its track.

Fig.05A: Ground Markings left over by the aircraft on unpaved surface of Runway 27

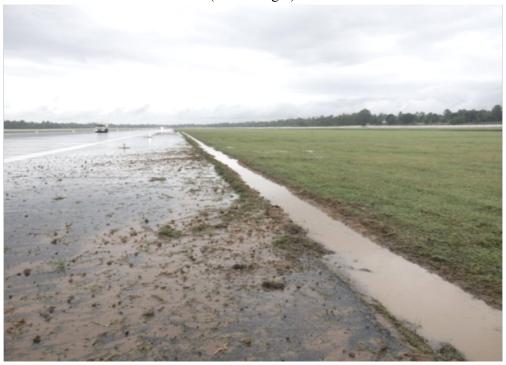
Fig 05B: Ground Markings left over by the aircraft on unpaved surface of Runway 27 (in clear light)
