CIVIL AVIATION DEPARTMENT

FINAL INVESTIGATION REPORT

FINAL INVESTIGATION REPORT ON GROUND INCIDENT INVOLVING M/s AIR
INDIA EXPRESS AIRBUS A320N AIRCRAFT VT-ATJ
AT SURAT AIRPORT ON 13th March 2024

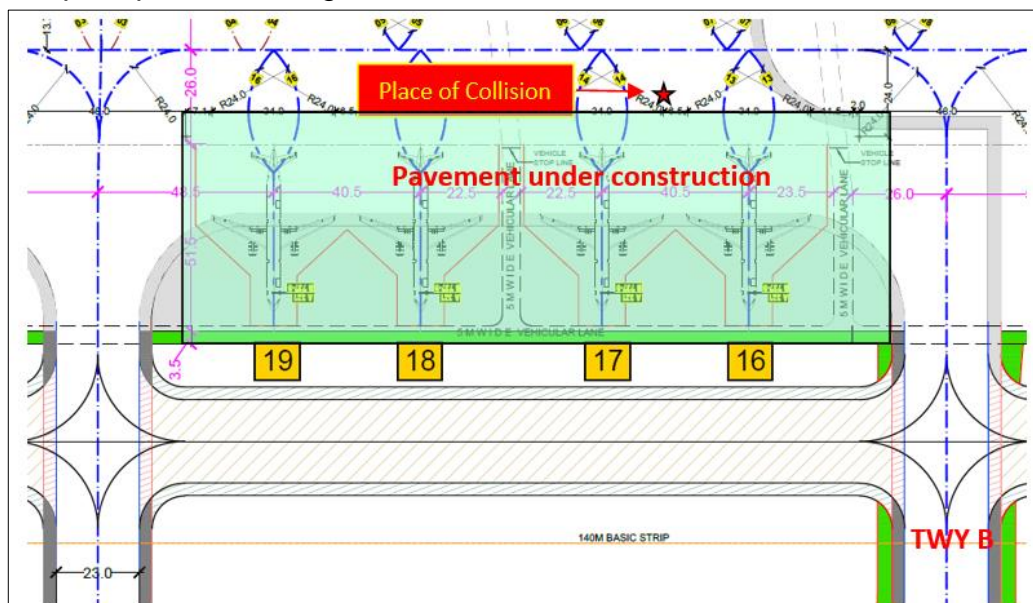
Construction of parallel taxi-track and the extension of the Apron between Taxiway A and Taxiway B were underway at Surat Airport. The construction works were being carried out by a contracted agency under the supervision of the aerodrome officials. Dump trucks, pavers and rollers were used for the same at a distance of 3.5 m from the apron pavement edge.

Fig.1: Place of collision and the under-construction pavement depicted in the approved apron proposed marking layout chart

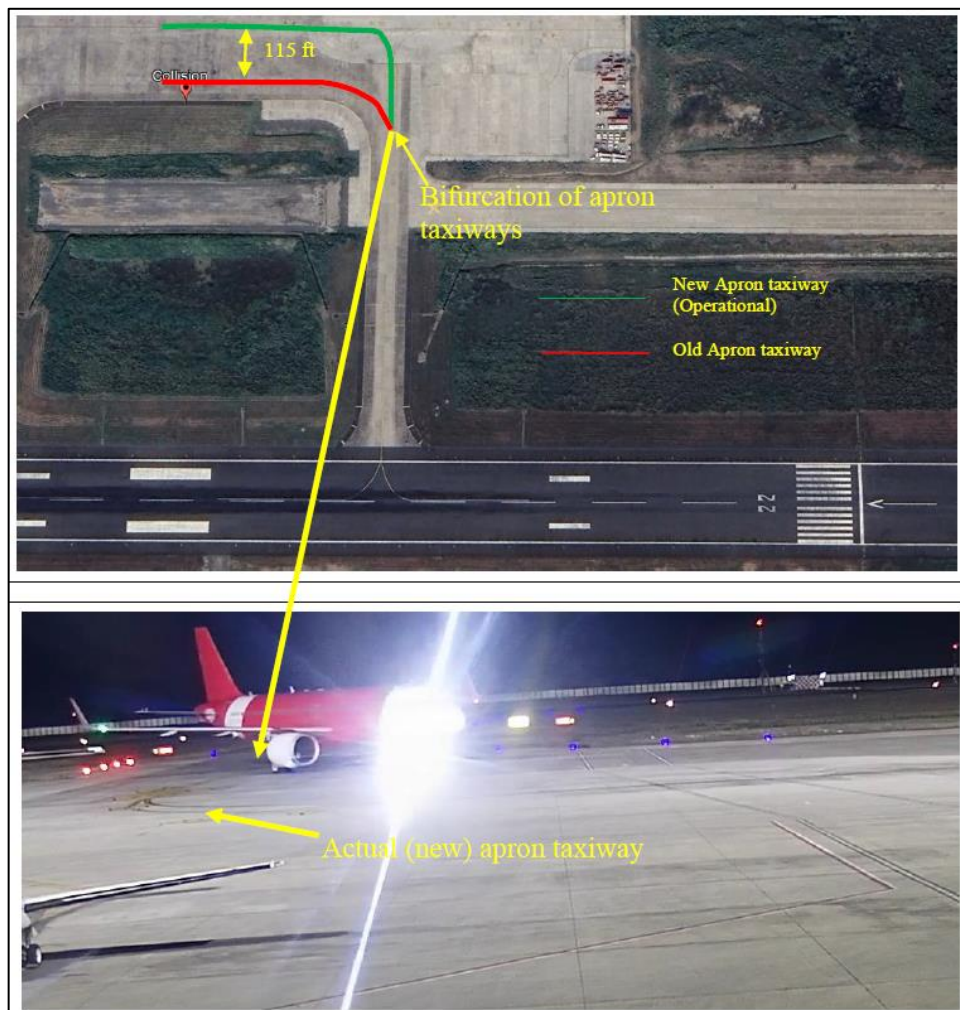
Fig. 2: Depiction of bifurcation of apron taxiway and AXB172 following old apron taxiway

The aircraft took a left turn on a non-operational (greyed-out) old apron taxiway, which is 9m away from the apron pavement edge.

The aerodrome operator had greyed out the entire old apron taxiway and the new apron taxiway was painted from a point 358 ft from the runway holding point. However, apart from painting the old apron taxiway with grey/black paint, no other measures were taken to declare the apron taxiway unserviceable. Further, all the previous markings related to the stand on the old apron taxiway were also painted out with grey/black paint.

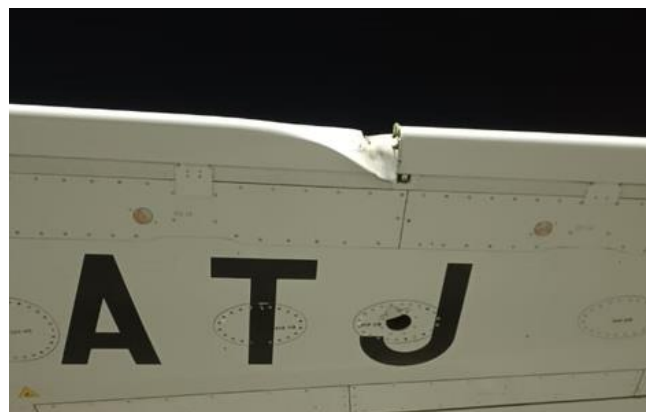
The collision of LH wing of the aircraft with the extended bed of the construction dump truck resulted in damage to slat#5 of Left-Hand side wing leading edge.

Fig.3: Damage to Slat#5 of LH wing

- 3.1.15. The collision had damaged the LH wing Slat No. 5 of the aircraft VT-ATJ.

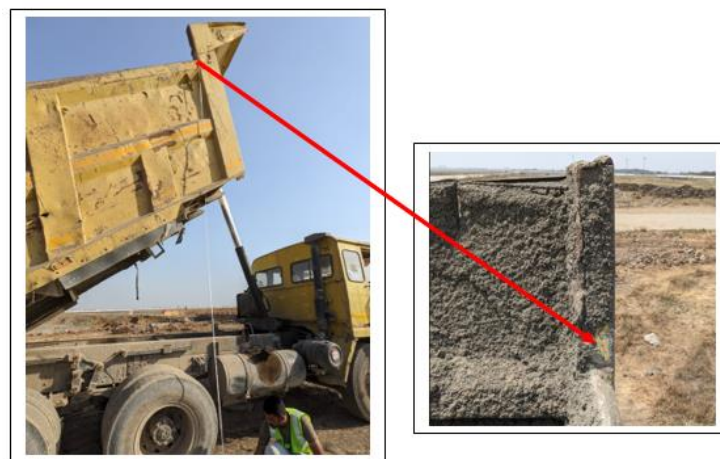
Fig.4: The construction dump truck and the scratch due to the collision

Except for a scratch at the area in which the LH wing leading edge of the aircraft hit, no damage was observed on the construction dump truck. The height from the scratch to the ground level, when the bed is extended, is 4.65m. Hence, the height of

the vehicle above the apron PQC (Pavement Quality Concrete) pavement level is 3.90m.

Further, the involved dump truck had flashing yellow lighting on the top of the vehicle as required by the CAR. However, the same would be invisible from behind when the bed of the dump truck is extended.

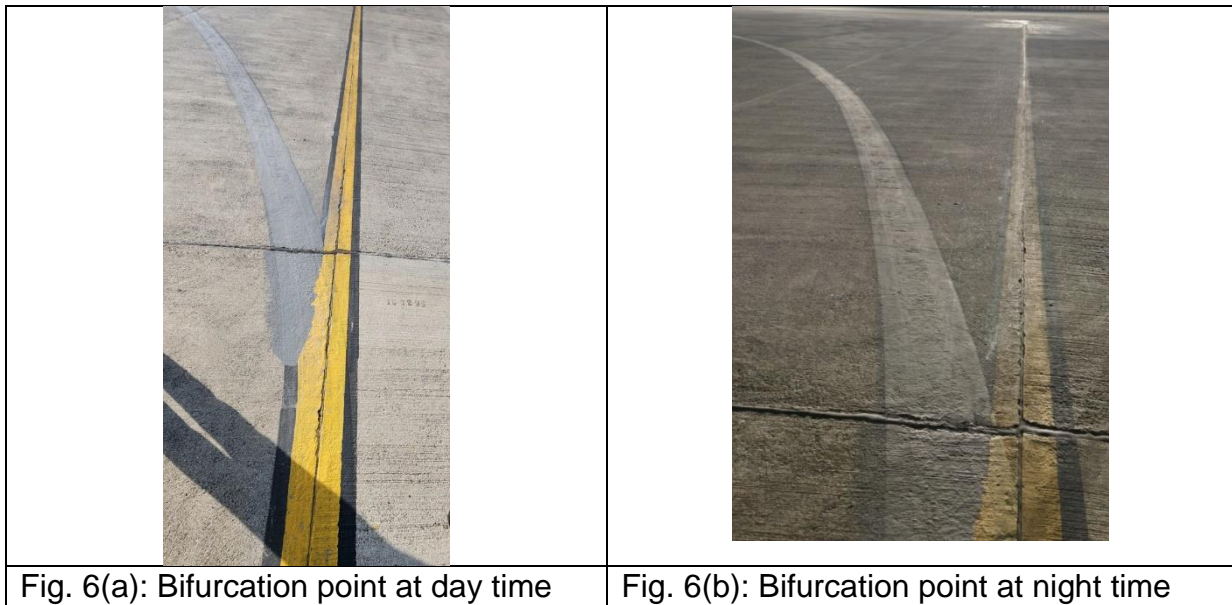
The new apron taxiway line was painted using regular water-based paint without any reflective materials. Para 5.2.1.7 of CAR Section 4 Series B Part 1 states “At aerodromes where operations take place at night, pavement markings should be made with reflective materials designed to enhance the visibility of the markings.”

During, the site investigation the next day after the incident with same meteorological conditions, the apron inspection was carried out at around 17:00 local time and at around 23:45 local time. The following are the pictures which were taken at approx. 5 ft above the apron elevation.

To address the issue of confusing markings on the apron, after the incident, observations were raised by O/o DAS-WR for lack of reflective materials for markings

and lack of conspicuous apron visual markings. Appropriate corrective actions were taken by the aerodrome operator. Currently, the apron taxiway centre line markings are made using reflective materials.

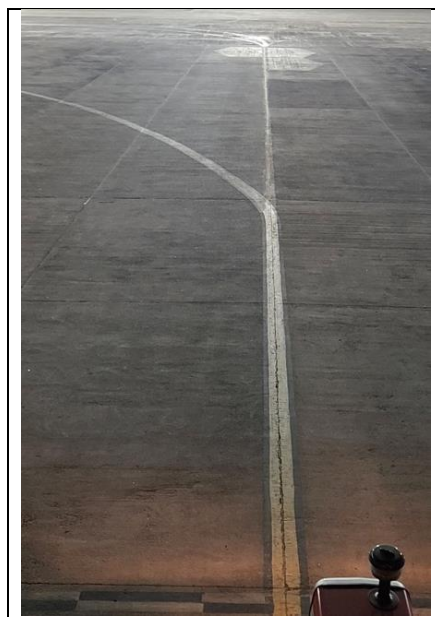
Fig.7: Image of bifurcation of apron taxiways at approx. 16 ft above apron elevation.
(at night time)

The actual (new) apron taxiway was last painted in the third week of February 2024. The actual taxiway would only be clear once the person is approx. 6 ft short of the bifurcation point.

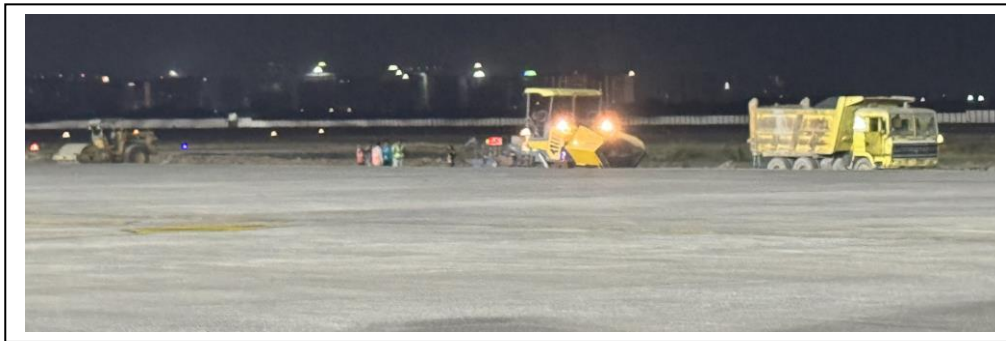
At the time of the incident, only one taxiway edge light was available at the apron edge between TWY A and TWY B. This implies that the taxiway edge lights were not placed at a distance as required by the regulation on the straight section, which is approx. 150m.

Fig.8: One taxiway edge light at the time of incident and vehicles not having object flags

The dump truck, paver and roller which were used for the construction work, being movable objects, did not have the flags required by the CAR at the time of the incident (Ref. Fig 8).

In a total of three dual light (blue and red) housings were taken from construction at Apron A and were placed at the apron edge of Apron C construction, after the incident. All AGLs were serviceable as per the records maintained by the Electrical Department.
