FINAL INVESTIGATION REPORT ON RUNWAY EXCURSION INCIDENT OF AIRCRAFT CESSNA CARAVAN 208B, VT-AHB OF M/S NAV DURGA AVIATION PVT LTD AT CHANDRAPUR AIRPORT ON 11 JANUARY 2024.

GOVERNMENT OF INDIA OFFICE OF DIRECTOR OF AIR SAFETY (WR) INTEGRATED OPERATIONAL OFFICE COMPLEX, SAHAR ROAD, VILEPARLE (E), MUMBAI – 400099

FINAL REPORT ON RUNWAY EXCURSION INCIDENT OF AIRCRAFT CESSNA CARAVAN 208B, VT-AHB BELONGING TO M/S NAV DURGA AVIATION PVT LTD AT CHANDRAPUR AIRPORT ON 11 JANUARY 2024.

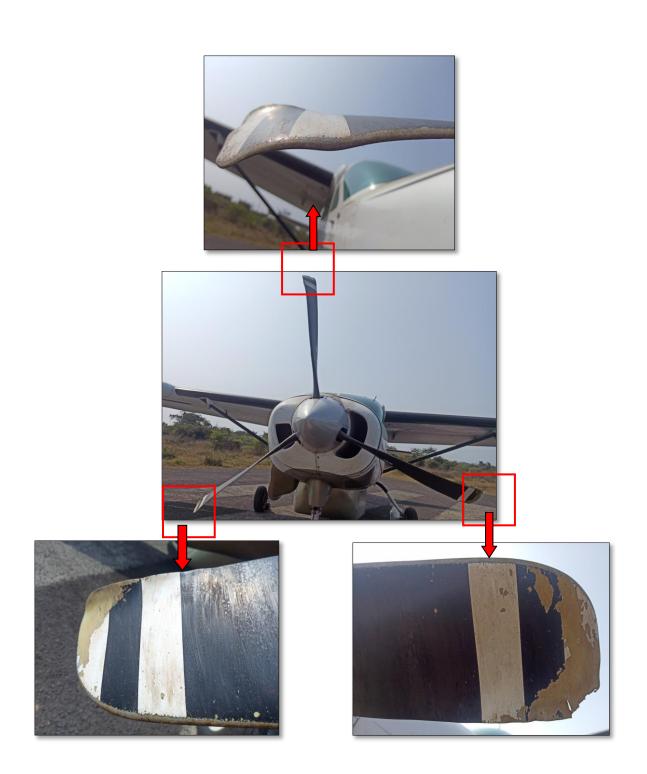
1.3.1 Aircraft Propeller – The propeller is fitted in front of the engine and engine is mounted on nose section of aircraft. It is bent on all the tips (03) as a result of propeller strike.

Figure 2 – Aircraft damaged Propeller tips

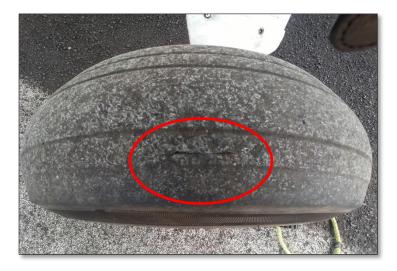
> LH tire condition- has light cut mark and more wear mark

Figure 3 – Left tire light cut mark and more wear mark

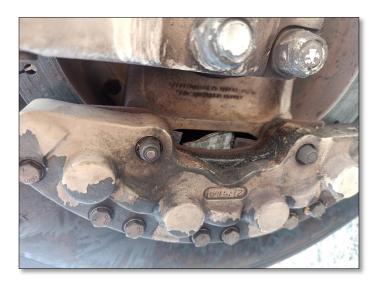
- ➤ RH landing gear brake condition- leaking (static)
- > RH brake seam is broken

Figure 6 – RH brake seam is broken

The RH brake seam was found damaged and leaking. The in-situ assessment clarified that the damage had happened during the aircraft movement on unpaved (kutcha) area. The markings of touchdown, brake application, aircraft rolling and subsequent veering towards left of Runway into kutcha area were observed during the site visit. No sign of propeller strike on the Runway was seen. The measurements were taken and is depicted in the below figure (Fig 12).

It was established during the site visit that the damages to the brake assembly and the associated leakages had occurred during the aircraft's movement on the unpaved area. Also it was established by the type trained engineer at the site that there were no abnormalities pertaining to the braking system of the aircraft. Therefore, the aircraft was considered airworthy at the time of the incident and the maintenance factor is ruled out.

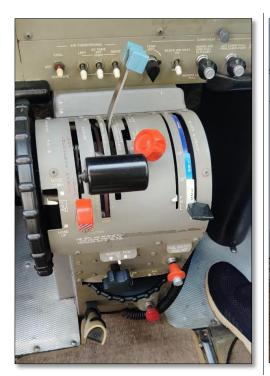
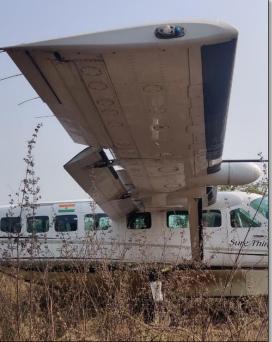
Subsequent to the incident, operational check of brakes was carried out by the qualified AME and found to be satisfactory. The aircraft was inspected during the site visit and found flaps were in 30 deg. Also from the cockpit inspection post incident it is understood that the crew had not pulled out fuel shutoff valve to the shut off position while securing the aircraft.

- 1. WING FLAPS Handle were in FULL position
- **2.** POWER Lever IDLE position
- **3.** FUEL SHUTOFF Knob NOT in OFF (Pull out) position

Fig. 11- Cockpit condition and Flap position

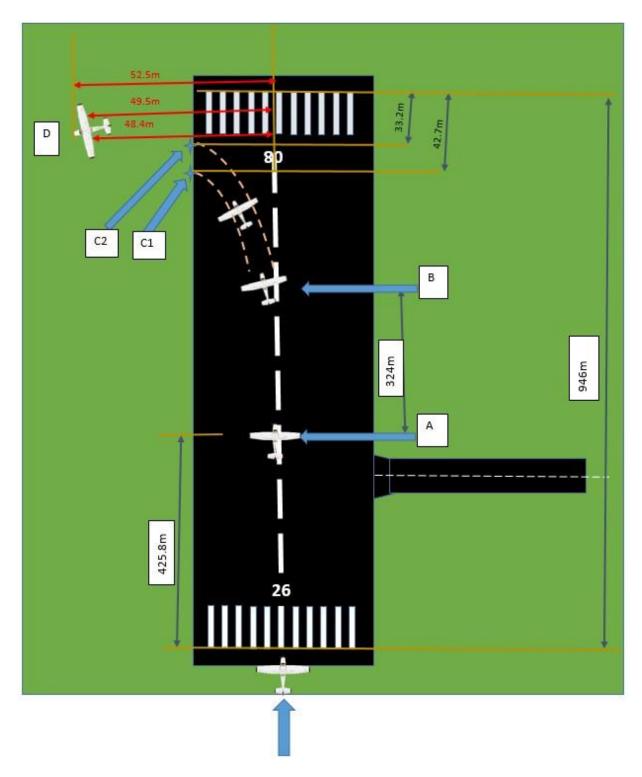
Approximate points of aircraft contacts with the runway surface were identified and the probable path taken by aircraft on the runway was generated with the help of video recordings made by a witness and the markings of aircraft tires. The following are the distances measured from point to point –

- The distance between the beginning of Runway 26 threshold markings and the touchdown point (A) is 425.8m.
- The distance between the beginning of Runway 26 threshold markings and the point from which aircraft started deviation to left (B) is 749.8m.
- The distance between the beginning of Runway 08 threshold markings and the point (C1) at which the LH tire exited RWY is 42.7m.
- The distance between the beginning of Runway 08 threshold markings and the point (C2) at which the RH tire exited RWY is 33.2m.
- The point D is the final resting location of the aircraft. The distance between the aircraft nose landing gear and centerline of Runway 26 is 52.5 m (towards left side). The distance between the aircraft RH landing gear and centerline of Runway 26 is 49.5m. The distance between the aircraft LH landing gear and centerline of Runway 26 is 48.4m.

Fig. 12– Landing roll profile and measurements _Aerial view (Not to be scaled)

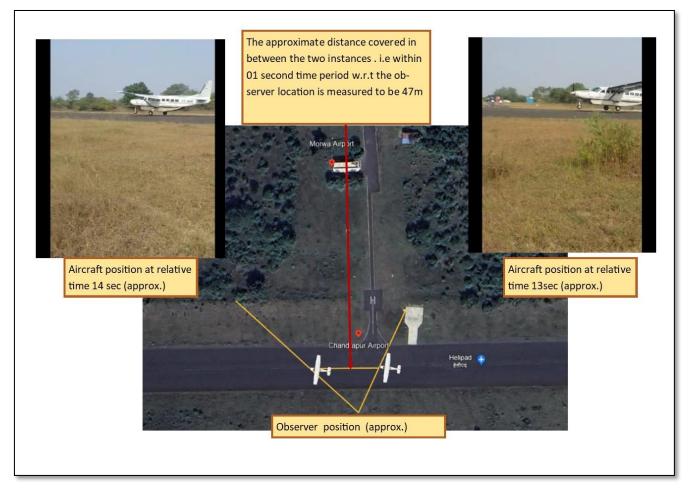
- One of the security guards positioned near the touchdown area of Chandrapur airport, video recorded the landing of the aircraft in his phone. Upon verifying the same, it was observed that the touchdown was done very late and was made after the taxi track. Also, as per one of the witnesses (guard), he felt that speed of the involved aircraft at touchdown was higher than the speed with which similar model aircraft normally lands at the airport.
- From the video recording, the relative time and visual clues were considered and compared with the references/measurements taken during the onsite visit. It has been established that the aircraft had covered almost 47 m (approx.) in one second after the touchdown. Thus, the approximate landing speed of aircraft VT-AHB is calculated to be 92 kts.

Fig. 13– Approximate distance traveled of aircraft VT-AHB in 1 Second

Upon reviewing the video recording of the landing phase made by the security guard, it is inferred that the aircraft was flying parallel to the runway at a very short height before making the touchdown. The touchdown was delayed due to this, resulting in a long landing. The touchdown of the aircraft was about to be 425.8m from the beginning of the Runway 26 threshold markings. From the analysis made with the help of references from the video recording and the measurements taken during the site visit, it is observed that the aircraft traversed a distance of approximate 47 meters in 1 second after its touchdown on the runway surface. This indicates that the speed of the aircraft during landing was approximate 92 knots, which was more than the prescribed landing speed of 75-85kts as per POH.
