**FINAL INVESTIGATION REPORT ON RUNWAY EXCURSION INCIDENT TO
M/s. CHIMES AVIATION PVT LTD
CESSNA 172R AIRCRAFT, VT-CAG
ON 17.07.2021 AT DHANA AIRSTRIP, MADHYA PRADESH.**

**GOVERNMENT OF INDIA
OFFICE OF DIRECTOR OF AIR SAFETY (WR)
INTEGRATED OPERATIONAL OFFICE COMPLEX,
SAHAR ROAD, VILEPARLE (E), MUMBAI – 400099**

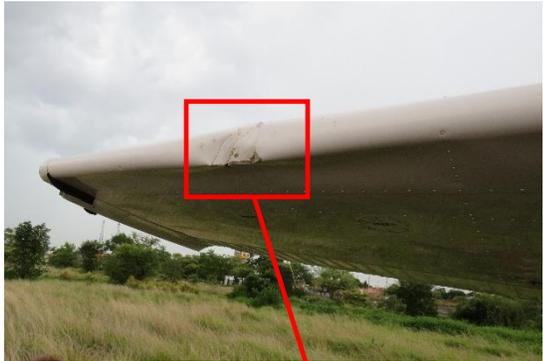
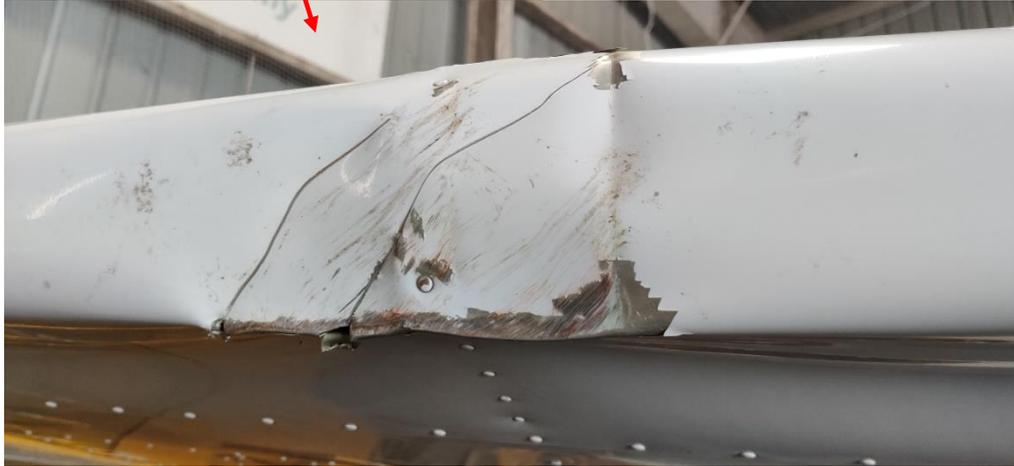
- i. RH main landing gear fairing assembly (Part no: 0541193-8), was damaged.
- ii. RH wing leading edge skin and rib near wing tip (WS 208) damaged, RH wing leading edge near WS 100 near wing strut attach point damaged.(Part no:- 0523029-4, 0523028-20 & 0523034-2).
- iii. RH wing-NAV light cover broken (Part no: 0723205-10).
- iv. Skin Aft Fuselage RH & Tail cone Fairing, (Part no. - 0512008-4 & 0530011-2) were found bulged/damaged.
- v. Fairing attachment point of vertical fin near FS 205.91 sheared-off (Part No- 0531012-2).

Fig. 01 Damage to the starboard wing leading edge

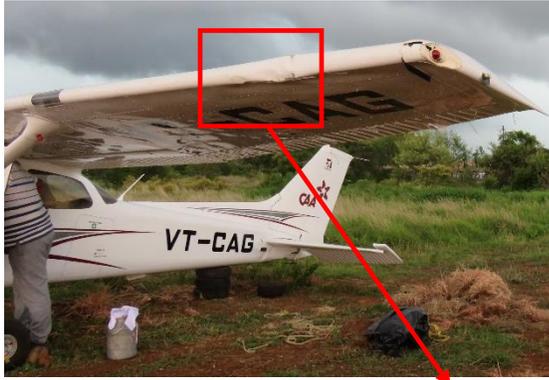
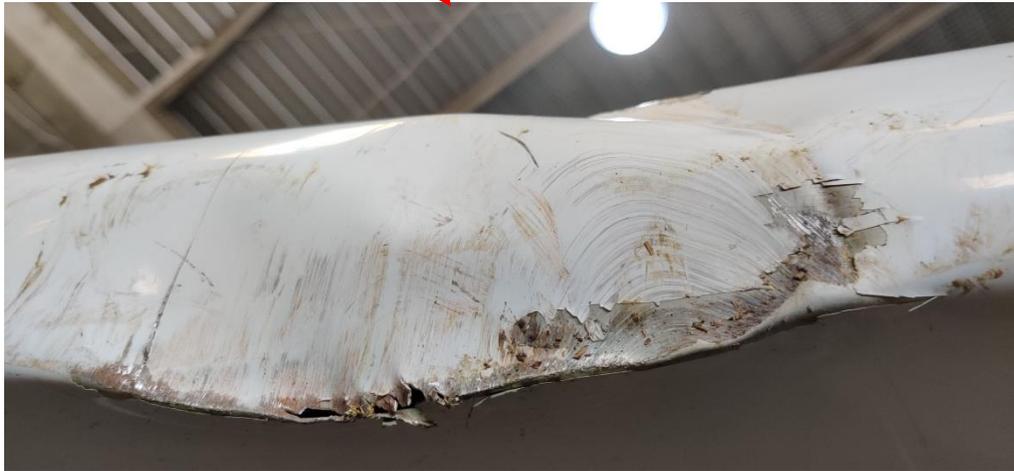
- x. LH side NAV light cover and wingtip assembly (Part No- 0723206-1) was damaged.
- xi. LH wing skin leading edge outboard (Part no- 0523029-5) and 02 ribs at WS 172.00 & WS 190.00 (part no. 0523034-1 & 0523035-1) found damaged.

Fig. 02 Damage to the port side wing leading edge

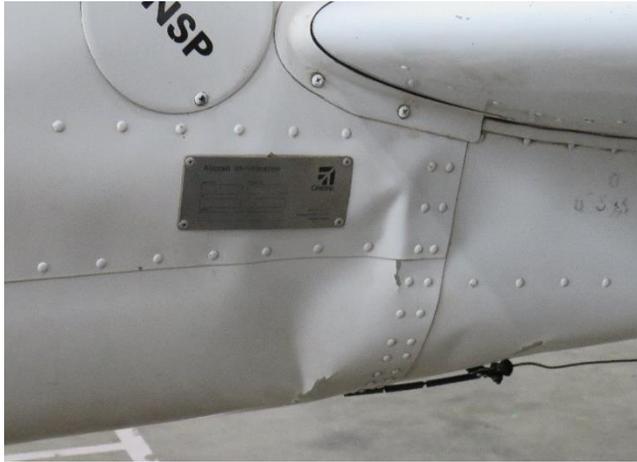
- vi. Tail section at bottom between FS 205.81 TO FS 228.68 damaged.
- vii. Bulging/damage on LH side aft fuselage skin (empennage area)-(Part no- 0512008-4 & 0530011-2).

Fig. 03 Bulging on LH side empennage area

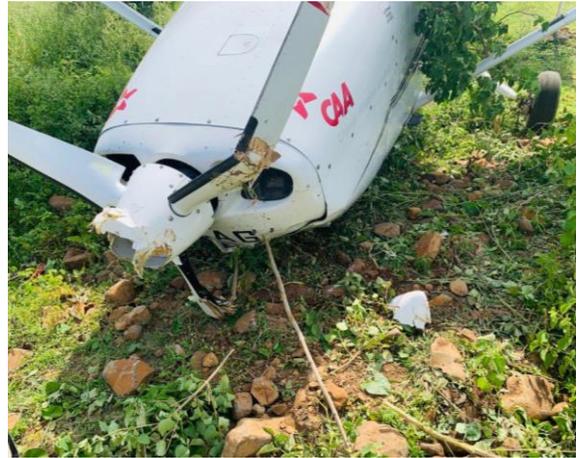
- xxvi. Weld Assembly & Bearing Assembly (Part No- 0411306-14 & 0411306-25 & S1674-1 & S1675-1) was damaged.
- xxvii. Aircraft Propeller (Part No- MTV-6A/187-129, S/N- 061157) and Propeller Spinner (Part no.-B-426_P-1071) damaged.

Fig. 04 Propeller damage

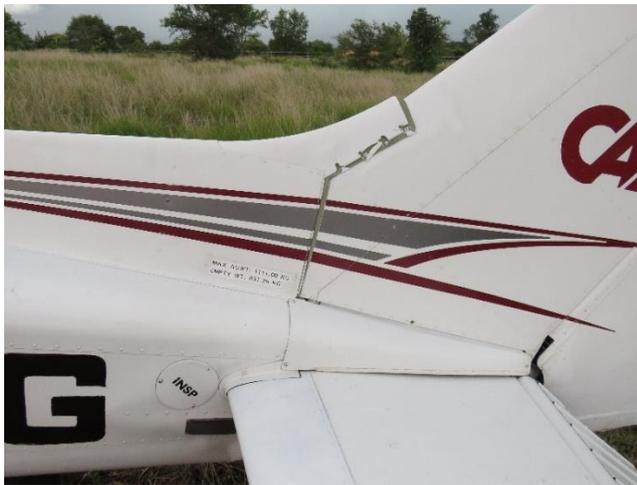
Fig. 05 Damage to bottom part of tail section

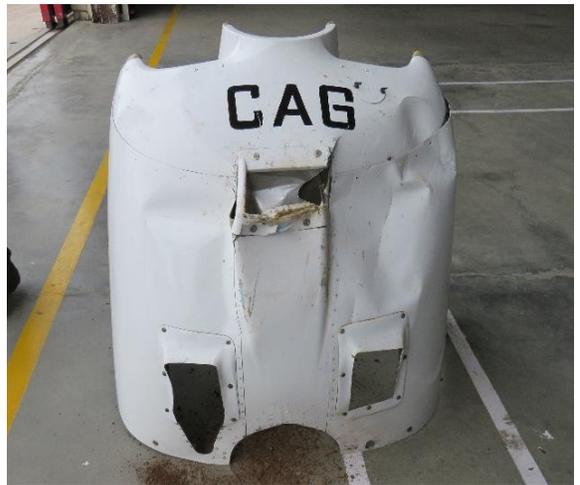
- xii. LH Landing Gear Fairing Assembly (Part No- 0541193-7) found damaged.
- xiii. Lower cowling (Part no- 0552242-7) found damaged.
- xiv. Nose Landing Gear Lower & upper fittings (Part no- 0543016-1 & 0543013-1) were found damaged.

Fig. 06 Damage to the bottom cowling

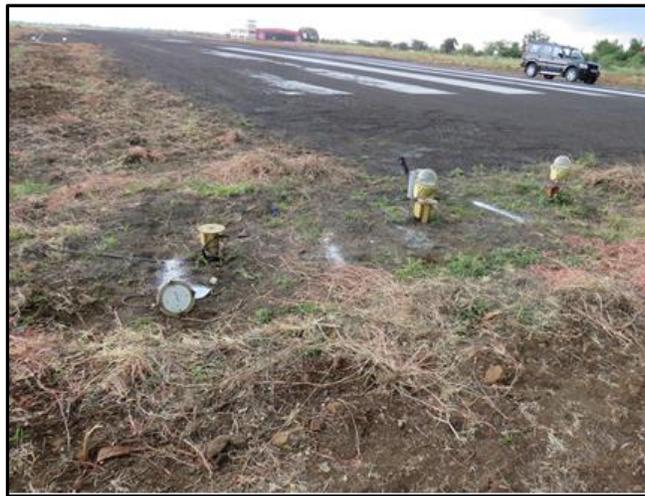
1. Damage to 01 Runway end light (RWY 17 RH far end) due aircraft hit.

Fig. 07. Damage to RWY 27 end light

- xiv. The damage to the RWY end light assembly was due to the aircraft overrun during its exit out of the RWY.
- xv. The runway 17 end portion was found degraded with loose pebbles during site inspection.

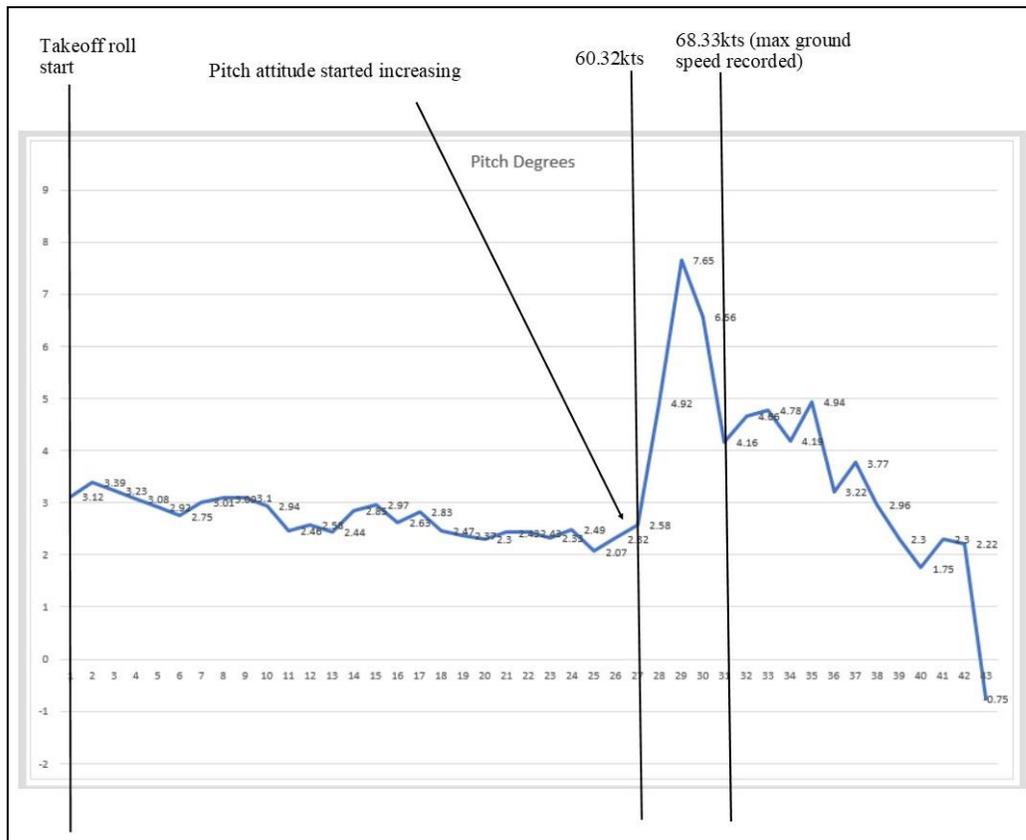
Fig.08 Pitch degree vs relevant time

The first takeoff and landing was uneventful and the aircraft after the first landing on RWY 17, back tracked from near the Taxiway 'B' and lined up for the second take off. The aircraft started rolling for the second takeoff at 14:43:21hrs (local time) on RWY 17. The pitch angle started increasing at a ground speed of around 60kts and reached a maximum pitch angle of 7.65 degrees. The maximum ground speed attained by the aircraft is 68.33kts during which the pitch angle was 4.16degrees. The aircraft had a pitch angle of 4.19degrees near TXWY B and 3.77degrees near to TXWY A.

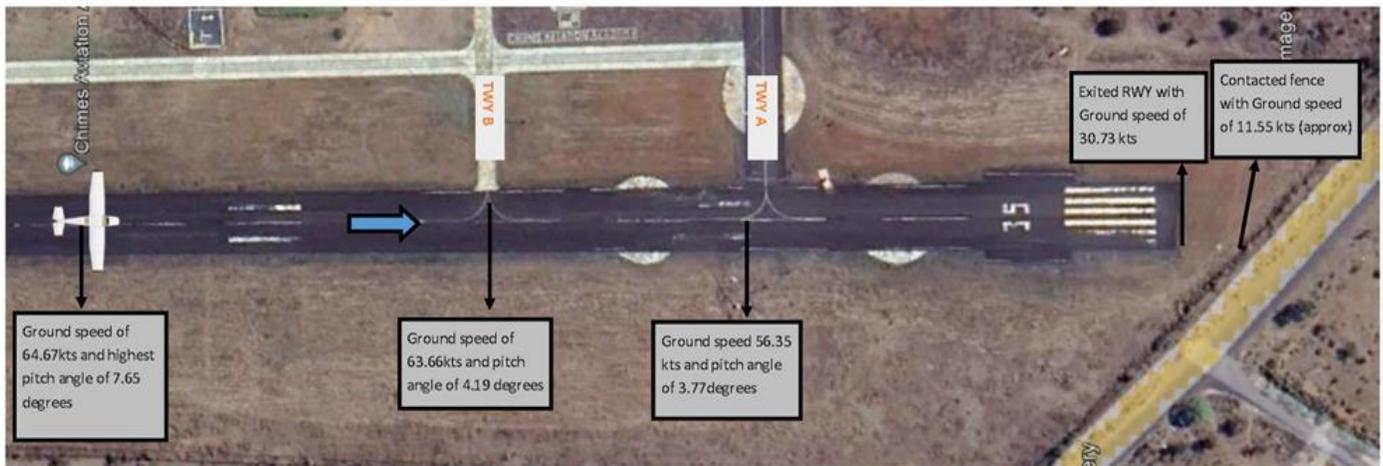
Fig.09 Aircraft ground speed and pitch correlation

The aircraft exited the runway with a ground speed of 30.73kts and contacted the fence with an approximate ground speed of 11.55kts. The average wind speed recorded by the aircraft during the second takeoff roll was 2.9kts. The data of the Mean Sea Level Altitude shows that the aircraft height had not increased more than 10ft from the ground surface. The brake parameters are not recorded in the Garmin data.

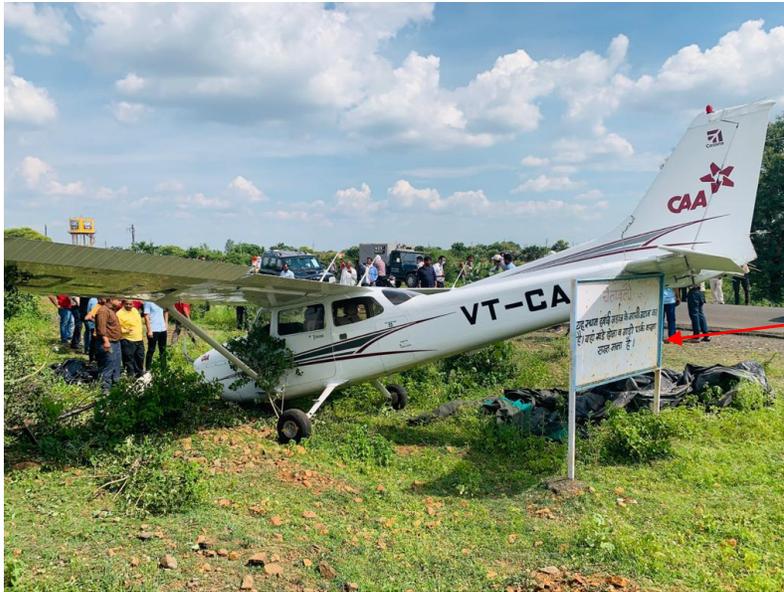
rolled over it towards the road. The aircraft passed down the small slope next to the fence and during its movement the horizontal stabilizer of the aircraft came in contact with one of the metallic notice boards placed on the road side. The aircraft got turned towards left with the tail pivoting on the board. The final position of the aircraft was facing east with LH horizontal stabilizer resting on the metal board and aircraft was at a distance of 82ft from the Runway end, measured perpendicular. The flap lever in the cockpit (in-situ) was found in Flaps 0 (UP) configuration. The engine controls were in switched off position and elevator trim NOT in takeoff position.

Fig. 10 Aircraft position after coming to halt (tail resting on notice board)

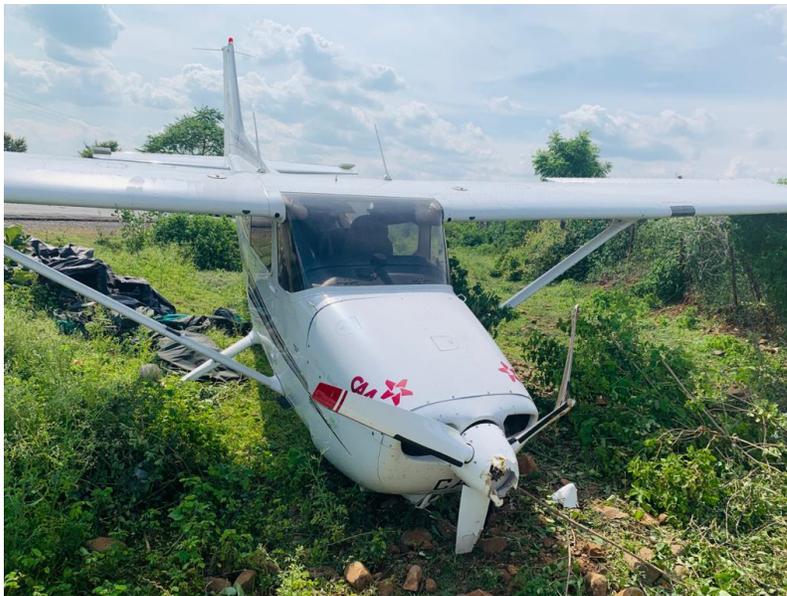
Fig. 11 Aircraft position after coming to halt (view from road side).

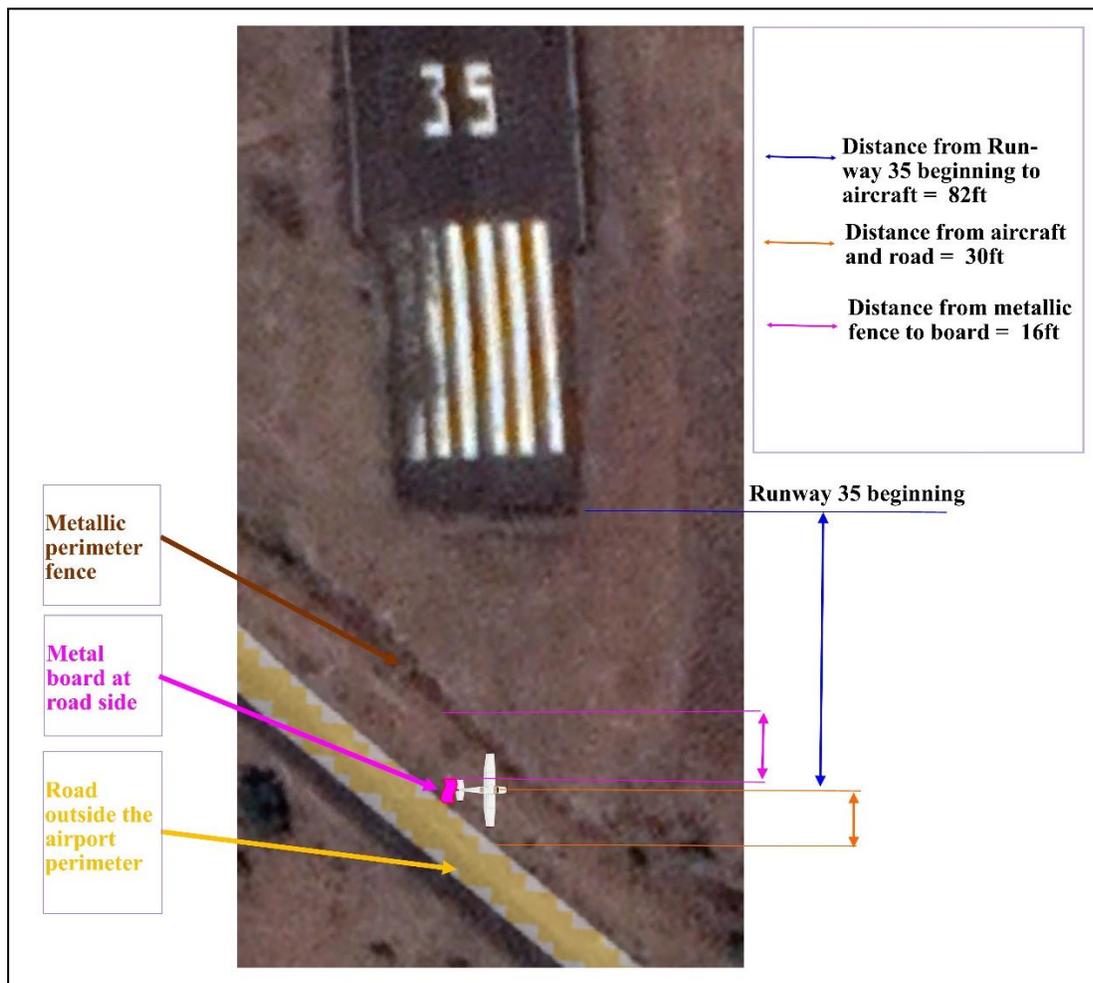
The actual location of touchdown could not be identified hence approximate touchdown location was obtained from the witness statement. The aircraft made the touchdown on RWY surface near to TXWY 'B' at around 2364ft from the RWY 17 beginning. The latitude longitude positions extracted from the Garmin system shows the path followed by the aircraft from the takeoff roll till halt. (Refer fig 13). The perimeter fencing of the airport is located at a distance of 68ft (perpendicular distance) from Runway end. The road is at a distance of 44ft from the fencing. The metallic sign board at the road side is at a perpendicular distance of 16ft from the fencing. The aircraft while moving out of the soft ground, came into contact with the metallic perimeter fence and damaged it and then

Fig.12.Aircraft position after coming to halt- aerial representation (not to scale)

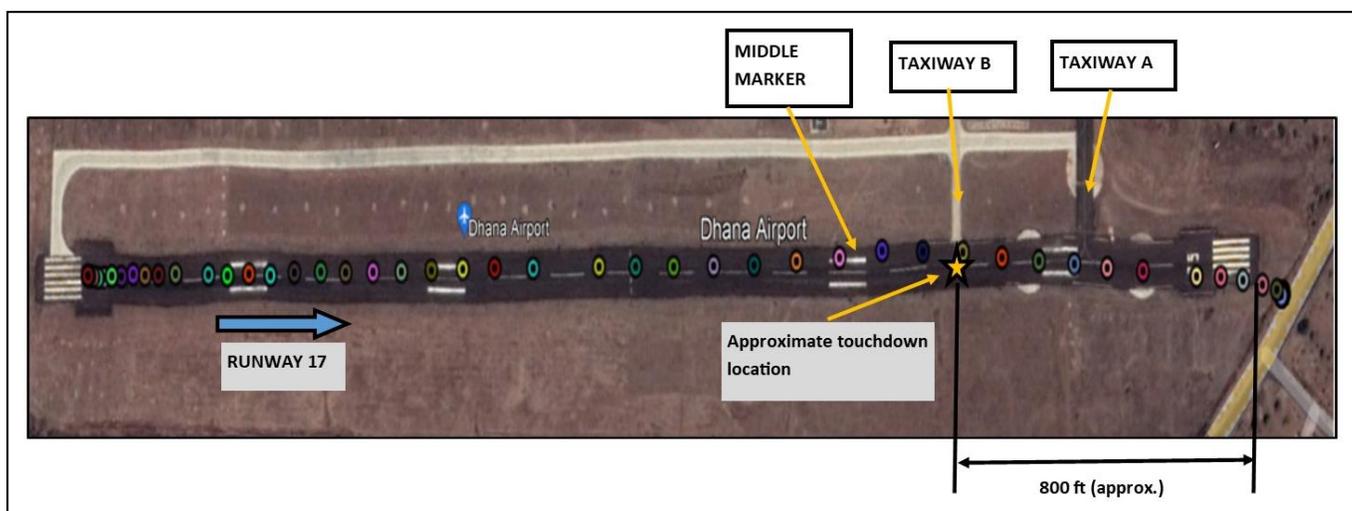
Fig.13.path followed by the aircraft on the runway (aerial view)
