FINAL INVESTIGATION REPORT ON SMOKE IN PASSENGER CABIN
INCIDENT OF M/S SPICEJET DASH8 Q-400 AIRCRAFT VT-SUR ON
02/07/2022 AT DELHI

DIRECTORATE GENERAL OF CIVIL AVIATION
GOVERNMENT OF INDIA
NEW DELHI-110003

**FINAL INVESTIGATION REPORT ON SMOKE IN PASSENGER CABIN INCIDENT
OF M/S SPICEJET DASH8 Q400 AIRCRAFT VT-SUR AT DELHI ON 02/07/2022**

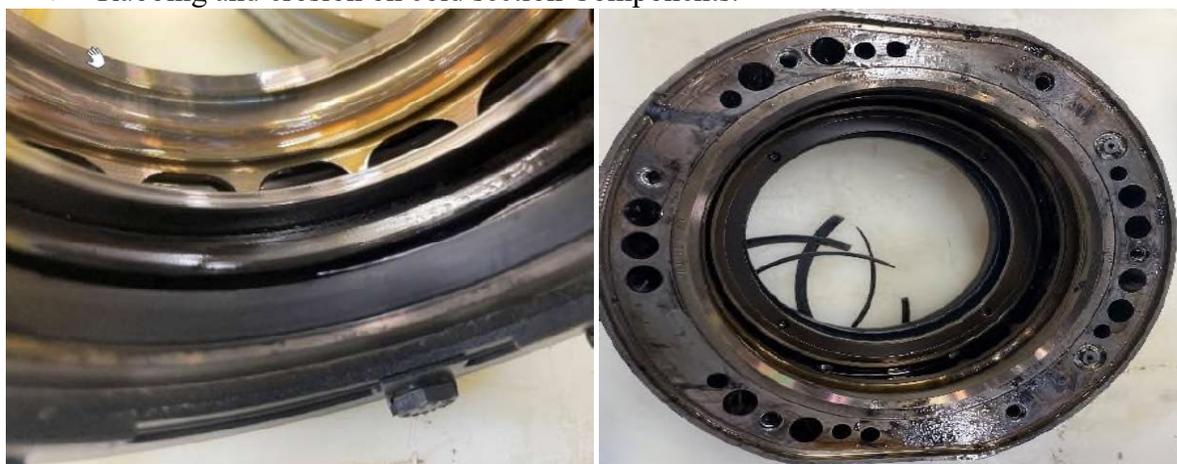
As per the Engine Shop report of Engine No. 1 (PCE-FA0459), during the engine review at teardown, the following were observed:

- Severely damaged N0.4 carbon seal and flexible housing
- Traces of oil in the cold section gas path components
- Cracks on inter-compressor case
- Rubbing and erosion on cold section Components.

It is evident from above observations that the damaged carbon seal of bearing No.4 on ENG#1 would have allowed ingress of lubricating oil into gas path and it entered into air conditioning system through P2.7 port and airframe ducts and resulted in smoke and odour in the passenger cabin.

2.1.7 As per the Engine Shop report of PCE-FA0459, during the engine review at teardown, it was observed that flexible housing & No.4 carbon seal on ENG # 1 was severely damaged with traces of oil in the cold section gas path components. Hence, it is concluded that, the damaged carbon seal of bearing No.4 on Engine #1 allowed the ingress of lubricating oil into gas path and it entered into the air conditioning system through engine bleed ports which led to smoke and odour in passenger cabin.

Damaged carbon seal of bearing No.4 on Engine #1 allowed ingress of lubricating oil into gas path and it entered into the air conditioning system through engine bleed ports which led to smoke and odour in passenger cabin.
