FINAL INVESTIGATION REPORT ON HARD LANDING INCIDENT INVOLVING M/s AIR INDIA LIMITED AIRBUS A 320-251N AIRCRAFT VT-CIQ ON 20.12.2023 AT DUBAI INTERNATIONAL AIRPORT

GOVERNMENT OF INDIA O/o DIRECTOR AIR SAFETY, WESTERN REGION, NEW INTEGRATED OPERATIONAL OFFICE COMPLEX, SAHAR ROAD, VILE PARLE (EAST), MUMBAI-400099

FINAL INVESTIGATION REPORT ON HARD LANDING INCIDENT M/s AIR INDIA LIMITED AIRBUS A320-251N AIRCRAFT VT-CIQ AT DUBAI INTERNATIONAL AIRPORT ON 20.12.2023

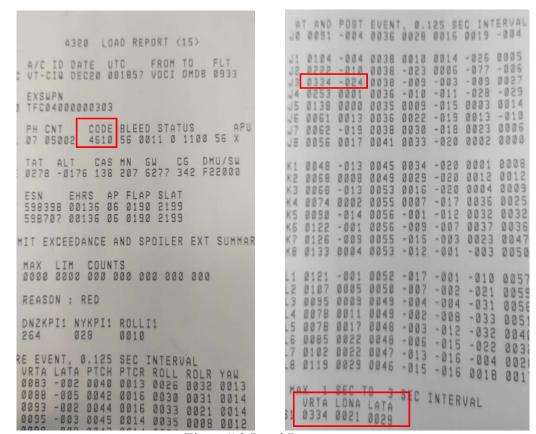
Figure# 2 Load Report

The load report reflected code 4610 indicating high vertical and lateral loads encountered by the aircraft during landing.

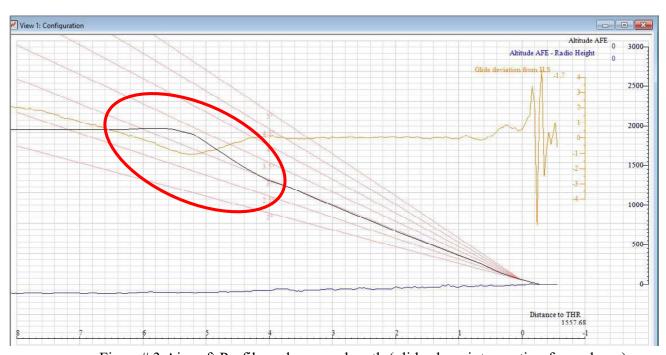
Figure# 3 Aircraft Profile and approach path (glide slope interception from above)

Before intercepting G/S from above, the landing gears were lowered as recommended in FCTM however the speed brakes were not used. Flaps were already in CONF2 at this time and A/P1 and A/THR was engaged. In order to capture G/S from above, the aircraft dived with reduction in pitch angle, an increase in CAS and rate of descent (the maximum vertical speed was recorded as -1696 ft/m), and a reduction in both engines' thrust. Subsequently, the APPR p/b was pressed and G/S could be captured at 1633ft RA when the aircraft was approx. 5NM from RWY threshold. The sequence of procedure for the glide slope interception from above was not followed as it was ascertained that crew selected APPR mode subsequent to start of descent. Further, the vertical interception was not monitored during descent as required by FCTM, as LS p/b (indicating G/S and LOC deviation scale) was not selected until the APPR p/b was pushed.

The CAS was increased upto 170.5kts during capturing of G/S from above whereas the speed restrictions as per the approach chart is 160kts. The violation of speed restriction was not intimated to ATC by the crew. The CAS started reducing subsequently and flap3 was deployed. Aircraft reached to the 3degree glide path at approx. 4NM instead of 6NM. Maintaining the same

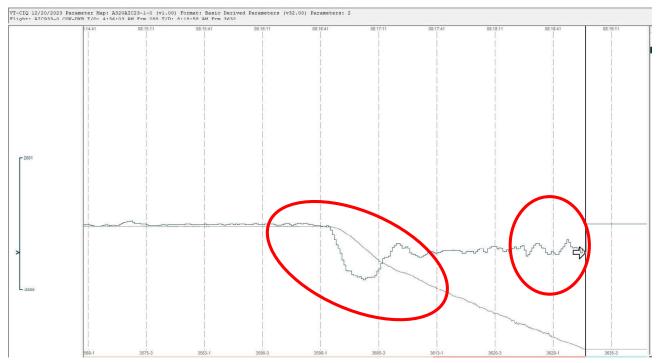
Figure# 4 Vertical speed Vs RA

- From 100ft RA to 49ft RA, the nose up and down pitch inputs were observed to have been given by P1 which resulted in a corresponding increase and decrease in the pitch attitude of the aircraft. The pitch of the aircraft increased from 4degree at 100ft RA to 5.6degree at 85ft RA and subsequently, decreased to 4degree when the aircraft reached at 49ft RA. The nose down input given by P1 increased the vertical speed from -688ft/m at 100ft RA to -880ft/m at 33ft RA.

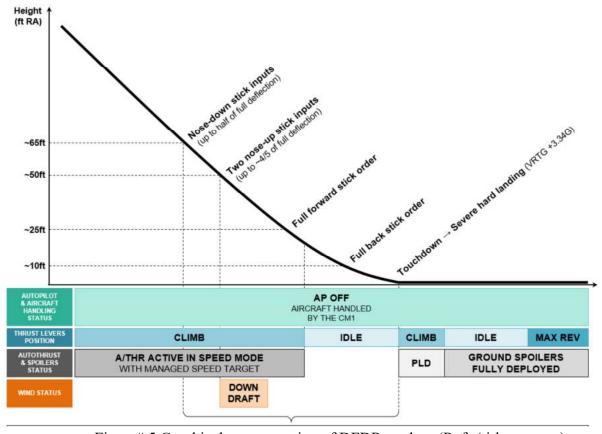
Figure# 5 Graphical representation of DFDR readout (Ref. Airbus report)

At 49ft RA, backward stick input was given by PIC for initiating flare whereas the FCTM recommends initiating flare in stabilized conditions at 30ft RA. At approx. 25ft RA, PIC applied a full forward stick order lowering the nose down to 2.8degree in next second which increased ROD to 864ft/m. Instead of holding the stick or releasing the back pressure from the sidestick, PIC applied forward pressure on the stick which is contrary to the FCTM guidance. Due to this

Additionally, M/s Airbus has apprised in their report that all available weather information sources highlight no adverse wind conditions during final approach and the aircraft encountered downdraft of wind approximately at 50ft RA. However, the effect of the downdraft was not considered contributory as the PIC had applied downward sidestick order at approx. 25ft RA during flare increasing the ROD to 864ft/m at touchdown.
