**Final Investigation Report of Engine In-Flight Shutdown Incident to M/s. AIX  
Connect Pvt Ltd Aircraft VT-VTZ (I5-1563) After Takeoff from Kolkata on  
08.01.2024.**

**O/o Director General of Civil Aviation  
Air Safety Directorate,  
New Delhi– 110003**

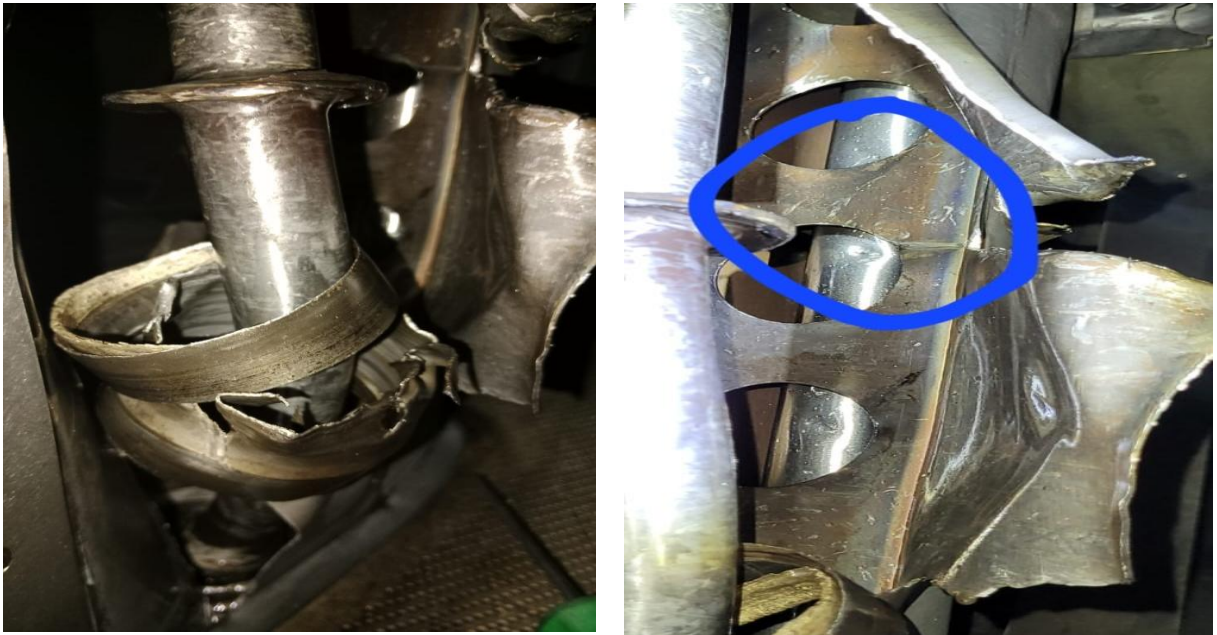
- 1.6.3.2. Post arrival engine 1 oil level was found at 13 QTZ. Fan frame strut # 07 was damaged along with radial drive shaft outer casing. No faults were detected in operational test of FADEC 1A & 1B with engine non motoring.

- 1.6.3.5. **Damages observed along with strut:** Fan duct panel @05:30 position corner area crack-adjacent right to the damaged strut. Aft acoustic panel liner stuck with damaged strut @6:30 position.

**Figure 6: Damages on the Fan frame strut #7**

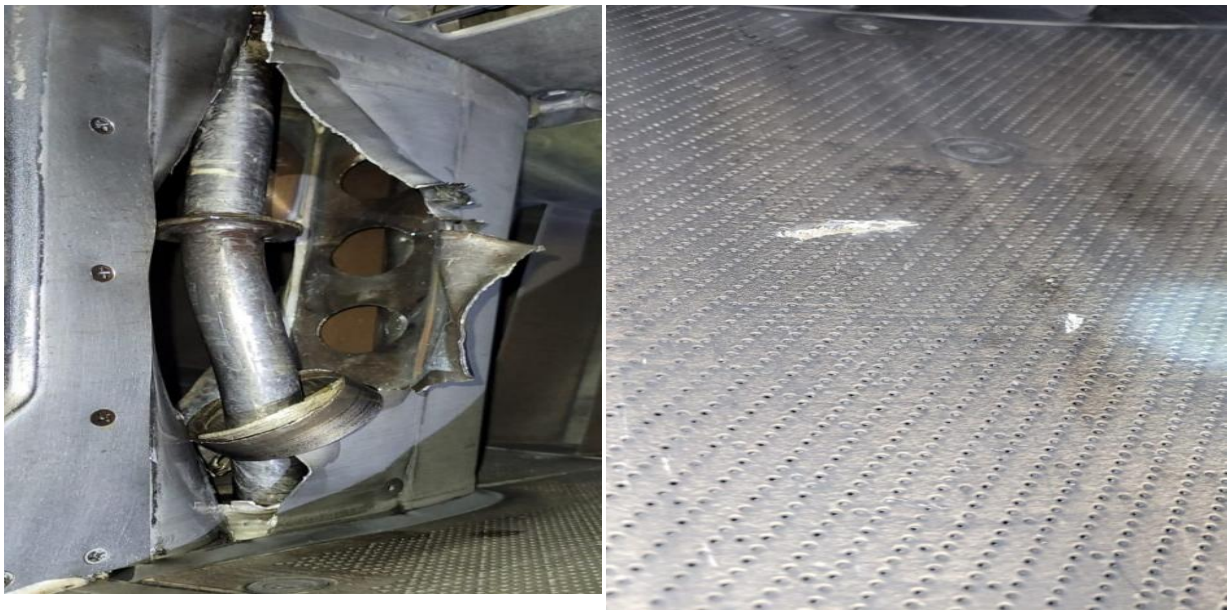
**Figure 7: Damages on the Fan frame strut #7 and RDS outer casing**

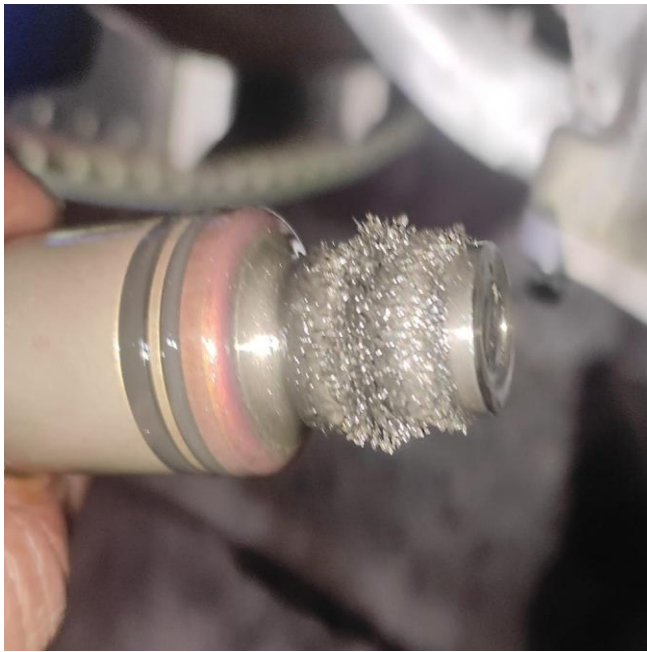
- 1.6.3.3. Fan & LPT stage 4 blades were checked for free rotation, found satisfactory.
- 1.6.3.4. EMCD visual indicator was pop out and particles were accumulated on EMCD magnetic detector. The check of the scavenge screens revealed particles in TGB screen. VBV (Variable bleed valve) system checked and found satisfactory. Fuel filter cartridge inspected and no contamination observed.

**Figure 8: EMCD magnetic detector**

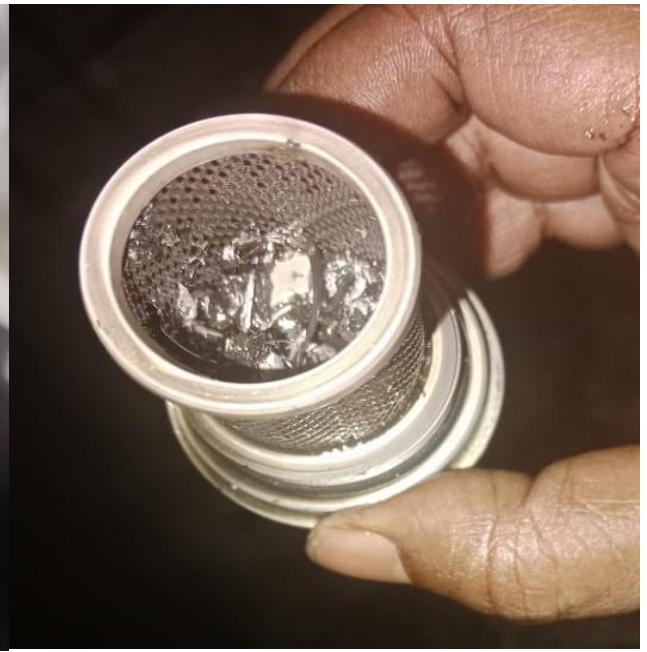
**Figure 9: TGB scavenge screen**

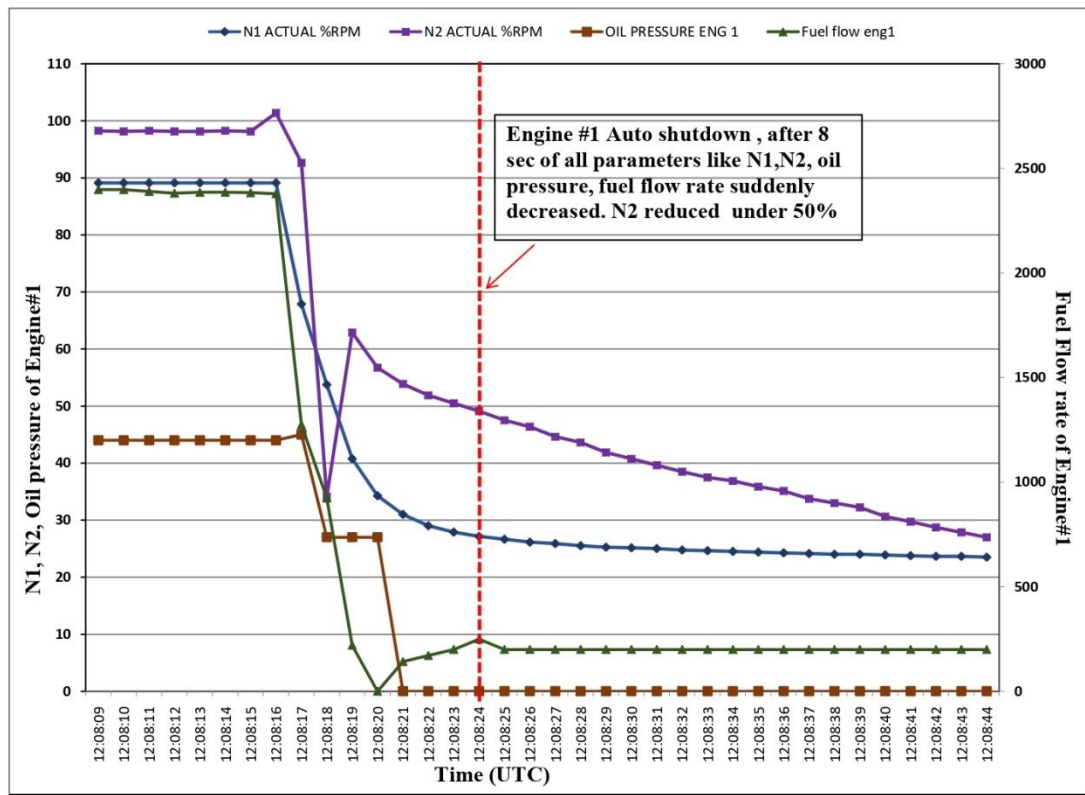
- At 12:08:16 UTC, engine 1 transferred pressure abruptly decreased from 84 to 0 within 02 seconds. PB burner system 1 decreased from 220.25 psi to 16 psi within 08 seconds.

- At 12:08:24 UTC, Engine #1 auto shutdown, after 8 sec of all parameters like N1, N2, oil pressure, fuel flow rate suddenly decreased.

**Graph 1: Time (UTC) vs N1, N2, Oil pressure of Engine #1 in primary axis and Fuel flow rate of Engine#1 in Secondary axis**

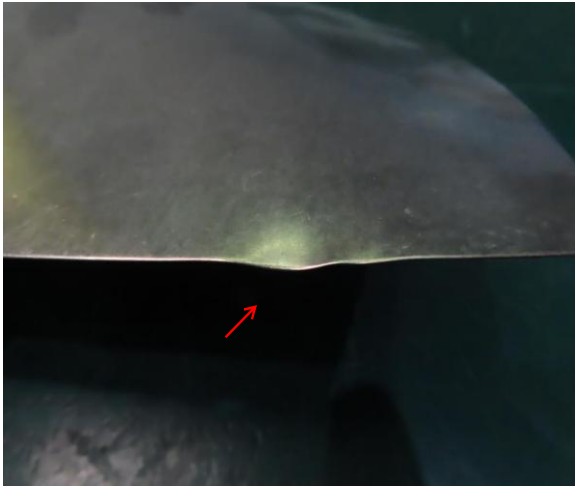
| S.no | Parts | Findings / Remarks |
|---|---|---|
| 1 | Fan Major Module | Found fan blade leading edge with distortion |

**Figure 9: Fan blade leading edge with distortion**

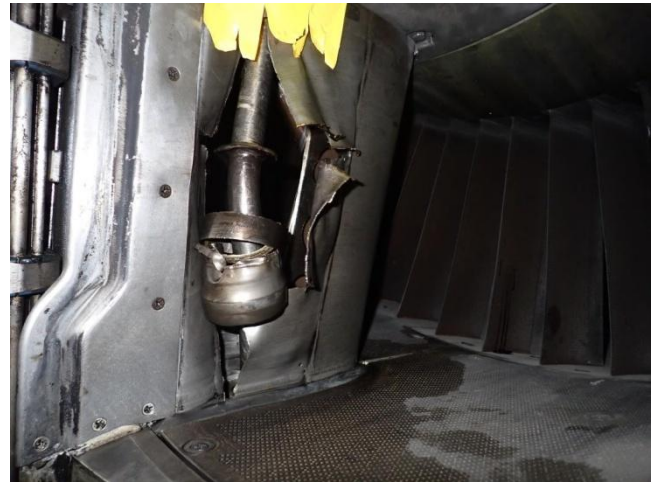
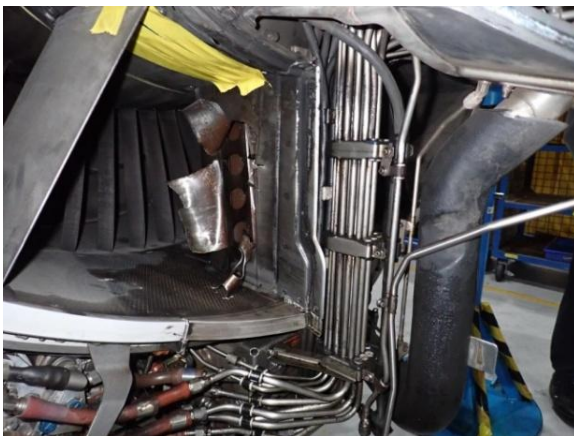
| S.no | Parts | Findings / Remarks |
|---|---|---|
| 4 | Fan frame | <ul style="list-style-type: none"><li>• Found fan frame strut 7 significant damage</li><li>• Found RDS shaft broken</li><li>• Found RDS housing significant worn</li><li>• Found 4EA OGVs leading edge missing</li></ul> |

**Figure 10: Fan frame strut 7 significant damage**

**Figure 11: Fan frame strut 7 significant damage**

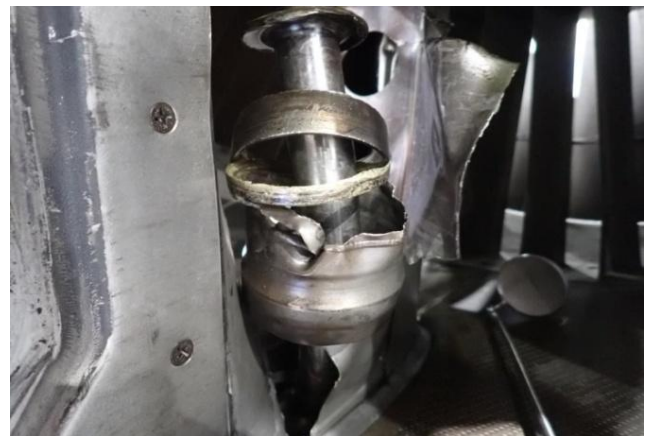
**Figure 12: RDS housing worn**

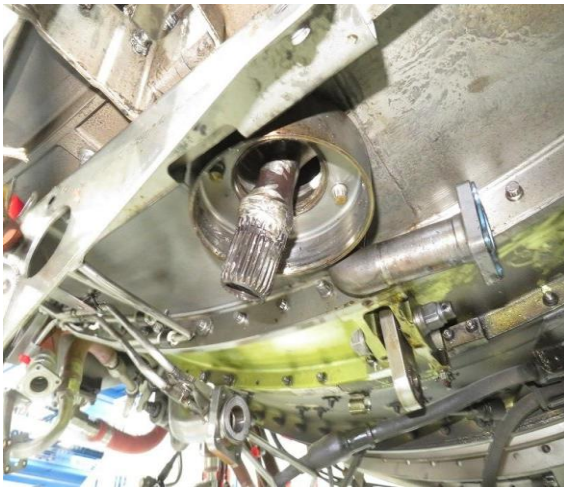
**Figure 13: Outer housing broken and wear**

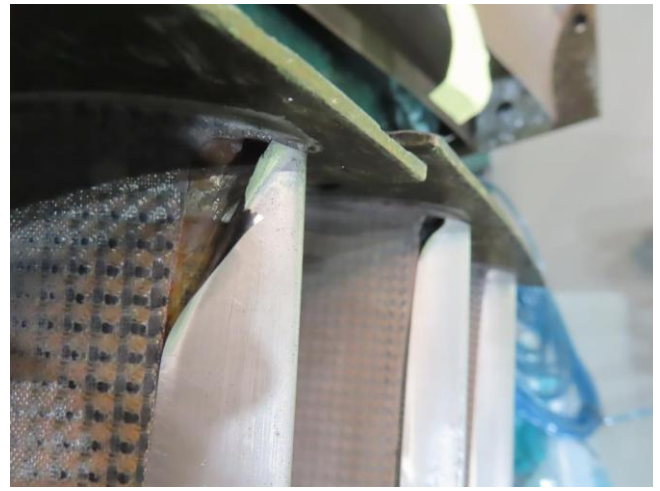
**Figure 14: OGV Leading edge metal sheet un-bond**

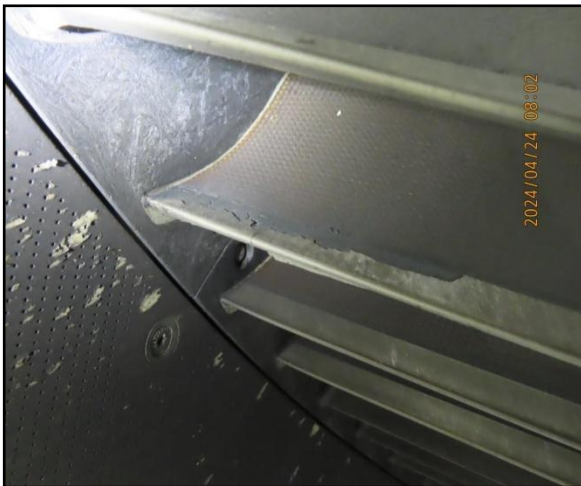
**Figure 15: OGV metal sheet missing material**

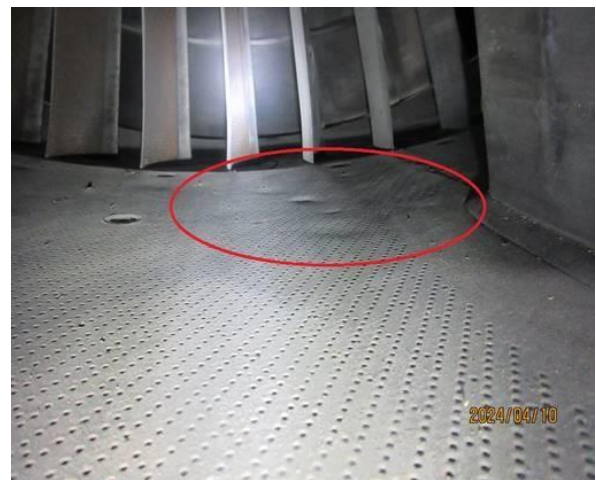
**Figure 16: Middle acoustical panel impact damage**

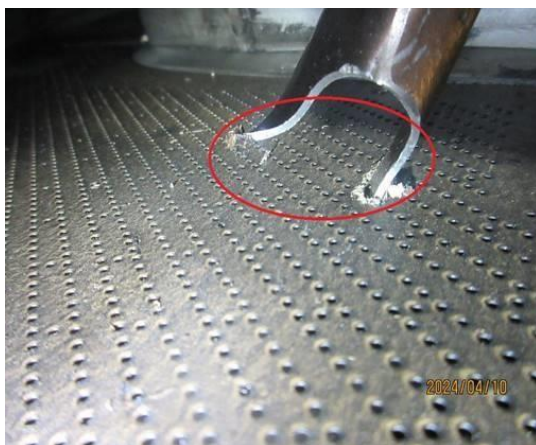
**Figure 17: After acoustical panel DOD damage**

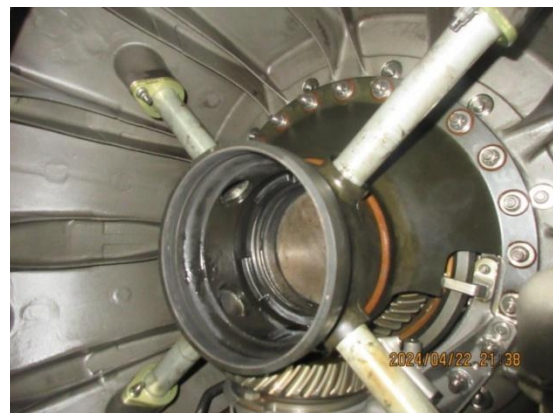
**Figure 18: FWD oil stationary seal seized with IGB**

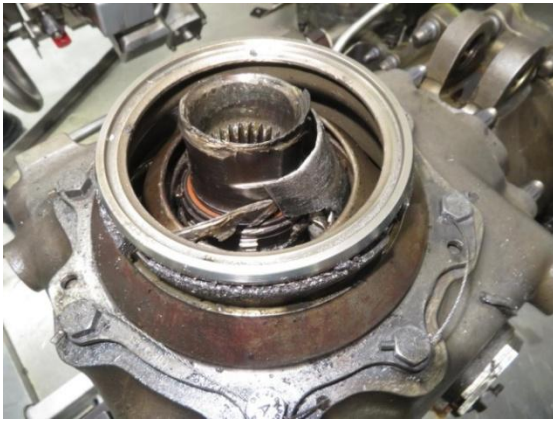
**Figure 19: TGB input adapter security bolt with wrong safety**

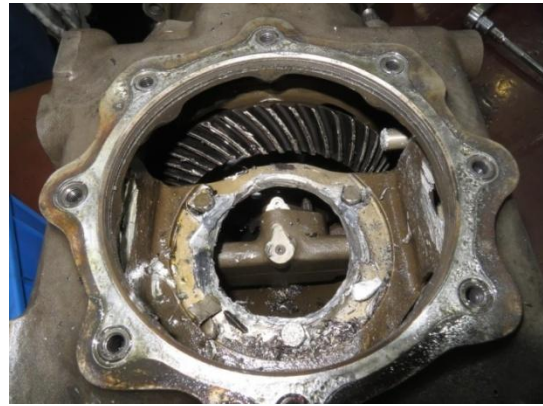
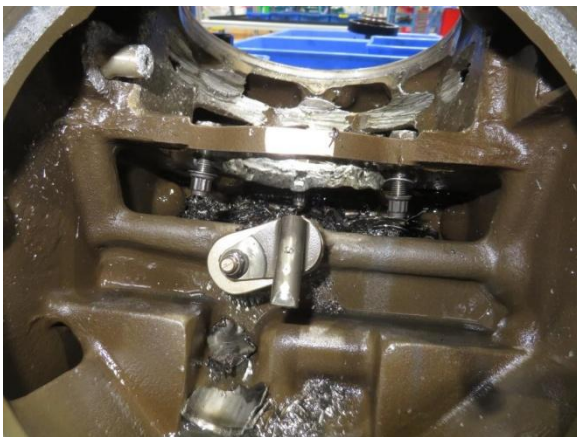
| 9 | Transfer Gear Box – TGB | Found TGB with excessive damage |

**Figure 20: TGB housing excessive damage and wear**

**Figure 21: TGB housing excessive damage and wear**

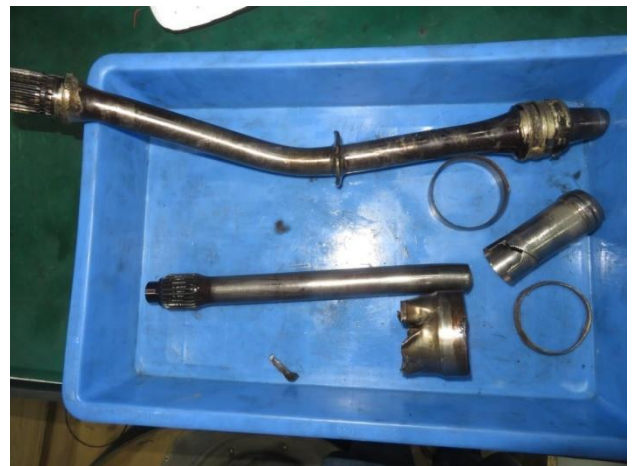
**Figure 22: RDS shaft broken**

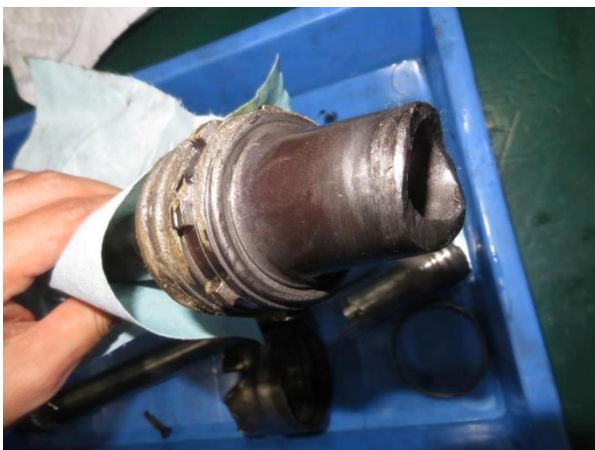
**Figure 23: RDS Bearing missing**

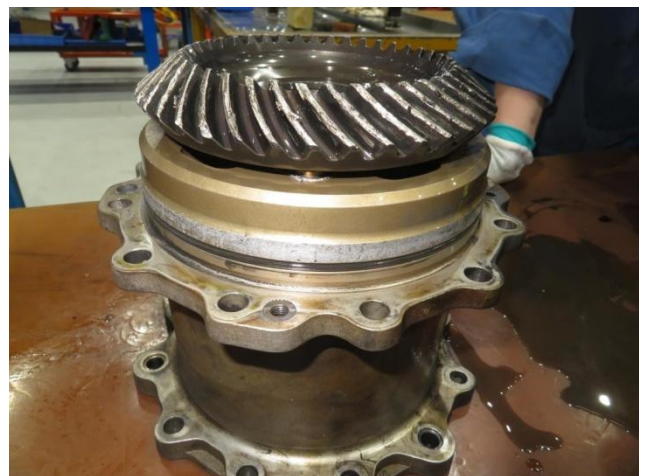
**Figure 24: Output gear damage**

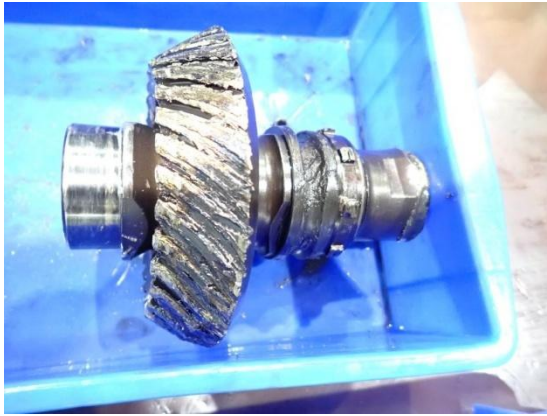
**Figure 25: TGB input shaft excessive damage**

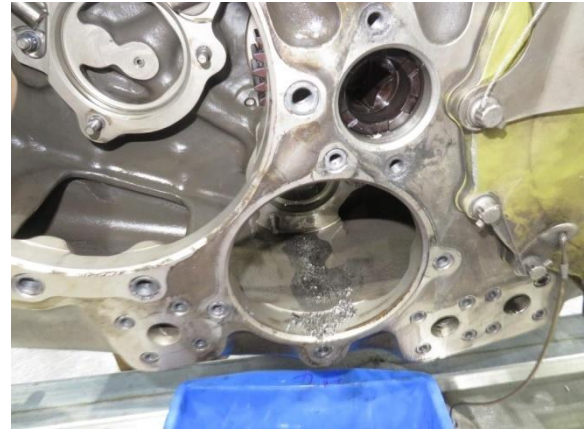
| 10 | AGB | Found large amount debris in AGB lower area |

**Figure 26: Large amount debris in AGB lower area**

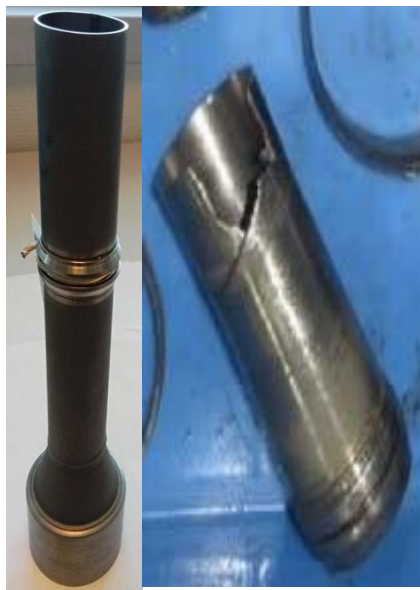
**Figure 27: Comparison of RDS inner housing upper side remaining section with good condition**

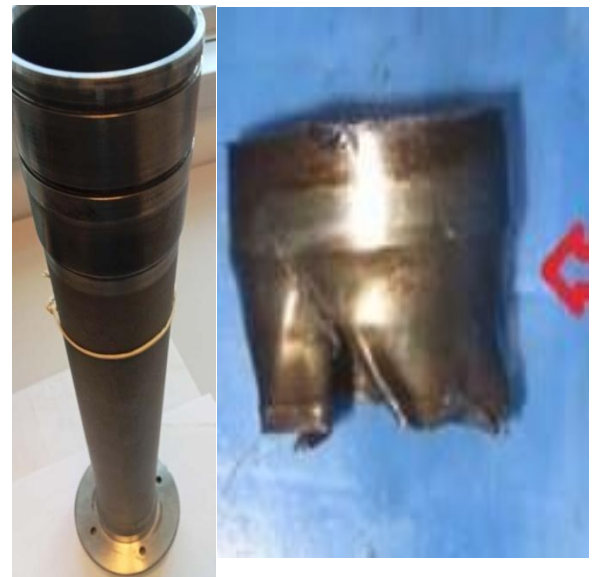
**Figure 28: Comparison of RDS outer housing upper side remaining section with good condition**

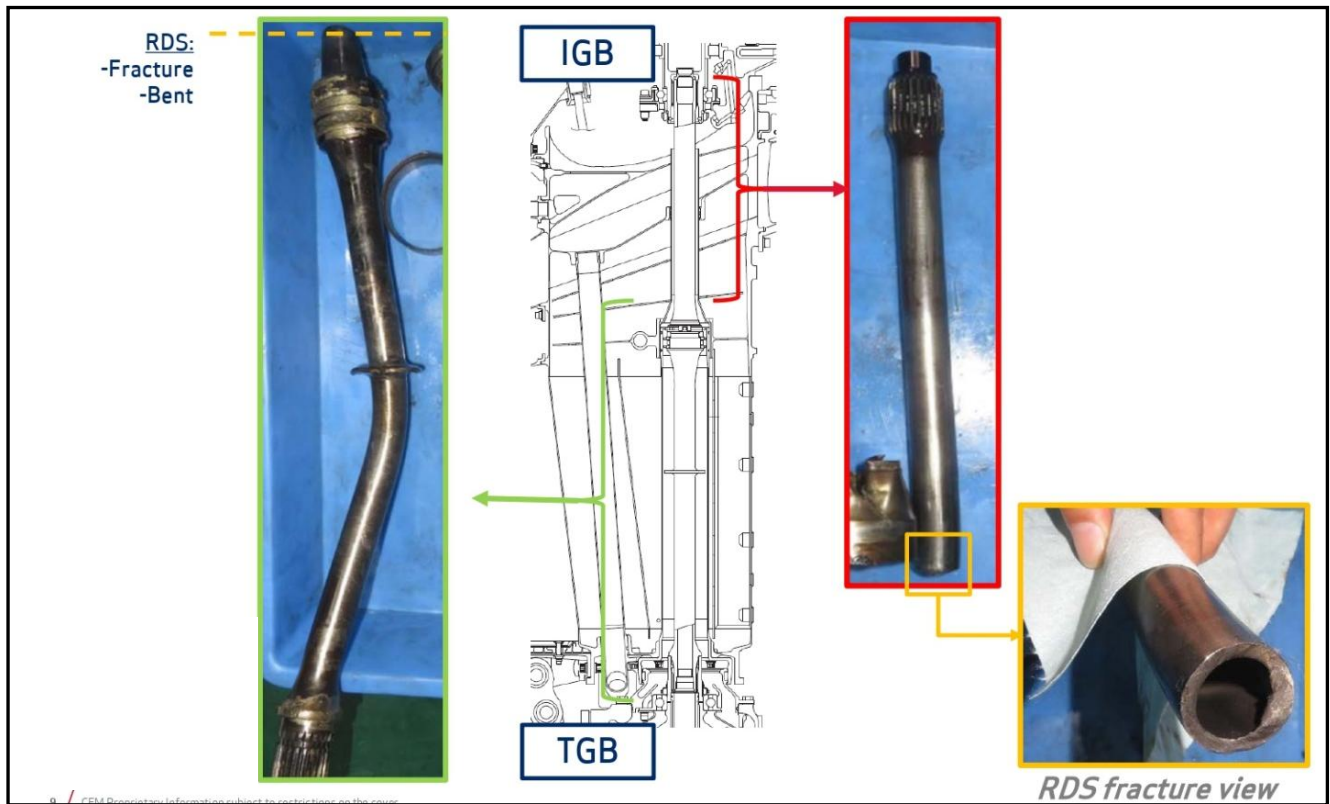
Inspection on the radial drive shaft reveals that the RDS got bent/distorted and broken, splines on TGB side very worn and marked, roller bearing deteriorated, missing rollers, cage melted, inner race present and vespel nut worn out.

Figure 29: Inspection of radial shaft condition (Source: M/s CFM)

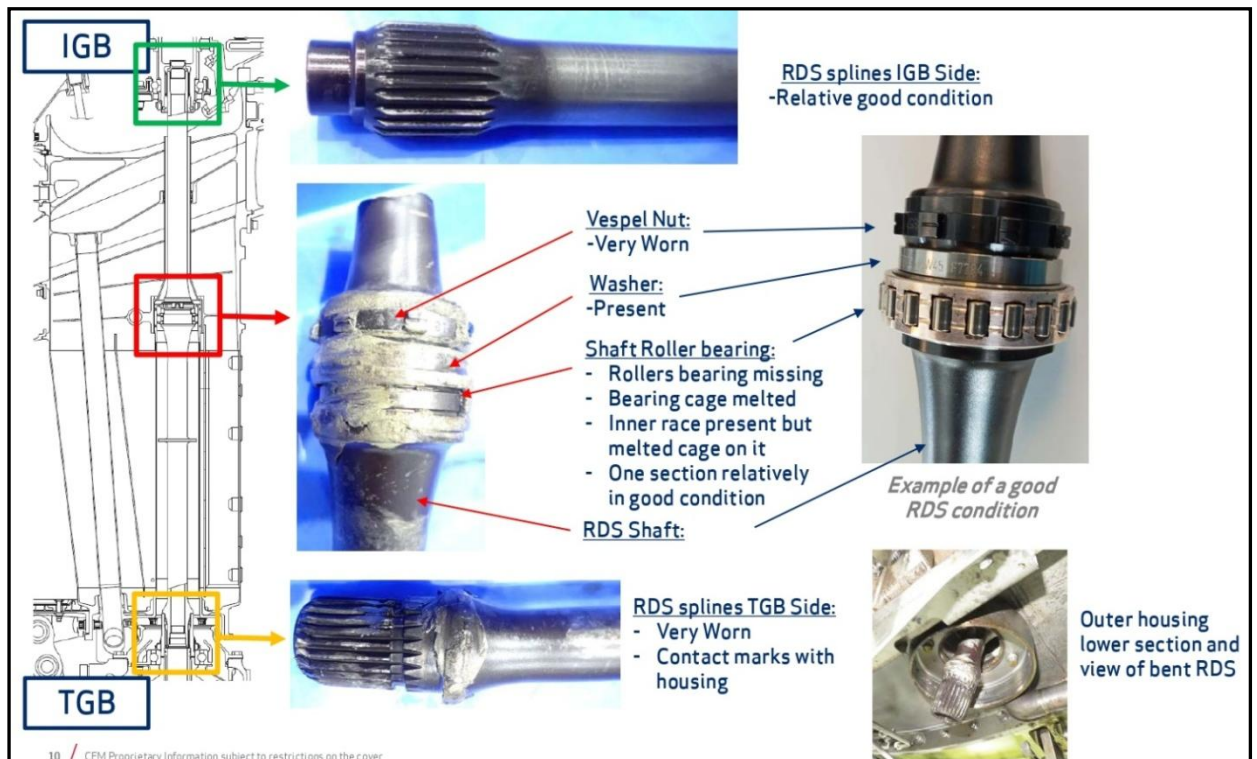
Figure 30: Inspection of RDS splines IGB and TGB side (Source: M/s CFM)

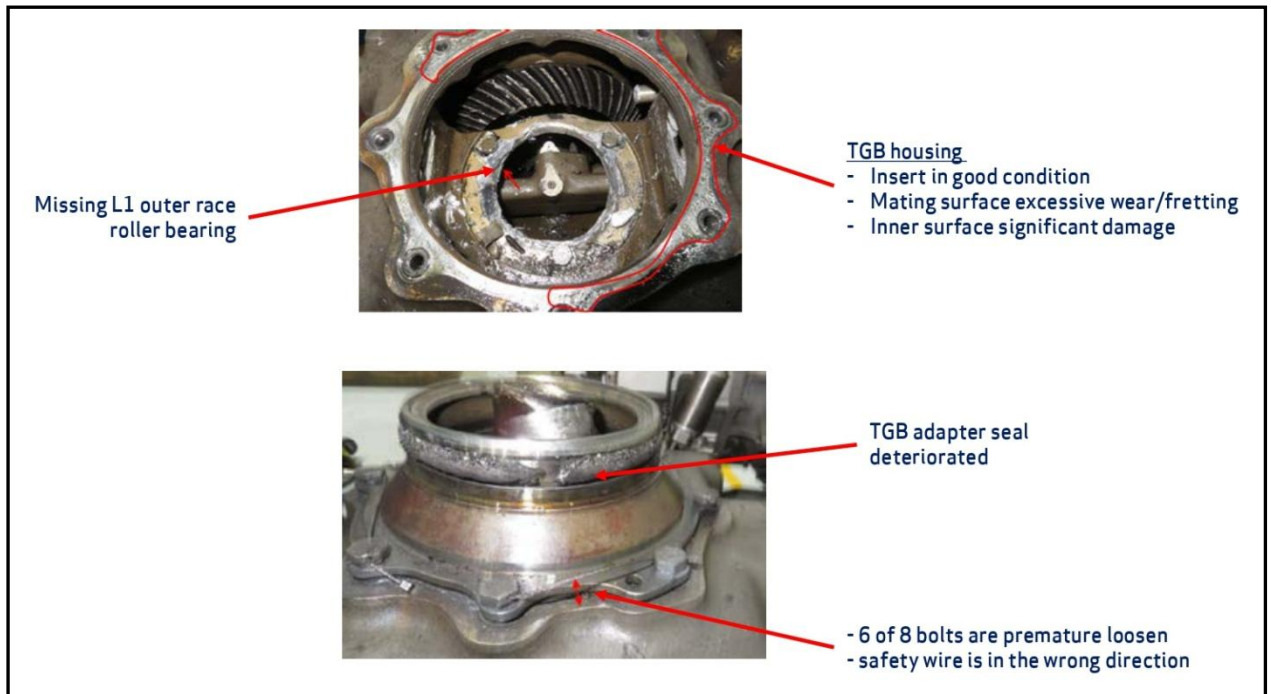
Inspection on the TGB housing / adapter seal reveals that the TGB adapter seal found cut, some bolts found loose and safety wire in the wrong direction.

**Figure 31: Inspection of TGB housing and adapter seal**(Source: M/s CFM)

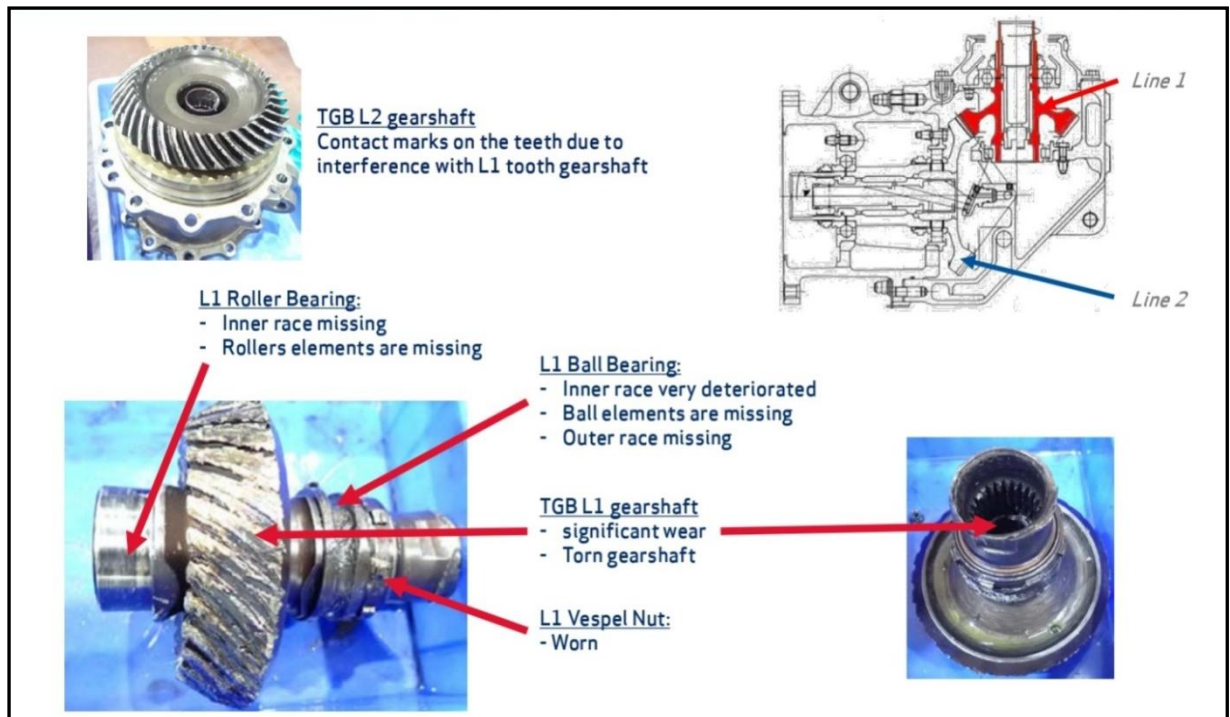
- Suspected root cause of the TGB deterioration is the result of the TGB L1 roller bearing.
- Root cause failure of the TGB L1 roller bearing not identified due to missing parts (bearing roller elements, races, ball bearing and heavy wear on TGB parts).

Inspection on the TGB Line 1 (L1) and Line 2 (L2) Gear shafts reveals that the Line 1 input bevel gear 31-tooth worn severely, Ball Bearing L1 missing, Roller Bearing L1 outer race missing, rollers missing and TGB Line 2 horizontal bevel gear shaft 40-tooth with contact marks.

**Figure 32: Inspection of TGB Gear shaft** (Source: M/s CFM)
