**FINAL INVESTIGATION REPORT ON  
BELLY LANDING INCIDENT TO  
M/s. SVKM'S NMIMS TECNAM P2006T AIRCRAFT, VT-MSP  
ON 06.01.2024 AT SHIRPUR AERODROME**

**GOVERNMENT OF INDIA  
O/o, DIRECTOR AIR SAFETY, WESTERN REGION,  
NEW INTEGRATED OPERATIONAL OFFICE COMPLEX,  
SAHAR ROAD, VILE PARLE (EAST), MUMBAI-400099**

**FINAL INVESTIGATION REPORT ON BELLY LANDING INCIDENT TO**  
**M/s. SVKM'S NMIMS TECNAM P2006T AIRCRAFT, VT-MSP**  
**ON 06.01.2024 AT SHIRPUR AERODROME**

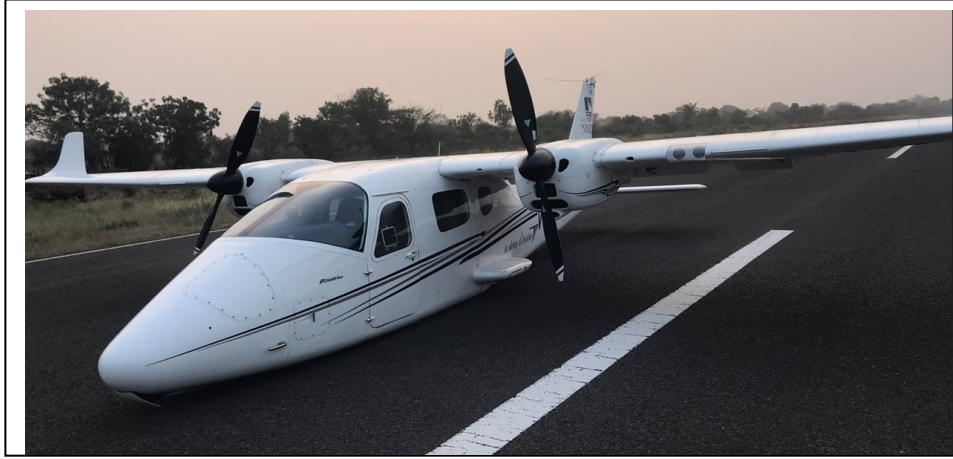
Most of the structural damage to the aircraft was sustained by panels of the underbelly and the damages to the equipment/system were restricted to communication and navigation antennas of the DME, Transponder, Marker Beacon and the COM 1 VHF. Further, the LH & RH main wheel hub sustained some damages.

Fig.1: Main Wreckage on the runway

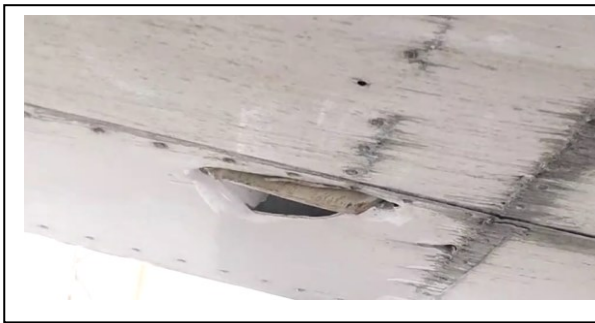
Fig.2: DME antenna

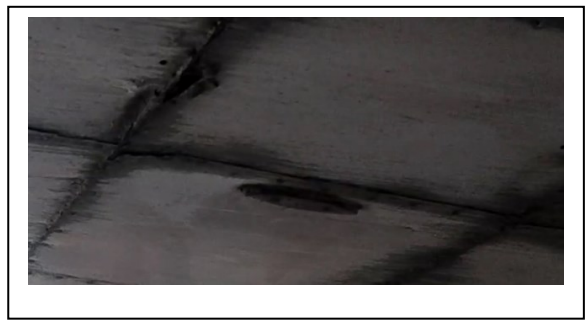
Fig.3: Transponder antenna

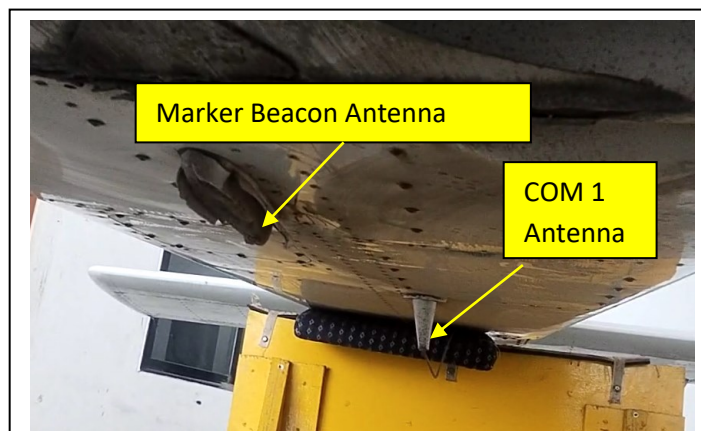
Fig.4: Marker Beacon and COM 1 Antenna

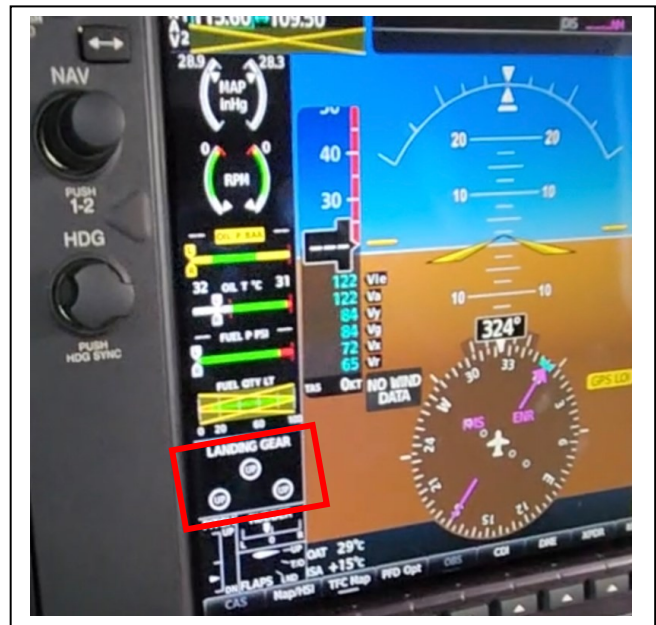
The three green indications is shown on the PFD only when the respective gear is “down-locked”, three amber cross is shown when the gear is in transit “up” or “down”. When the gear is uplocked, ‘UP’ will be shown on the PFD. for the respective landing gear. (Fig. 5)

Fig. 5: Landing gear uplock showing on the PFD

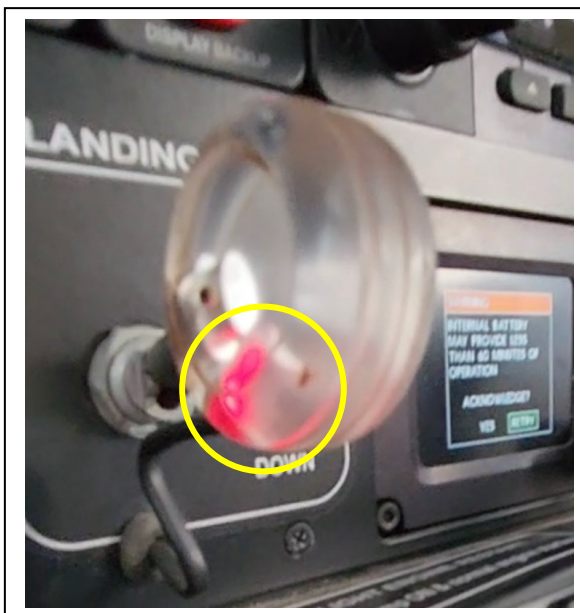
A warning horn alerts the pilot when the landing gear control knob is in UP position and at least one of the two throttle levers and/or flaps are respectively set to idle and to LAND position. Further, a red light is illuminated at the landing gear control knob for the aforesaid condition. (Fig. 6)

Fig. 6: Red light being illuminated on the landing gear control knob indicating and incorrect landing configuration

When the landing gear was in the retracted position and when the throttle lever was brought to idle position, the aural warning triggered and the red light on the landing gear knob were observed. Further, the stall warning horn was also simulated, triggering an aural warning.

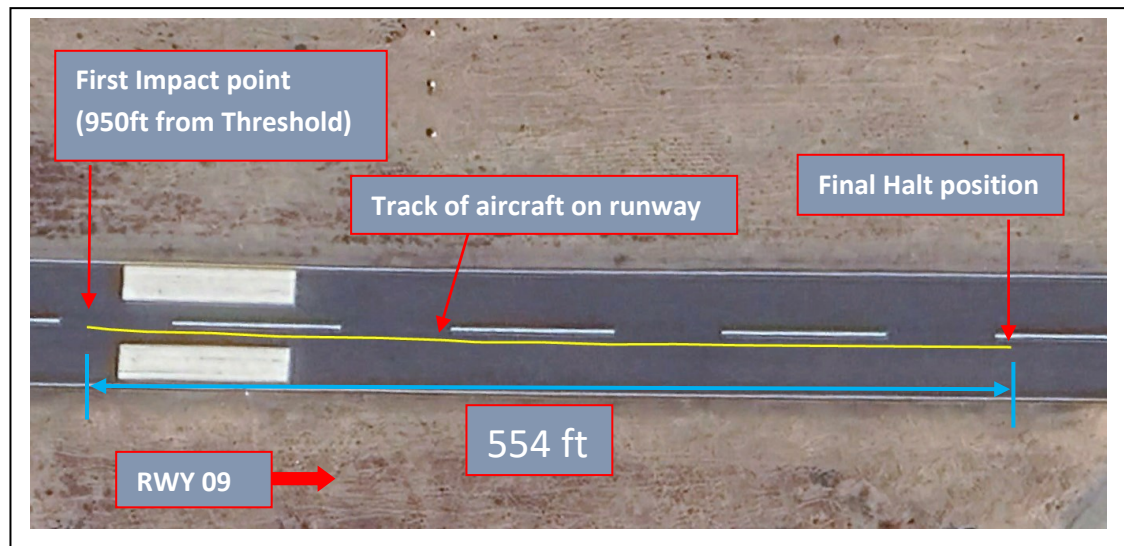
The aircraft landed on its belly on RWY 09, 950 ft from the threshold, and rested at 554 ft from the point of first contact, on a heading of 082 deg magnetic. There was no wreckage. The track of the aircraft after it had touchdown on the runway has been depicted below.

Fig.7: Track of aircraft during the belly landing
