The aircraft took off from Tiruchirappalli airport at 21:09 UTC and had an uneventful flight until the climb phase at FL230. While passing flight level (FL) 230, the crew heard a thud sound followed by a reduction in engine#1 N1 from 98% to approximately 65% N1 with an increase in engine vibration. Subsequently, the engine#1 fuel flow started decreasing and N2 was also dropped. All other engine parameters were within limits and no engine exceedance was observed. The engine#1 thrust lever was brought back to idle as per the non-normal checklist. ATC was informed and the crew decided to divert the aircraft to Chennai. The aircraft landed safely at Chennai by 22:04 UTC.

The probable cause of the incident was the failure to monitor the engine performance degradation trend alerts generated by the OEM, thereby delaying the customer notification report and recommended tasks, which led to the engine stall during the flight.

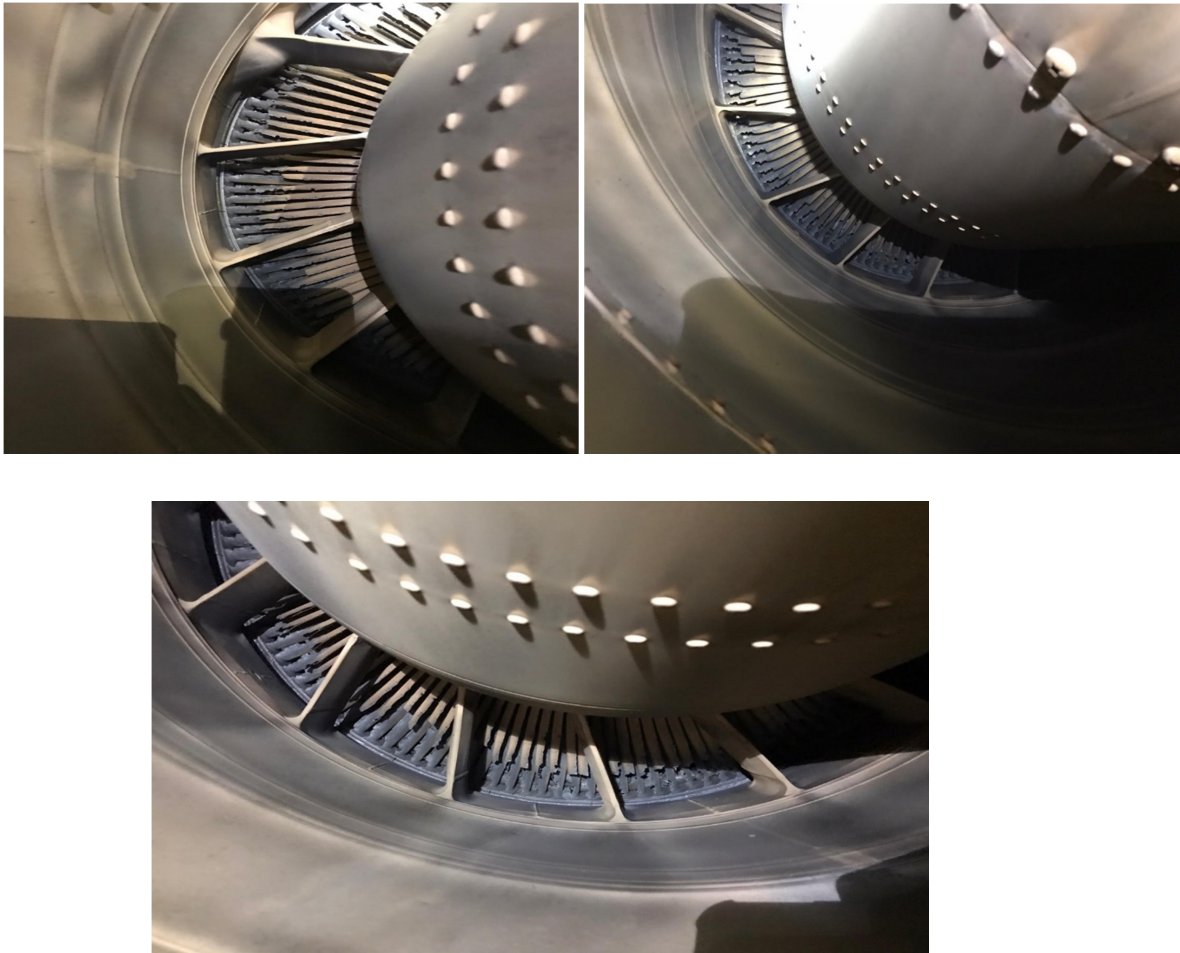
After landing at Chennai, during the detailed inspection by AME, the engine#1 inlet was found with no FOD ingestion or damage. During engine exhaust inspection, damage to the 3<sup>rd</sup> and 4<sup>th</sup> stage LPT rotor and stator with missing materials and a lot of broken pieces between the 4<sup>th</sup> stage stator and rotor. Aircraft declared AOG at Chennai and later the engine was replaced. Damage was limited to the engine and no other damage was reported.

**Engine LPT 3<sup>rd</sup> and 4<sup>th</sup> Stage blades were found damaged**

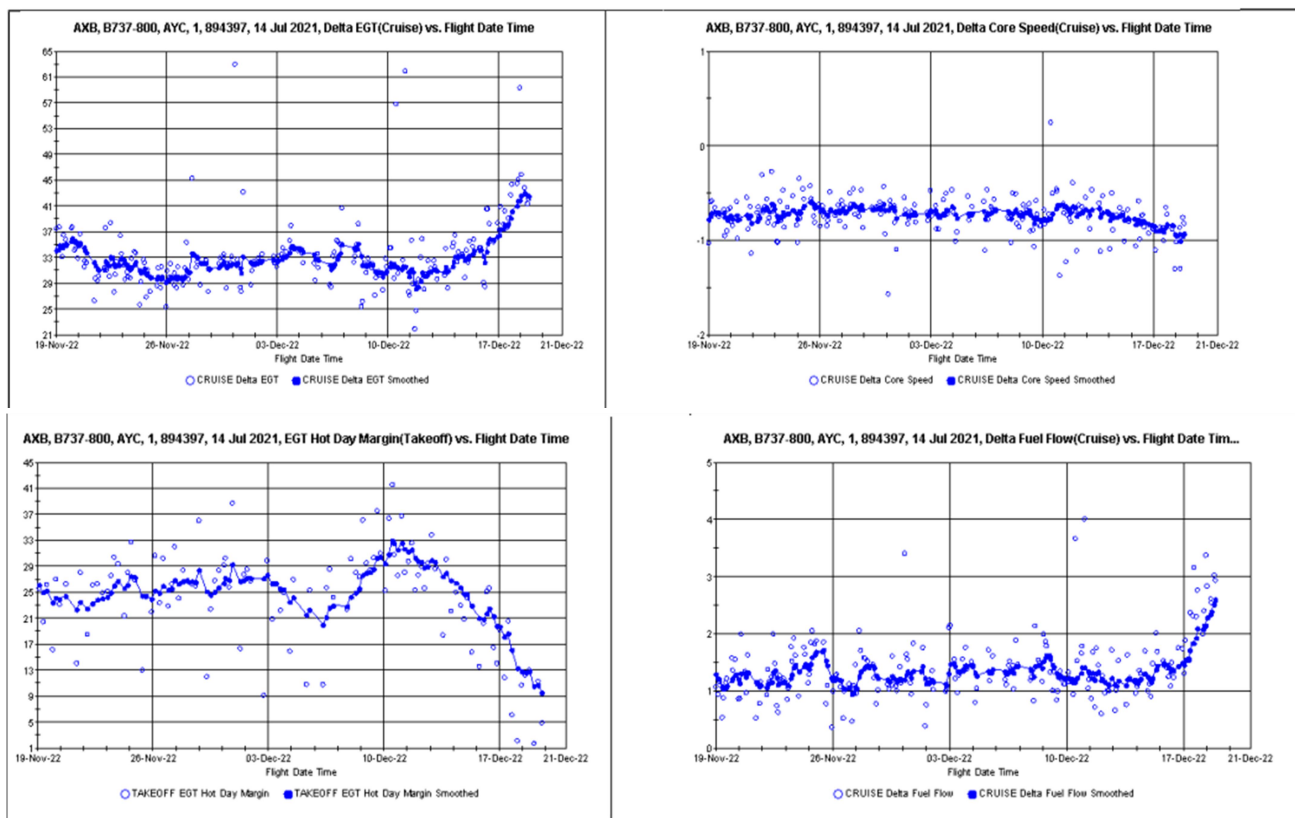
M/s Air India Express CAMO received CNR 20221220046 dated 20/12/22 from CFM with priority status as 'Normal' on engine serial number 894397 installed on VT-AYC LH position. During analysis by CFM, a gradual increase in Delta EGT, Delta Fuel Flow and a decrease in Delta Core Speed were observed, which prompted the subject CNR. To comply with the recommendations of the CFM, the CNR was discussed in the daily morning meeting on 21/12/2022 by AIXL CAMO and it was decided to issue a callout for an actuator test and troubleshoot for defects in the upcoming weekly inspection planned at Tiruchirappalli (VOTR) on 24/12/2022. The remaining recommendations as per CNR were decided for a later date. The callout for the actuator test was issued on 21/12/22 to the Planning Department for issuing to MRO, along with the weekly inspection planned at VOTR on 24/12/2022. However, due to TAT probe fault, the aircraft was grounded at Singapore (SIN) on 21/12/2023. Subsequently, the weekly inspection plan was changed by MCC and it was performed at Sharjah (OMSJ) on 23/12/2022. As the CNR status remained unchanged as 'Normal', it was decided by the CAMO department to perform the issued callout along with the next weekly Inspection on 28/12/2022 at VOTR. Before carrying out any troubleshooting, on 26/12/22 the subject engine experienced a stall and the aircraft diverted and landed in Chennai (VOMM). During inspection, the engine was declared unserviceable. After the receipt of CNR, the aircraft flew for 89:23 flight hours/24 flight cycles. The image of the CNR received by M/s Air India Express is placed below:

**Graph showing the increase in Delta EGT, Delta Fuel Flow and a decrease in Delta Core Speed vs Flight date time**

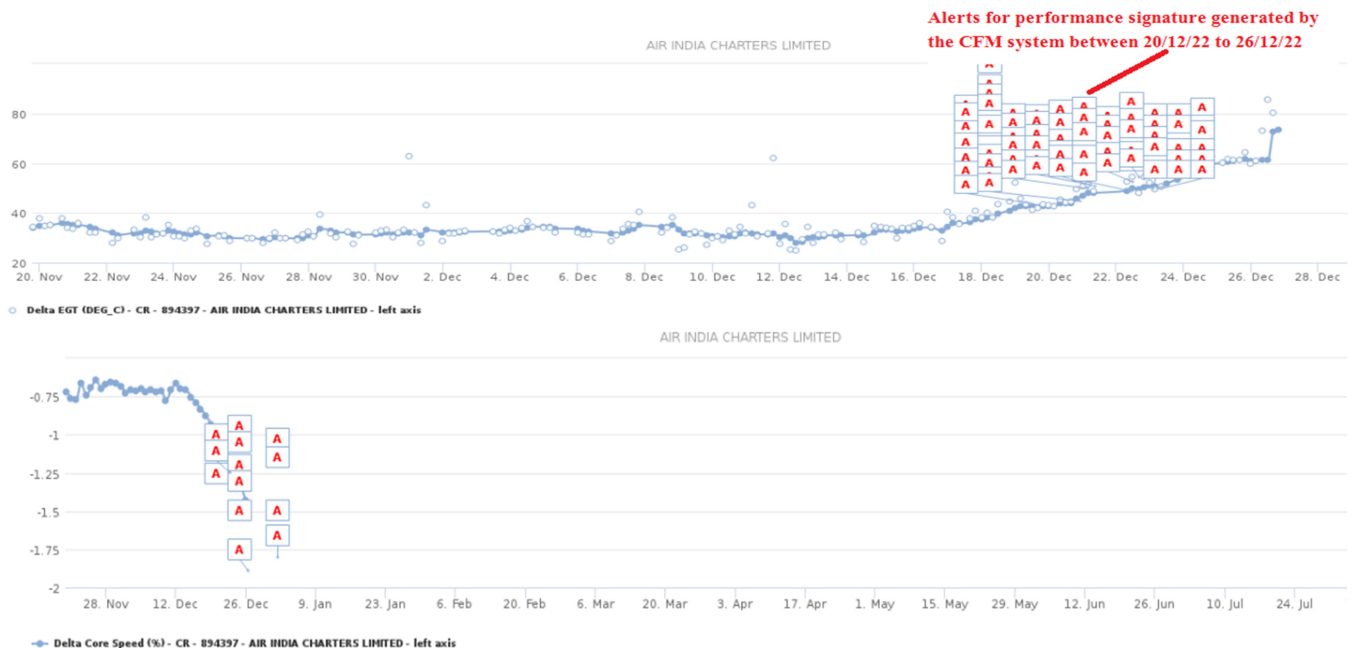
After the CNR was issued on 20/12/22, 8 alerts for performance signatures were generated by the system between 20/12/2022 and 26/12/2022. These alerts have been analyzed and "added to the case" by the concerned team according to the CFM process, because the signature observed was for the same trend that caused the CNR issued for performance degradation (which was already open at the airline's end). If any other parameter shift had been observed, then a different CNR would have been issued with a category based on the criticality, but this was not the case. Hence, the CNR category was not changed by the CFM.

Image Showing Alerts generated on myCFMPortal for Delta EGT and Delta Core Speed

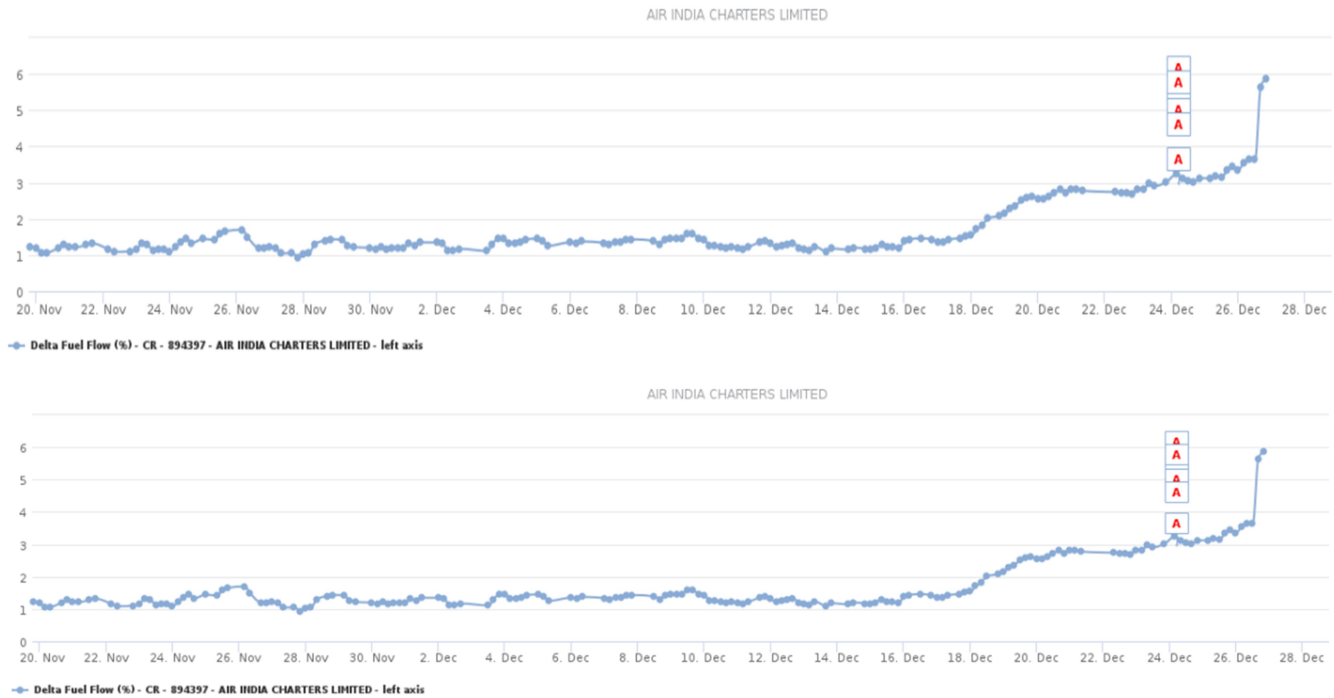
During the analysis of “myCFMportal” access by the M/s AIXL CAMO department, it was observed that even after the receipt of CNR dated 20/12/22, alerts for performance signatures were

generated by CFM system between 20/12/22 and 26/12/22 and the EGT shift of the subject engine continued. However, it seems that the airline did not monitor the performance alerts nor address the issue properly to carry out the CNR-recommended tasks on an urgent basis.

**Image Showing Alerts generated on myCFMPortal for EGT Hot Day margin and Delta Fuel Flow**

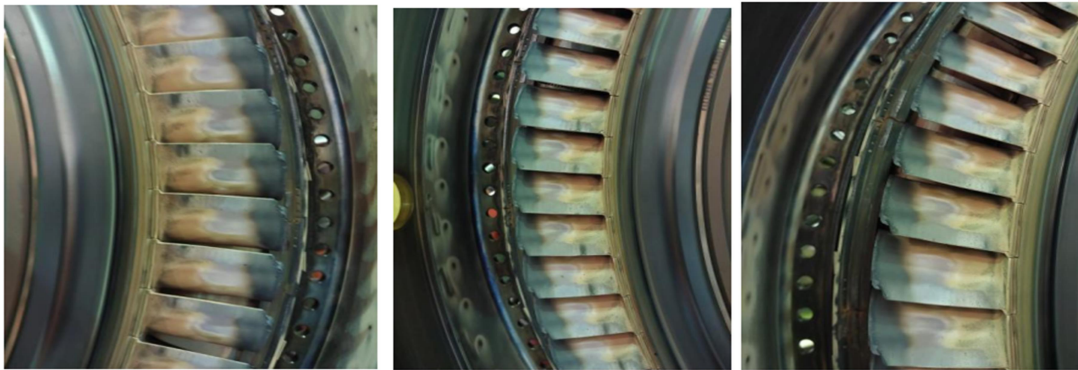
- 1) All HPT Stage#1 blades were found with missing material on the trailing edge tip. Indicating wear with shroud trailing edge area

- i. No foreign object was noticed during the engine disassembly.
- ii. HPT blade T/E noticed with missing material indicating abnormal blade rub with shroud T/E.

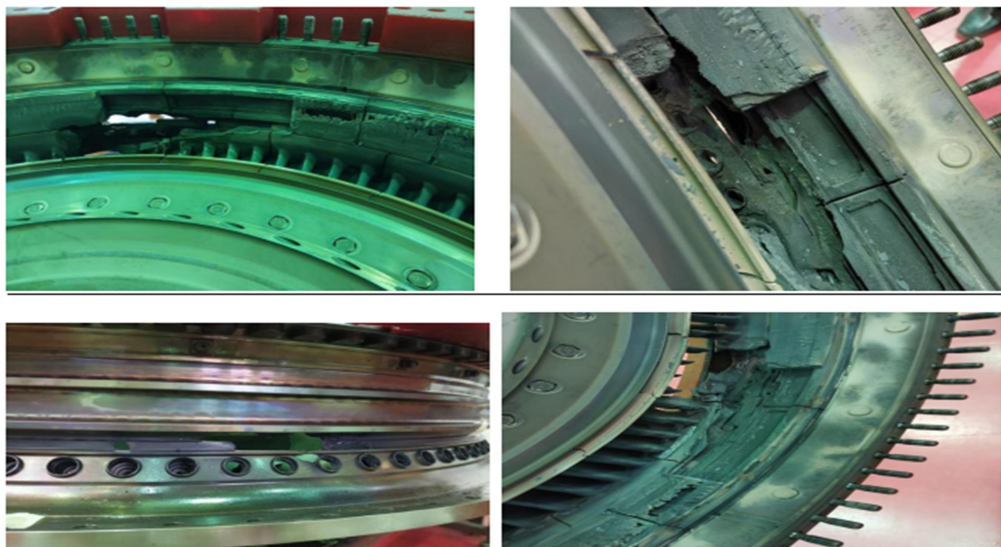
- 2) HPT shroud Qty.3 was found missing along with HPT case and also found with missing material between 6-7 O'clock position

- iii. HPT shroud liberation is a known condition for CFM. The most typical scenario is when the HPT Shroud's liberation damages the HPT Blades and that results in the immediate engine shutdown.

- iv. The affected HPT stage#1 shroud P/N 2080M28P09 (N500 material) was introduced as per the SB 72-0740 standard. This part number shroud material testing demonstrated equivalent performance at normal operating temperature. However, when the cooling flow is compromised and the operating temperature elevates, it is susceptible to accelerated corrosion and oxidation.

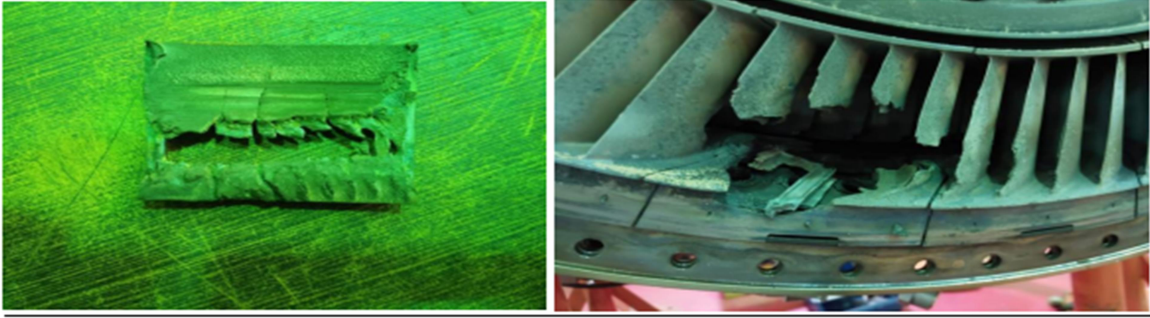
- 3) Adjacent HPT shroud was found with missing material and heavy burning.

- v. Cooling flow was compromised due to HPT hanger cooling holes plugging. The HPT shrouds that are not liberated are found heavily burned through, which is a clear sign of lack of cooling.

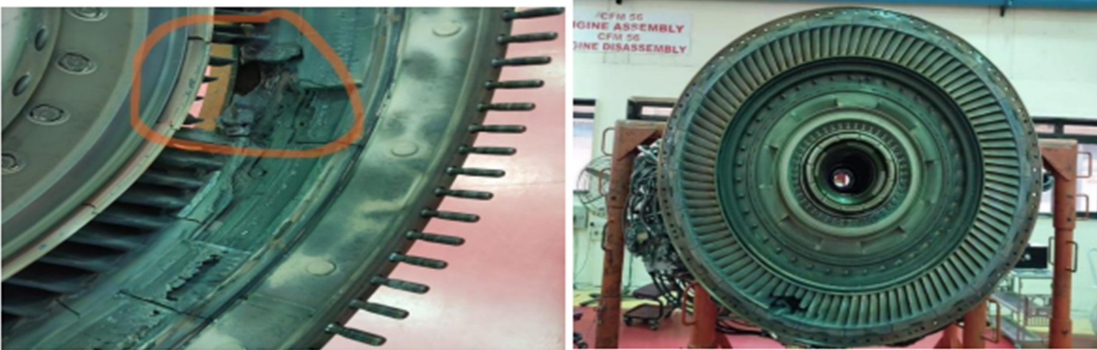
- 4) HPT hanger support was having missing shrouds (No. 1) observed with missing Air Baffle

- vi. HPT hangers with P/N 1808M6106 were installed on the engine which did not have air filters. Hence, through SB 72-0816 and SB 72-0961, CFM recommends the customer's choice to install the HPT hangers having air filters to decrease the possibility of similar issues.

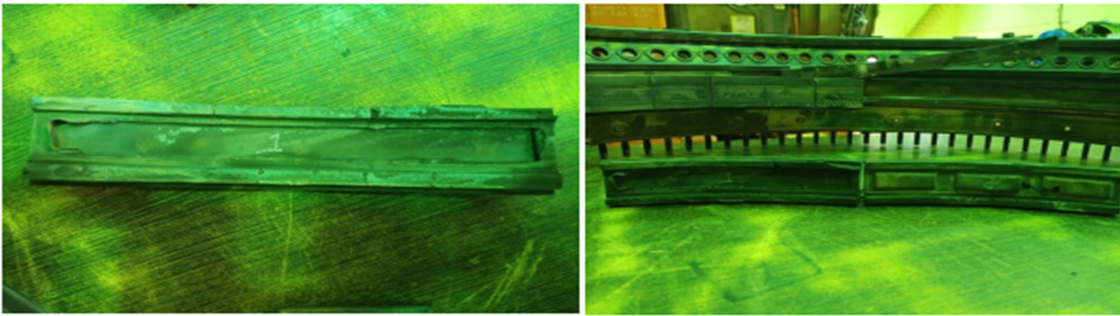
- 5) PT stage#1 Nozzles with missing material at the Outer platform area.

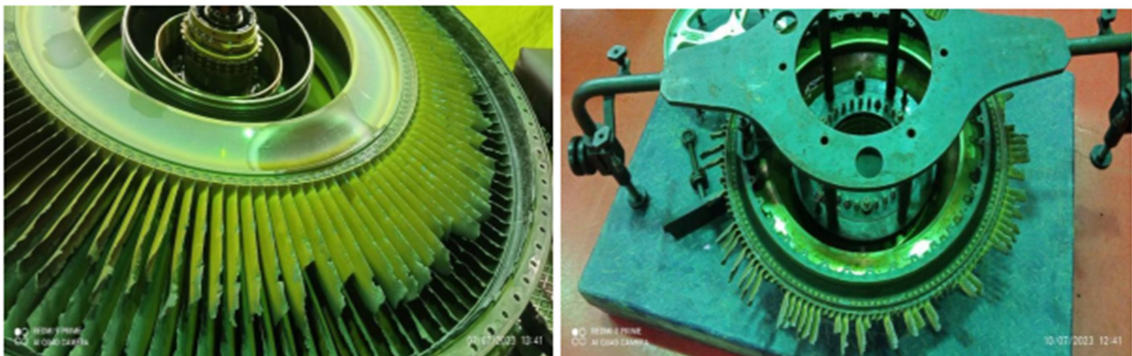
- 6) LPT Rotor Stator Assembly stage#1 to stage#4 was found extensively damaged with missing Material

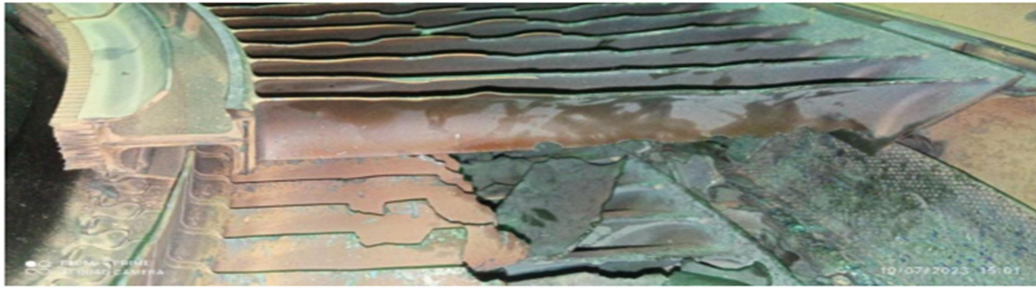
7) LPT NGV stage#1 to stage#4 was found extensively damaged

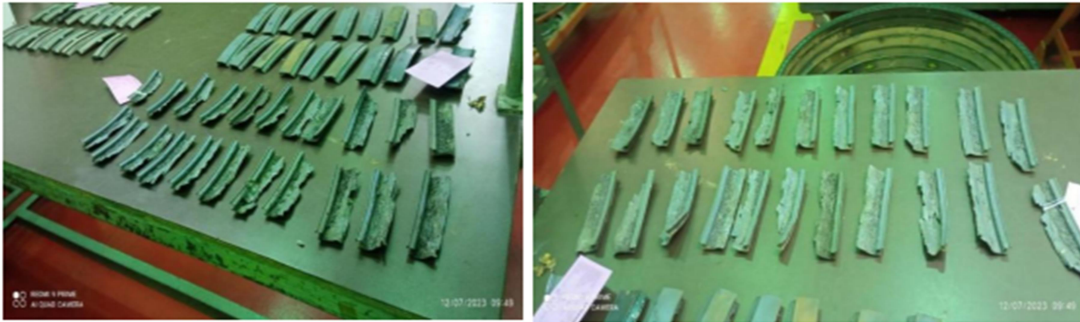
8) LPT Stationary Seal Segment from stage#1 to stage#2 was found with missing honeycomb /missing material and damaged seals

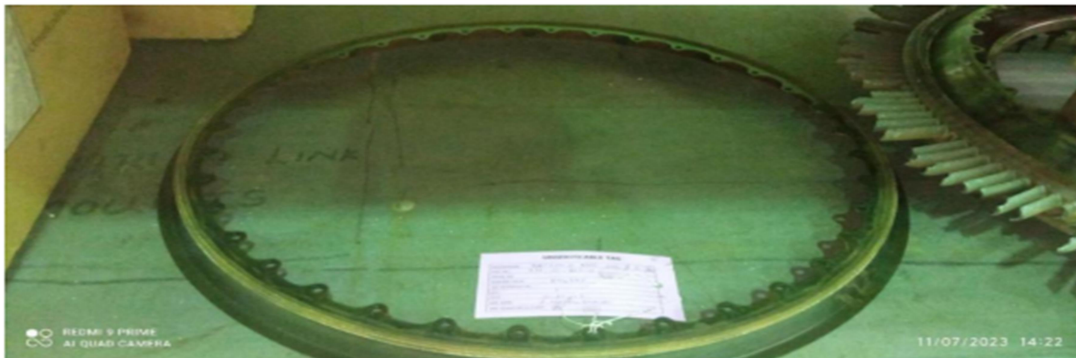
9) LPT Rotating air seal was found damaged/wear

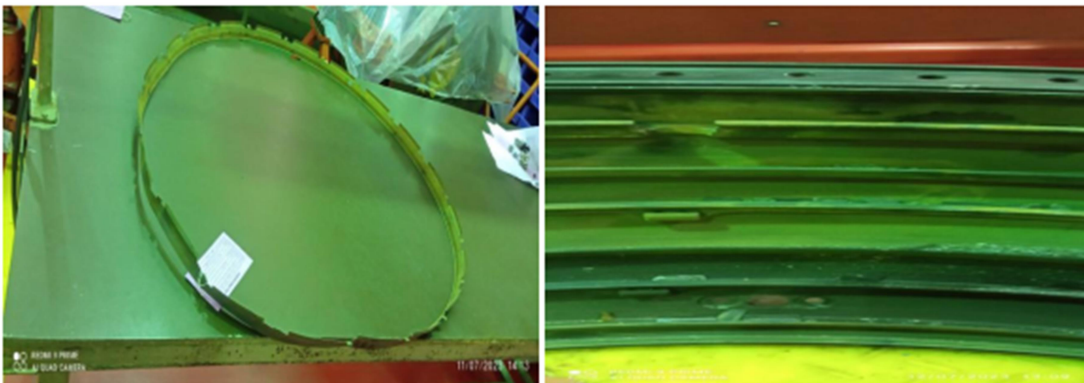
10) All other LPT hardware found damaged/distorted

11) LPT Turbine Rear Frame Assembly - Found with dents on strut area and TRF frame. Dents found with damage exceeding the manual limit
