FINAL INVESTIGATION REPORT

**IN FLIGHT ENGINE #1 FAILURE INCIDENT OF M/S INDIGO A321-251NX
AIRCRAFT VT-ILN ON 10/06/2023 AT DELHI**

DIRECTORATE GENERAL OF CIVIL AVIATION
GOVERNMENT OF INDIA
NEW DELHI-110003

FINAL INVESTIGATION REPORT OF IN FLIGHT ENGINE #1 FAILURE
INCIDENT OF M/S INDIGO A321-251NX AIRCRAFT VT-ILN ON 10/06/2023 AT
DELHI

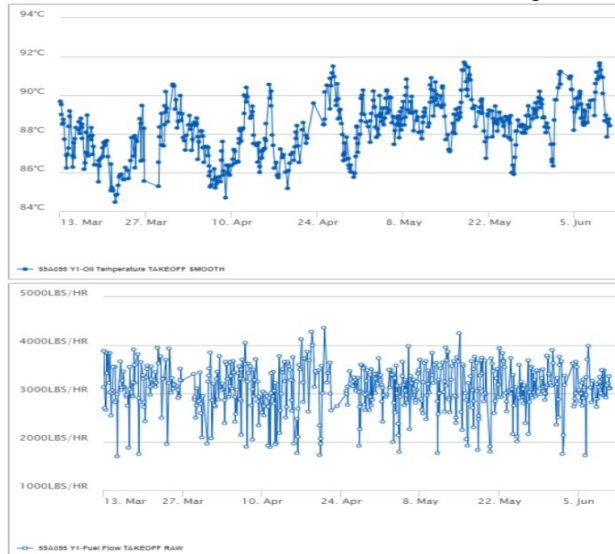
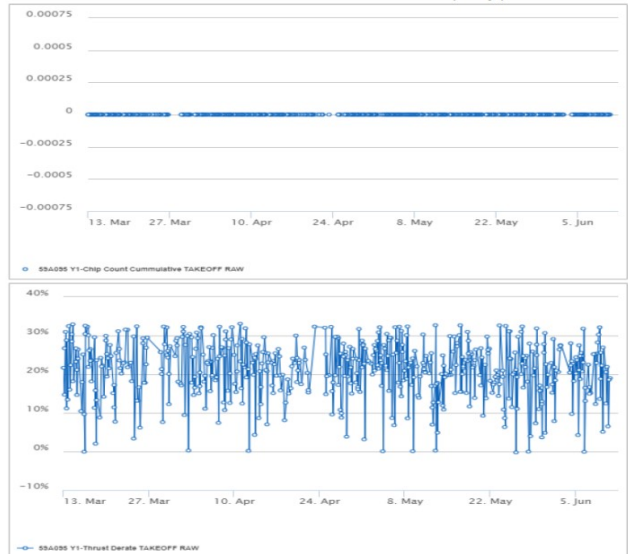
TREND DATA FOR LESSOR AUDIT: VT-ILN - A321neo - Interglobe Aviation Limited

Below are engine trend charts prepared by OEM monitoring team. In case of any limit exceedance, the relevant OEM notification is generated for that engine.

There has been no related OEM notification and customer notification report (CNR) on the engine prior to the engine removal post subject incident. The engine has no related maintenance history. Scrutiny of the tech log pages 30 days prior to the date of occurrence revealed that no similar snag was reported on this aircraft.
