Directorate General of Civil Aviation

**FINAL INVESTIGATION REPORT ON IN-FLIGHT SEPARATION OF RIGHT-SIDE
PASSENGER WINDOW TRANSPARENCY TO M/S NATIONAL FLYING TRAINING
INSTITUTE PVT. LTD DIAMOND DA-40 AIRCRAFT VT-NFF ON 23.12.2021.**

**Final Investigation Report on In-Flight Separation of Right-Side Passenger
Window Transparency To M/s NFTI Diamond DA-40 Aircraft VT-NFF
On 23.12.2021**

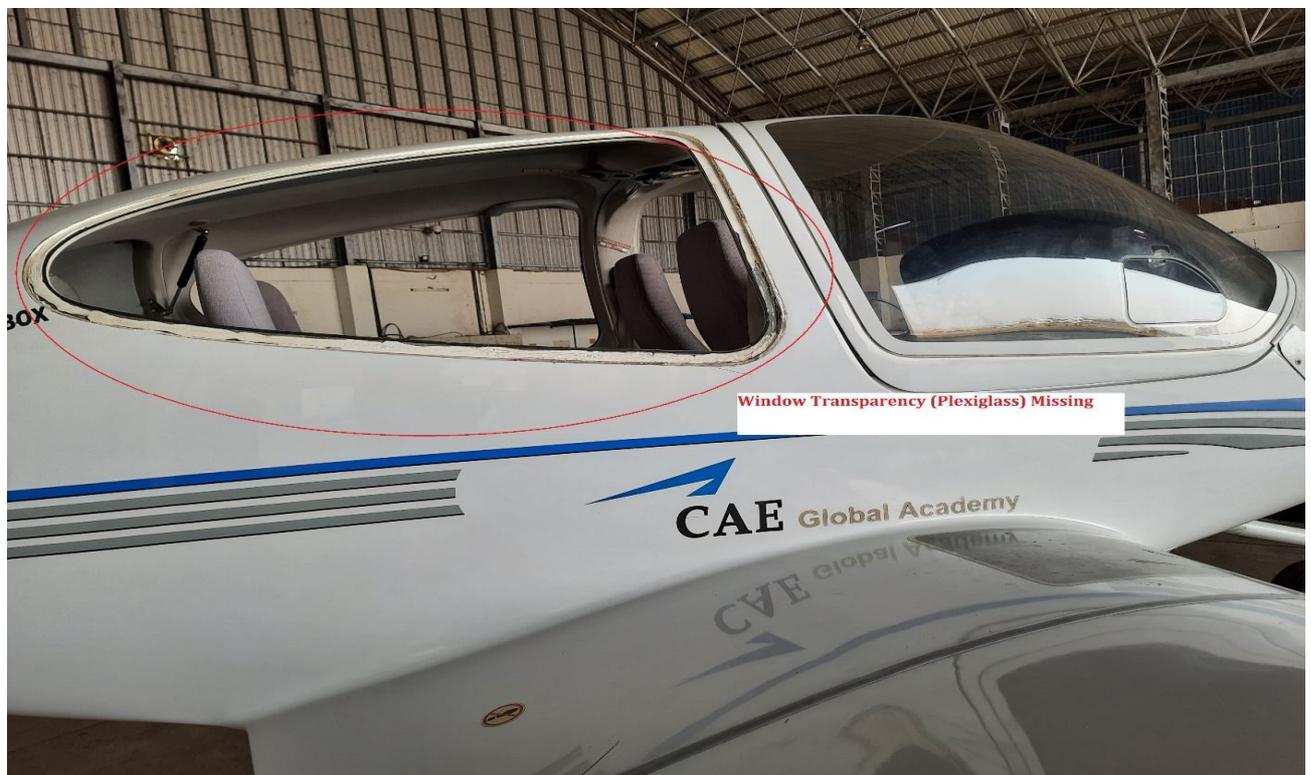
- i. Window transparency (Acrylic Glass) of right-side passenger compartment was found missing.

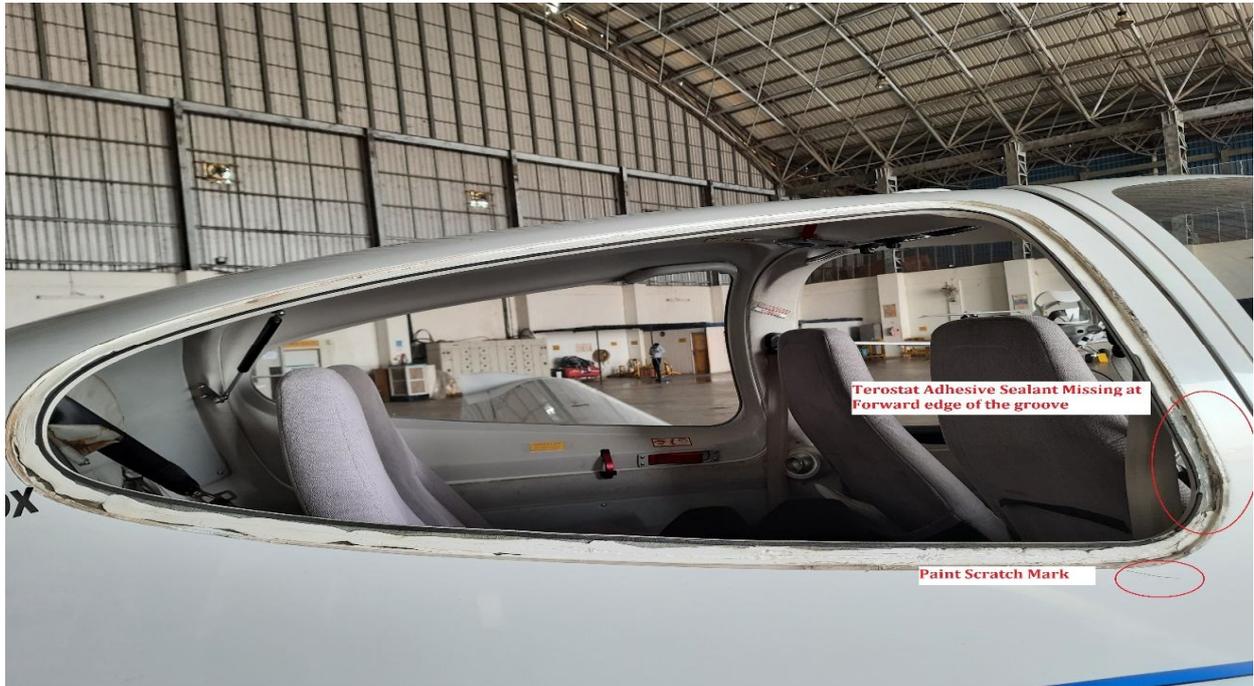
- ii. Paint peel off about 2.5 inches long was observed just below the location where the window transparency was installed.
- iii. Observed separation of elastic adhesive at one point on the forward edge of the groove where the window was installed.

Damage was limited to the detached item (window transparency) and no other damage was reported.

From the above, it is inferred that the applied terostat adhesive sealant on the window transparency could have deteriorated over a period of time.

Operator had carried out one time inspection on all other aircrafts and the condition of the window transparency was found satisfactory. Further, manufacturer advised operator to check the condition of window on a regular basis during maintenance by pushing the window transparency with the fingers right above the frame from the inside to the outside with a gently force and also to check for cracked seals around the window. Accordingly, operator had amended the DI Schedule, 25 Hrs. inspection schedule, 50 Hrs/ 03 Months inspection schedule and 100 Hrs/ 06 Months inspection schedule to incorporate the same.

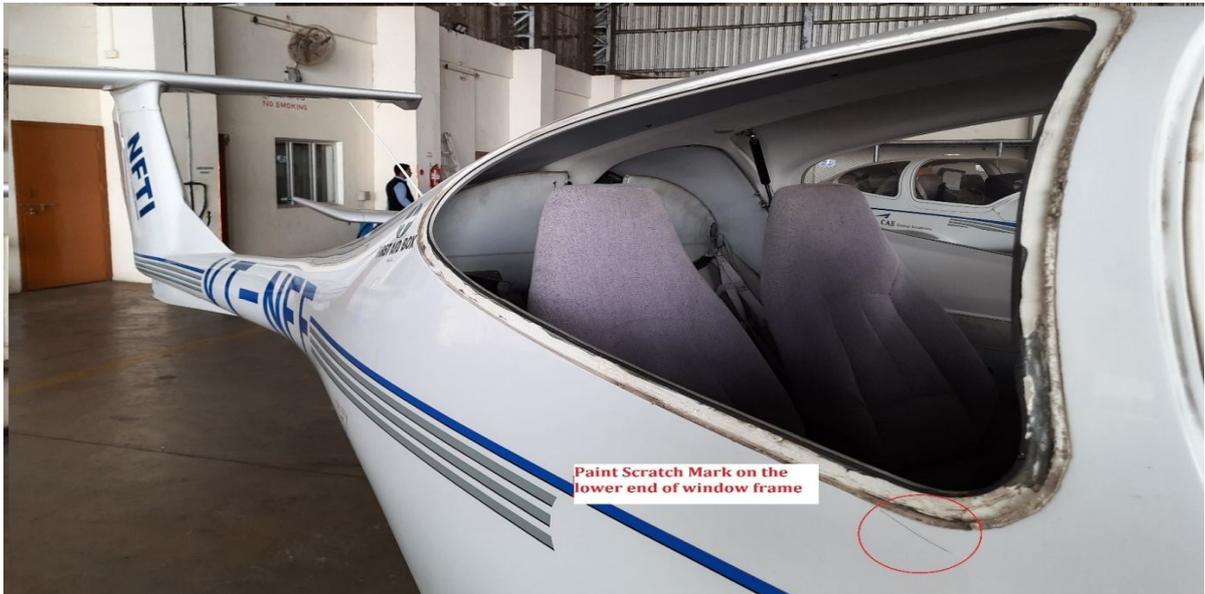
During the aircraft visit, apart from the missing of window transparency, there was small paint peel off about 2.5 inches long was observed just below the location where the window transparency was installed. This was observed to be not due to detachment of window transparency during flight. The same was not documented/any entry were made by the engineering staffs/crew during their routine inspections.
