**FINAL INVESTIGATION REPORT ON  
AIR TURN BACK INCIDENT TO  
M/s AIR INDIA LTD AIRBUS A320-251N AIRCRAFT  
VT-EXM ON 19/05/2022 AT MUMBAI**

**GOVERNMENT OF INDIA  
O/o DIRECTOR AIR SAFETY, WESTERN REGION,  
NEW INTEGRATED OPERATIONAL OFFICE COMPLEX,  
SAHAR ROAD, VILE PARLE (EAST), MUMBAI-400099**

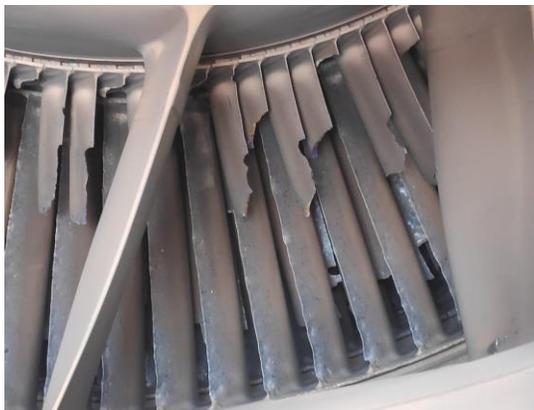
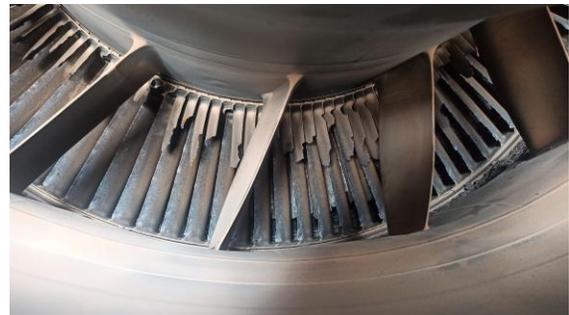
On arrival at Mumbai, aircraft VT-EXM was inspected by the AME. During inspection, Engine # 2 last two stages of LPT & LPT NGVs found damaged/ missing material. Boroscope inspection of the engine revealed liberation of aft catenary arm from the HPT rotor interstage seal (mid-seal). Consequential damage to HPT and LPT blades downstream was also seen in the boroscope inspection as per images depicted below:

Image# 1 Damage to Eng# 2 LPT blades

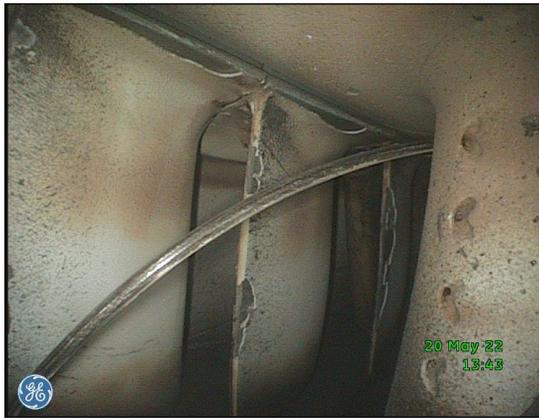
Image# 2 HPT Stage1 blade trailing edge & liberated material

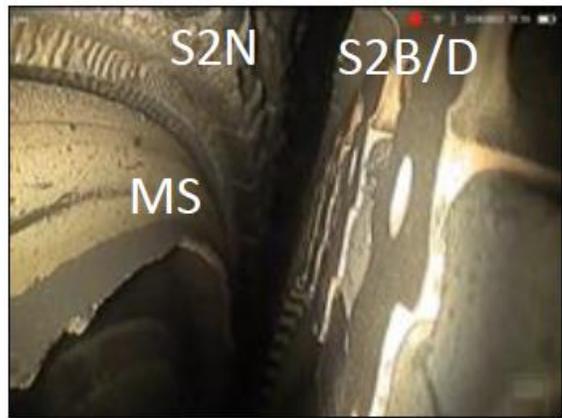
Image# 3 Damaged HPT rotor interstage seal (Mid-seal)

The most probable cause of the incident is liberation of the aft catenary arm from the HPT rotor interstage seal (mid-seal) due to inadequate peen coverage/ intensity and visible turning lines (re-machined surface) in the aft rabbet fillet.

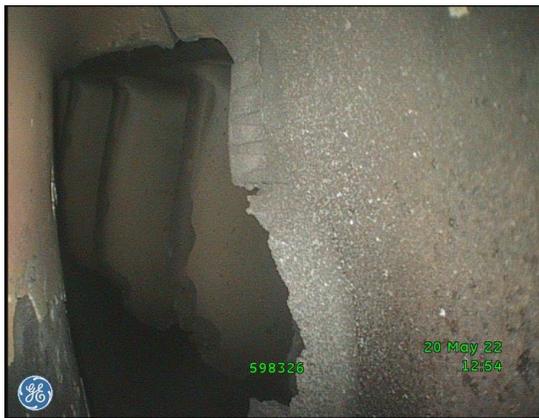
Image# 4 HPT Stage2 blade leading edge

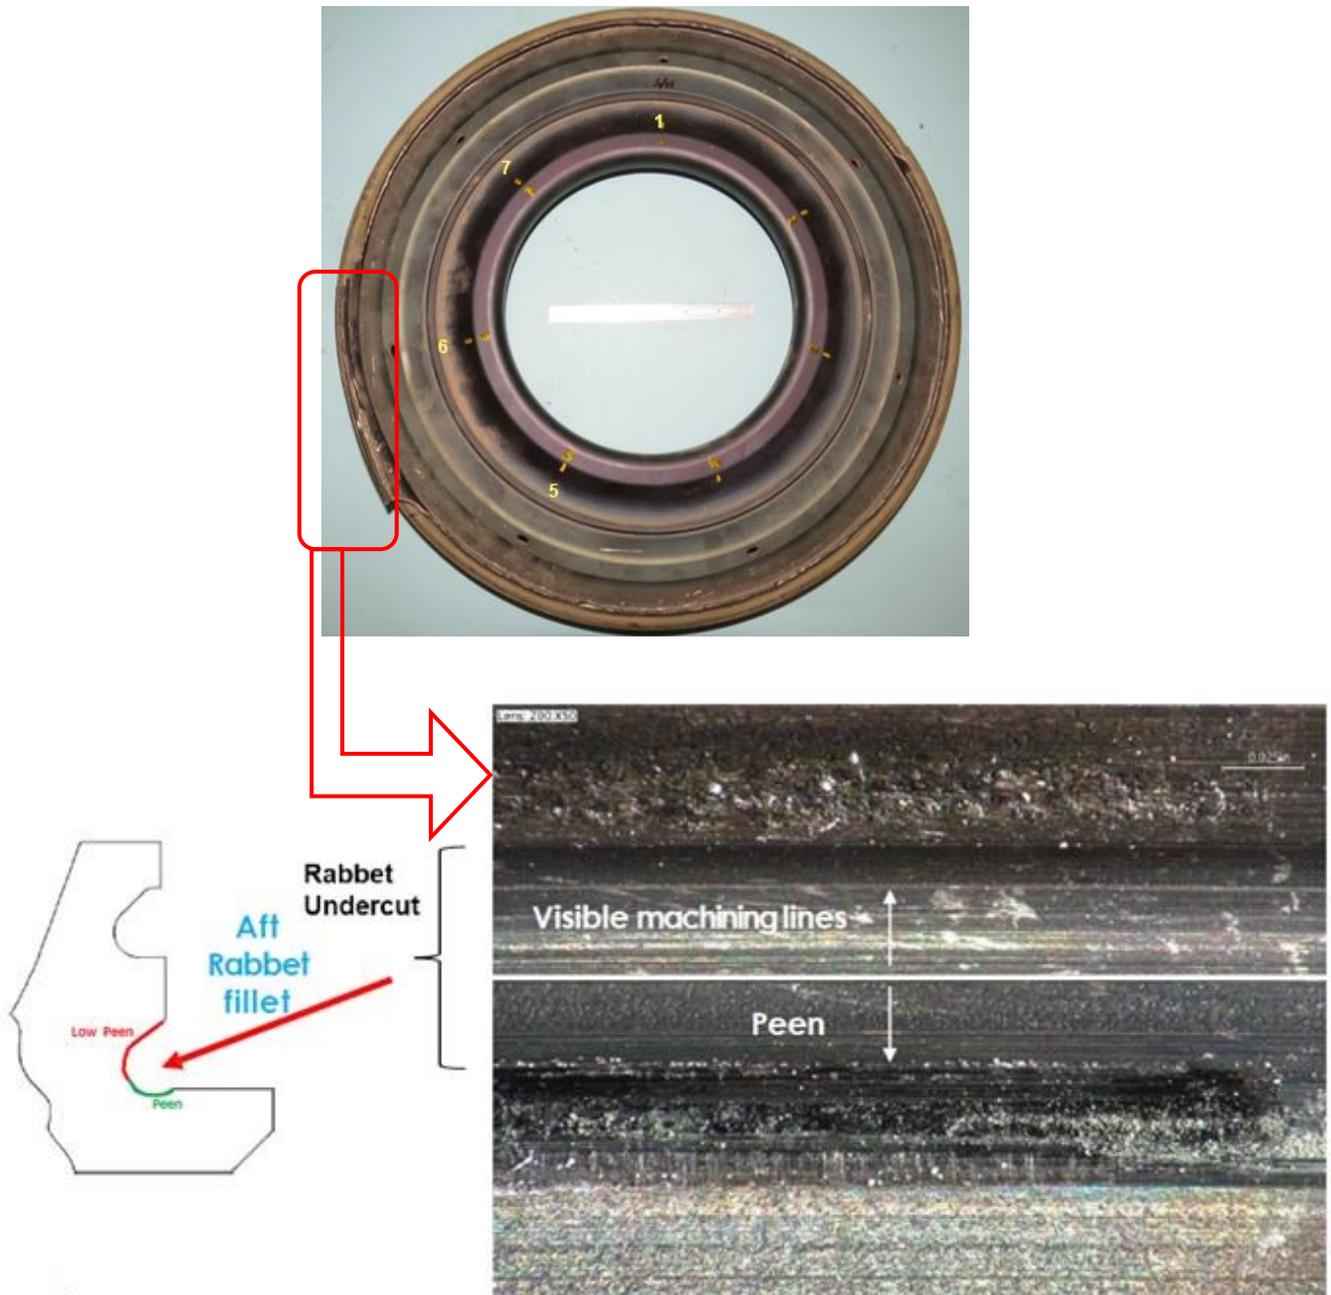
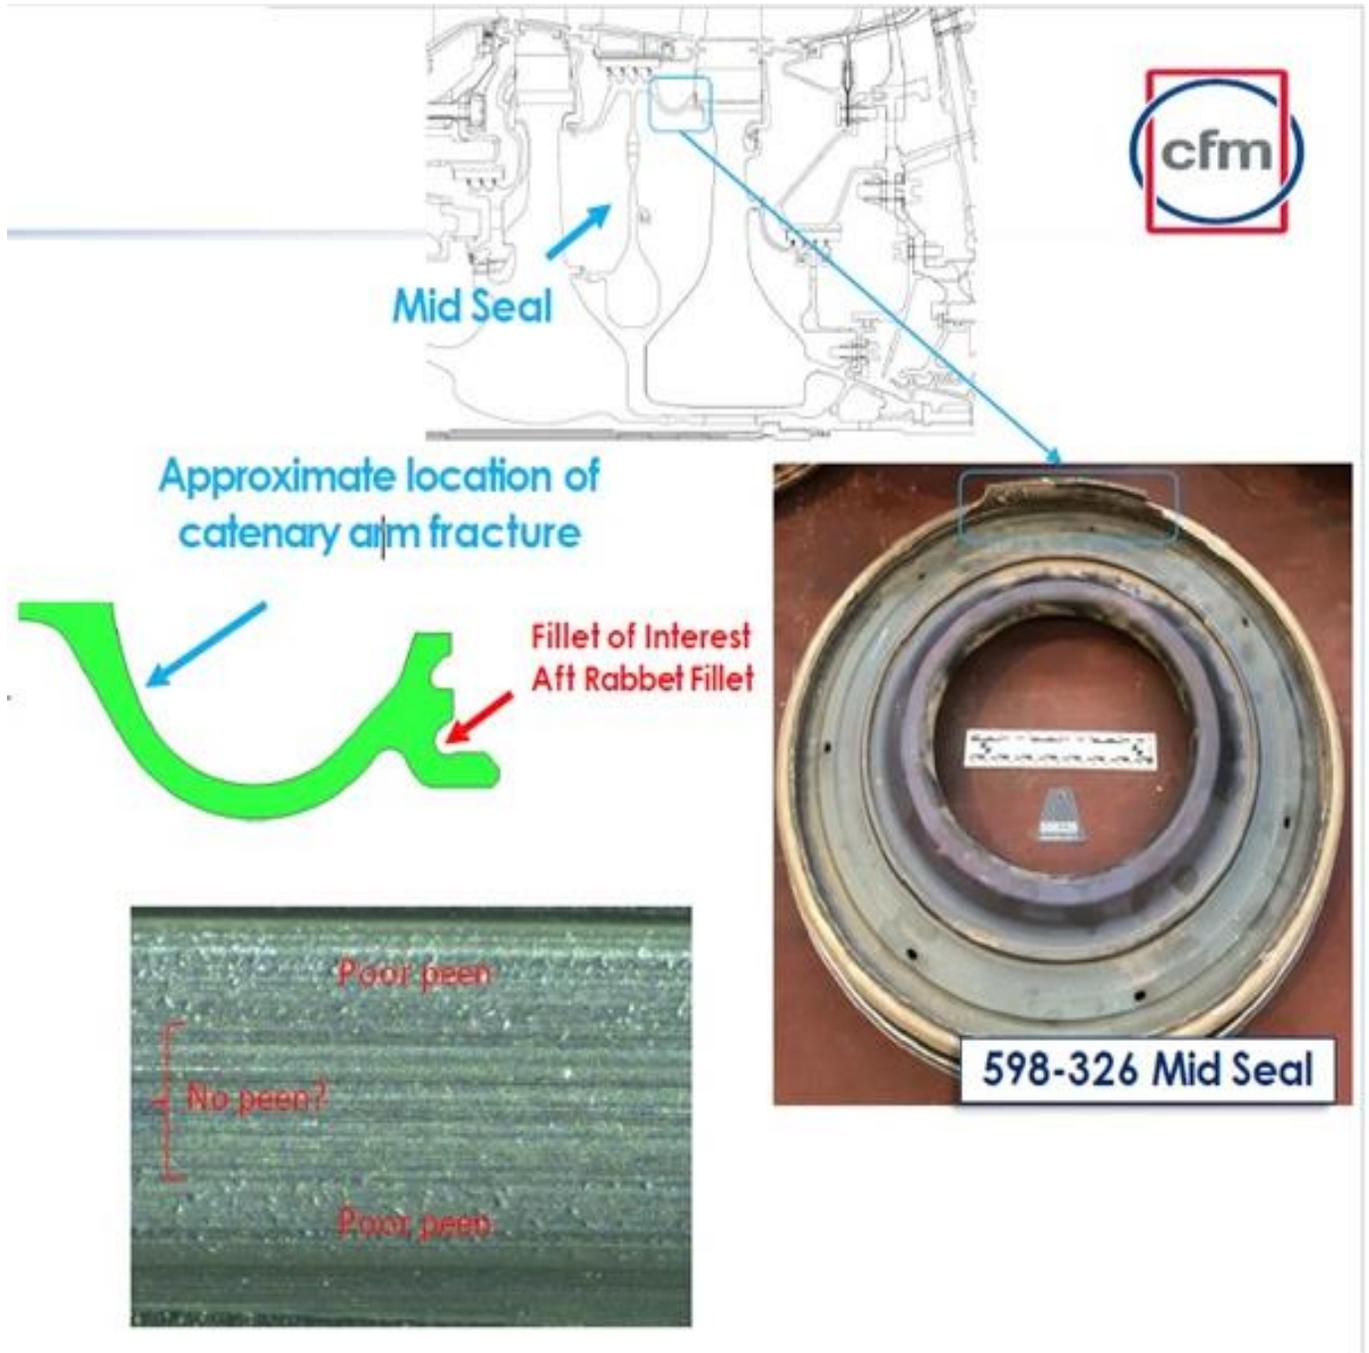
- Non-design intent surface condition in aft rabbet fillet.
- Inadequate peen coverage or intensity and visible turning lines (re-machined surface) in rabbet fillet resulting in debited low cycle fatigue capability.

Image# 20A HPT rotor interstage seal (mid-seal) investigation findings

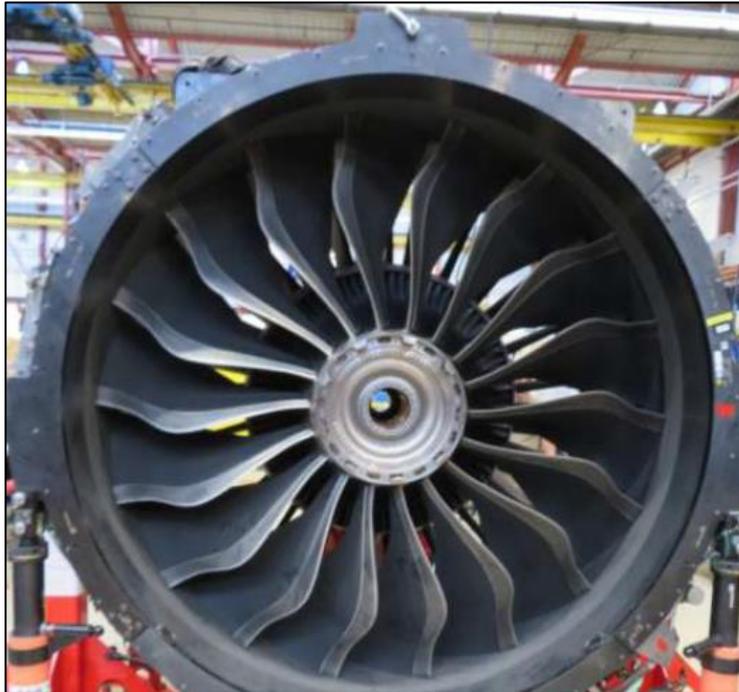
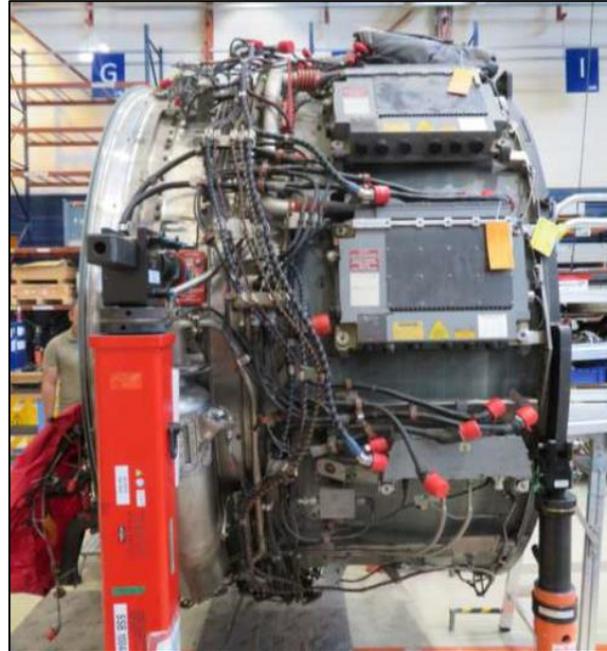
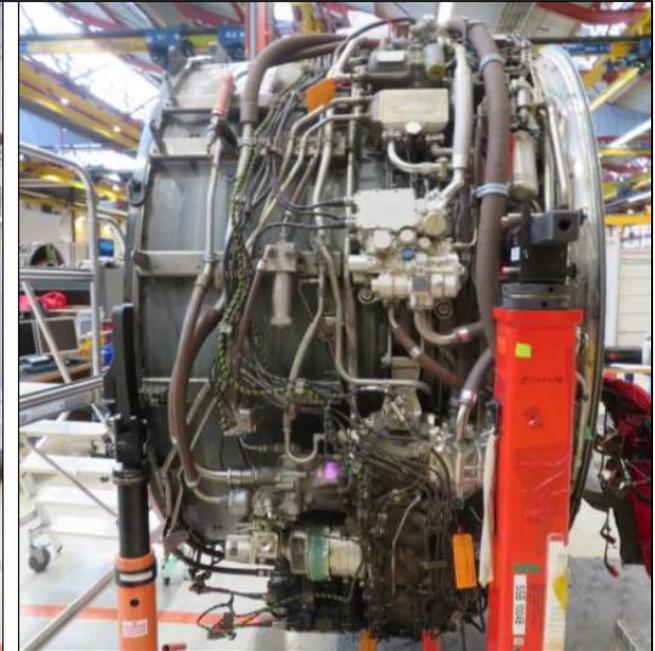
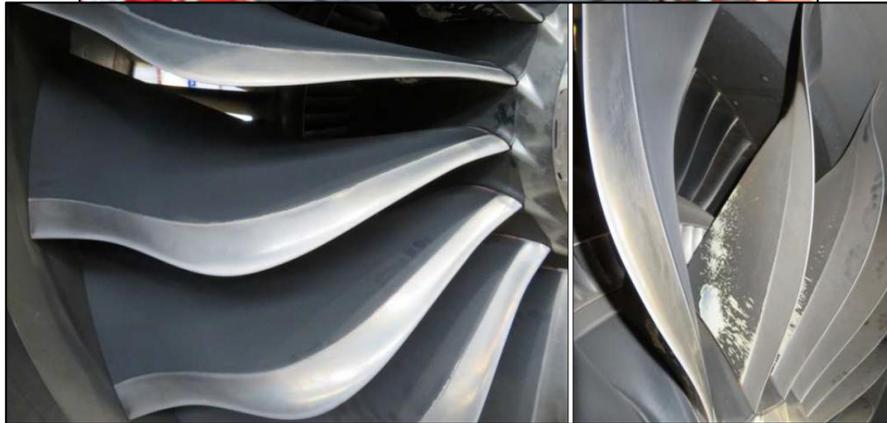
# 598-326 Teardown – Fan & Booster Modules

No unusual distress at Fan blades or external to fan module

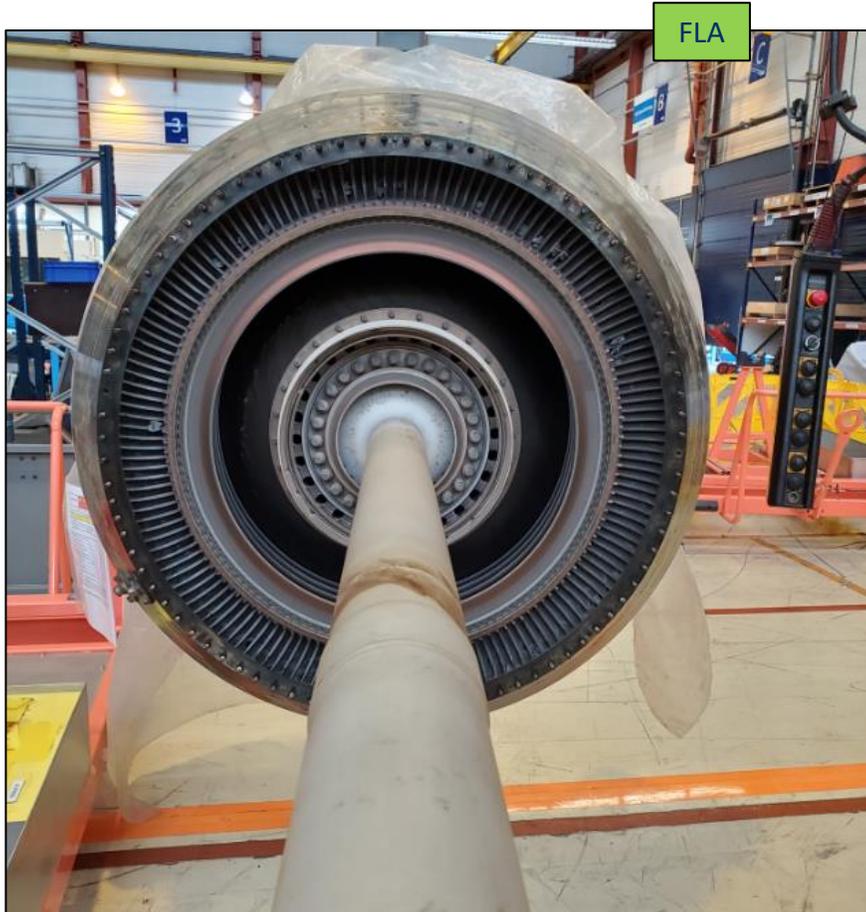
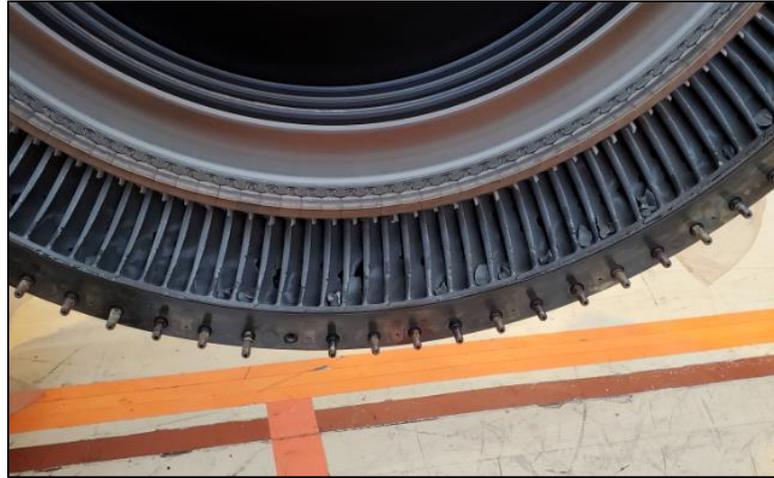
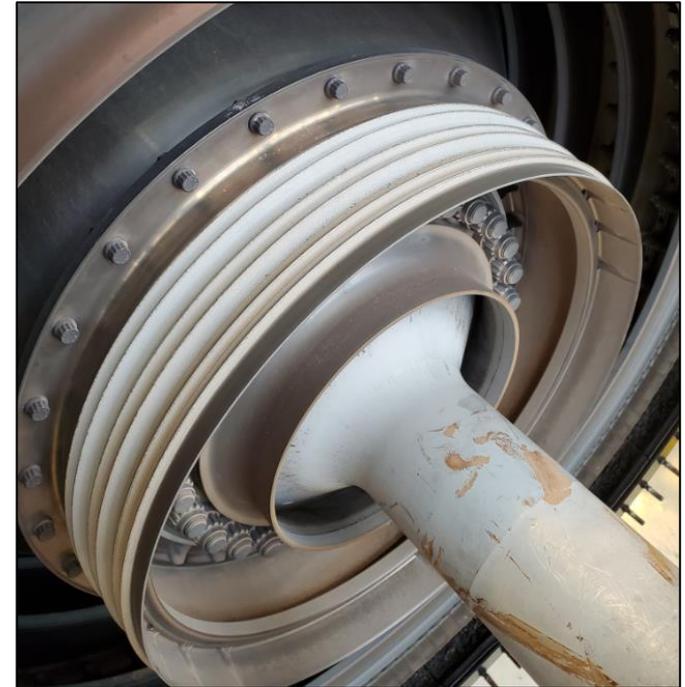
# 598-326 Teardown – Low Pressure Turbine Module

**LPTB1 row missing above platform, debris found mostly at 6:00 – M10 rotating seal teeth in typical condition**

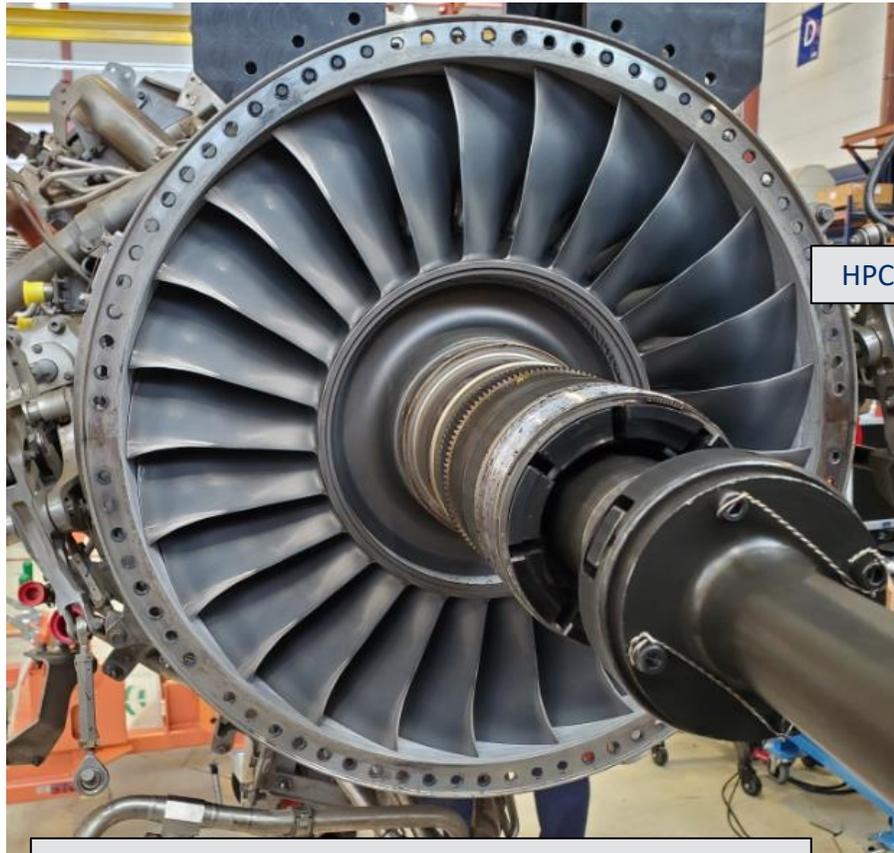
# 598-326 Teardown – High Pressure Compressor Module

HPC Fwd Case heavy rub

- Additional BSI inspection to be performed of HPC airfoils – *June 27<sup>th</sup>*

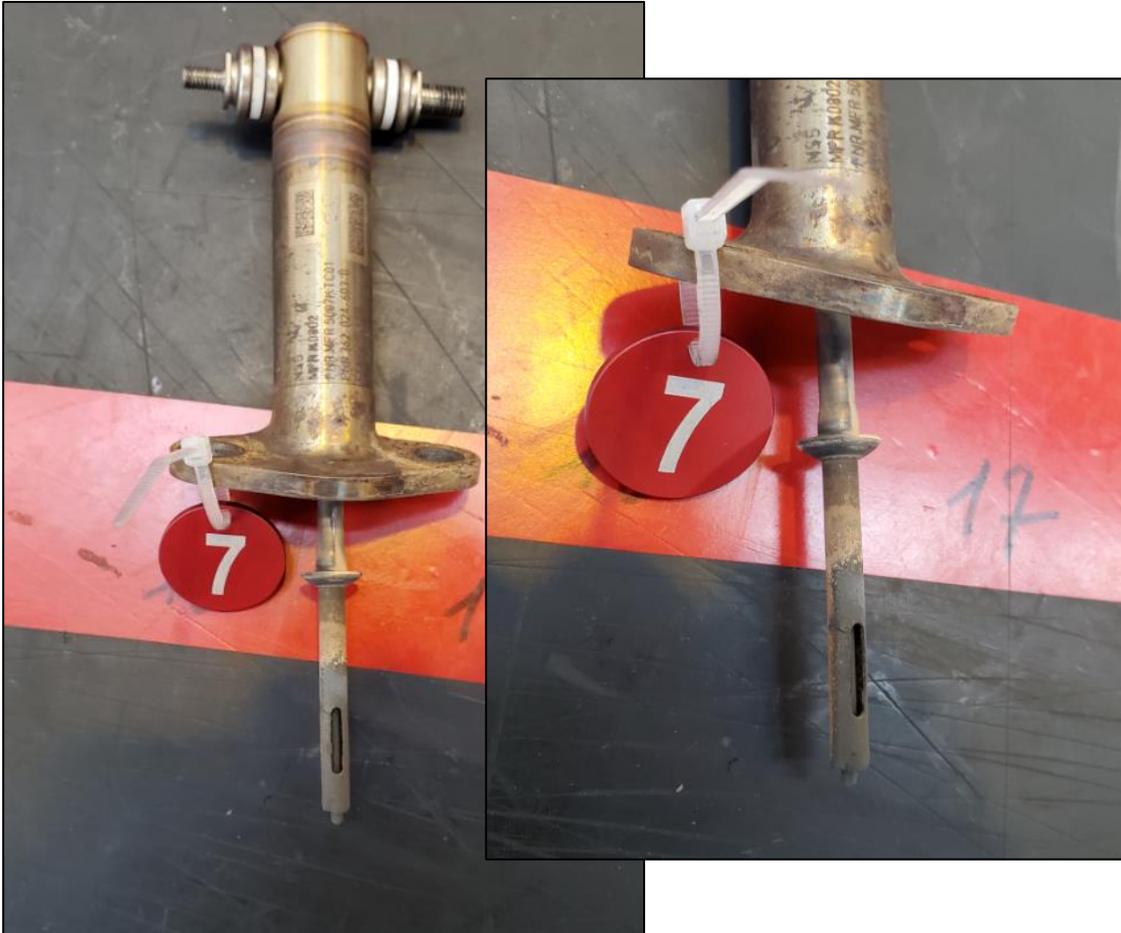
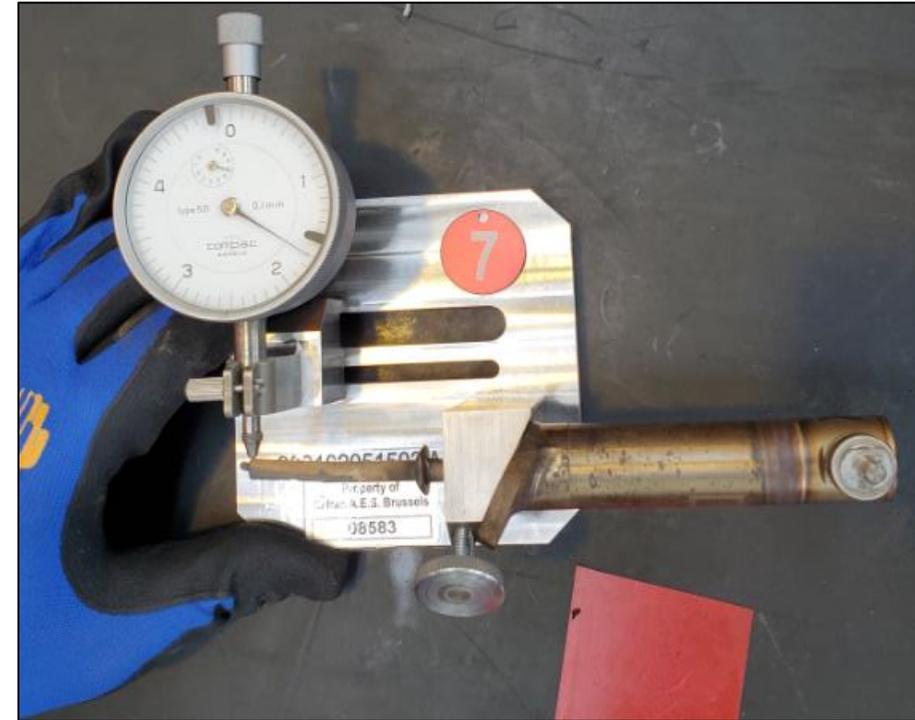
# 598-326 Teardown – EGT Probes

**EGT probe 7 with minor impact damage – 3 probes with creep deformation (consistent with field observations)**

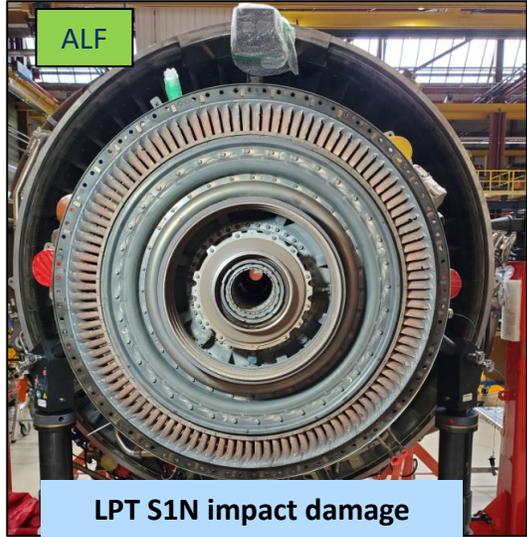
LPT S1N impact damage

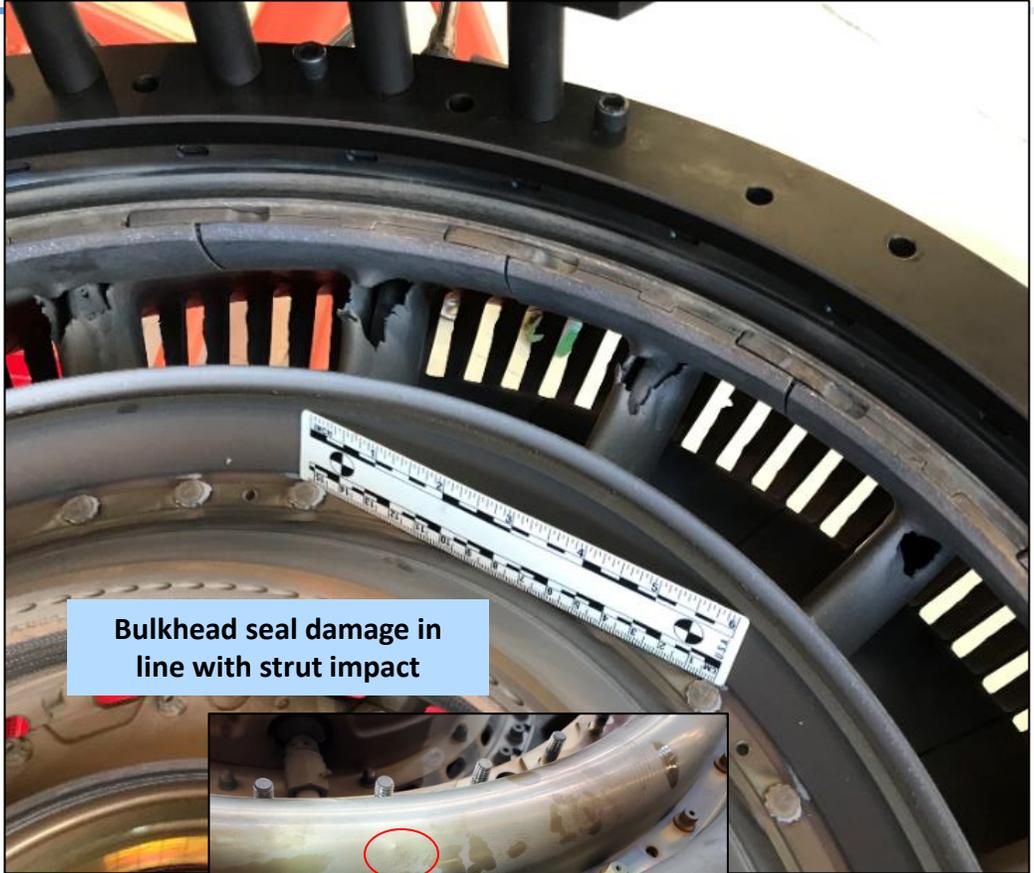
Bulkhead seal damage in line with strut impact

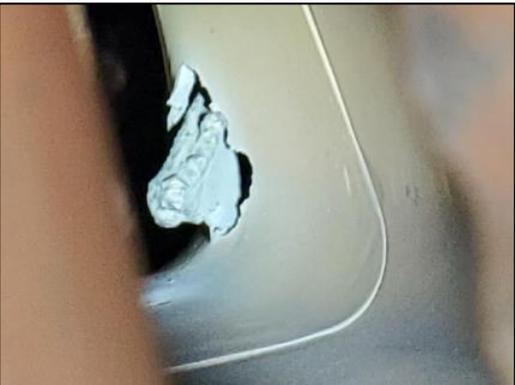
MS aft-arm fragment in TCF fairing

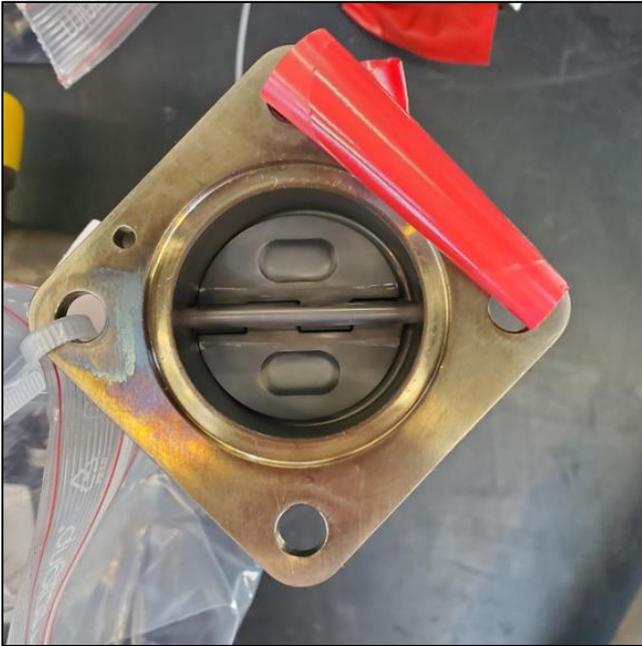
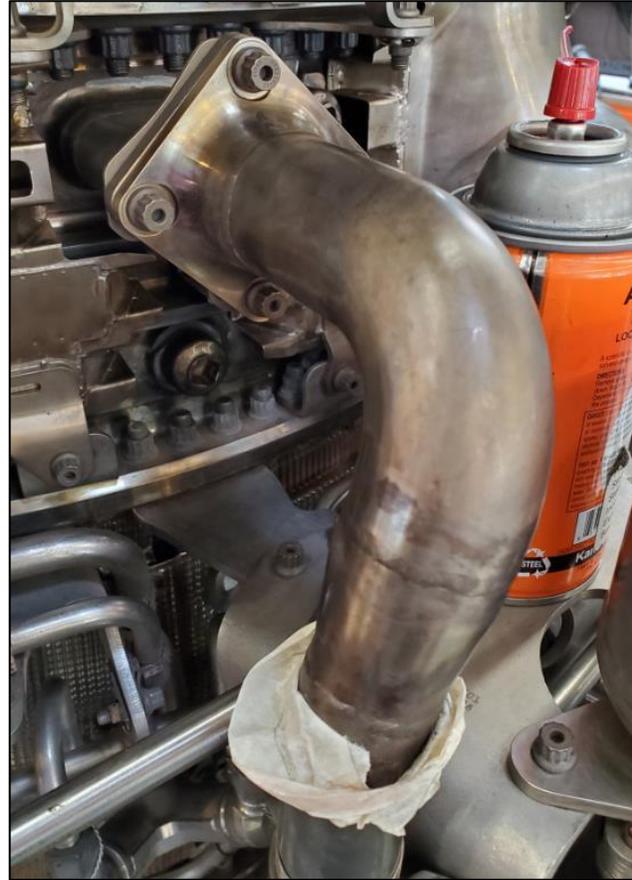
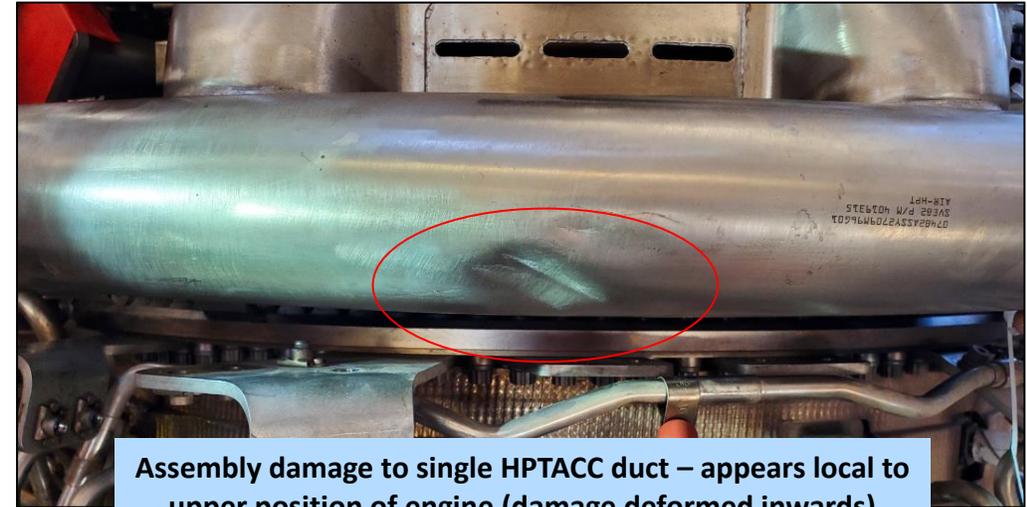
# 598-326 Teardown – Externals (HPC Stage 7 Bleed Pipe, HPTACC duct)

Assembly damage to single HPTACC duct – appears local to upper position of engine (damage deformed inwards)

**Internal (BSI) and external visual of S7 domestic bleed pipes OK – flapper valve function as expected**

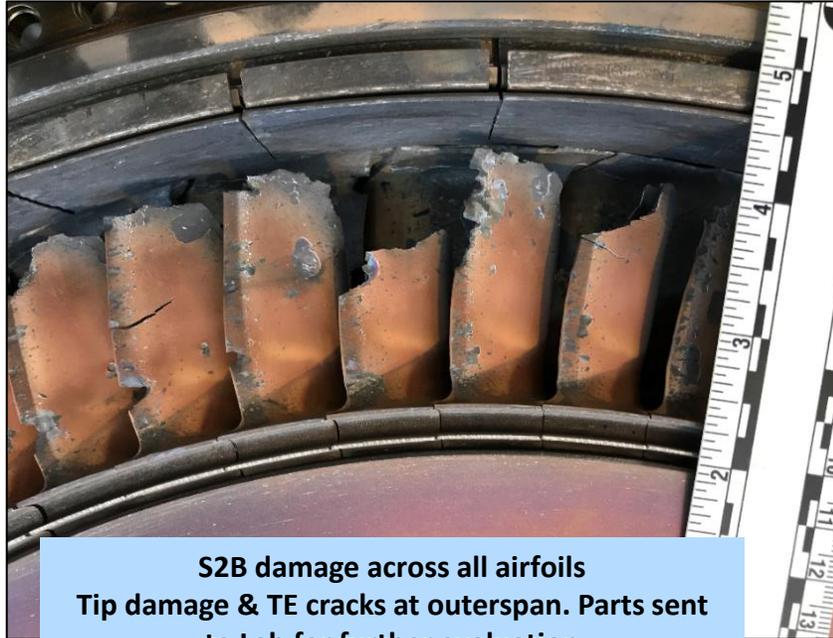
**S2B damage across all airfoils  
Tip damage & TE cracks at outerspan. Parts sent  
to Lab for further evaluation**

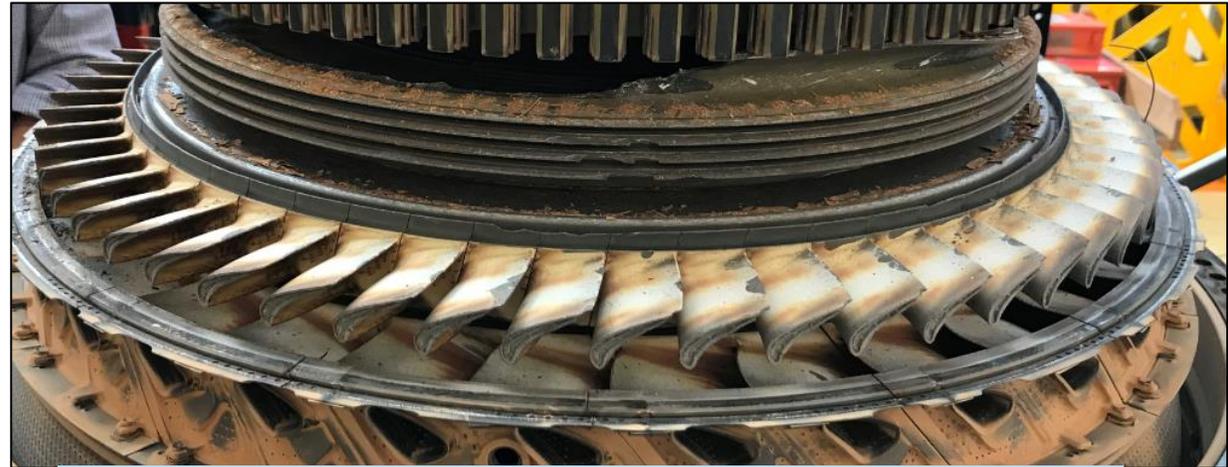
**S1B in good condition , minor missing TBC, tip condition good (minimal rub)**

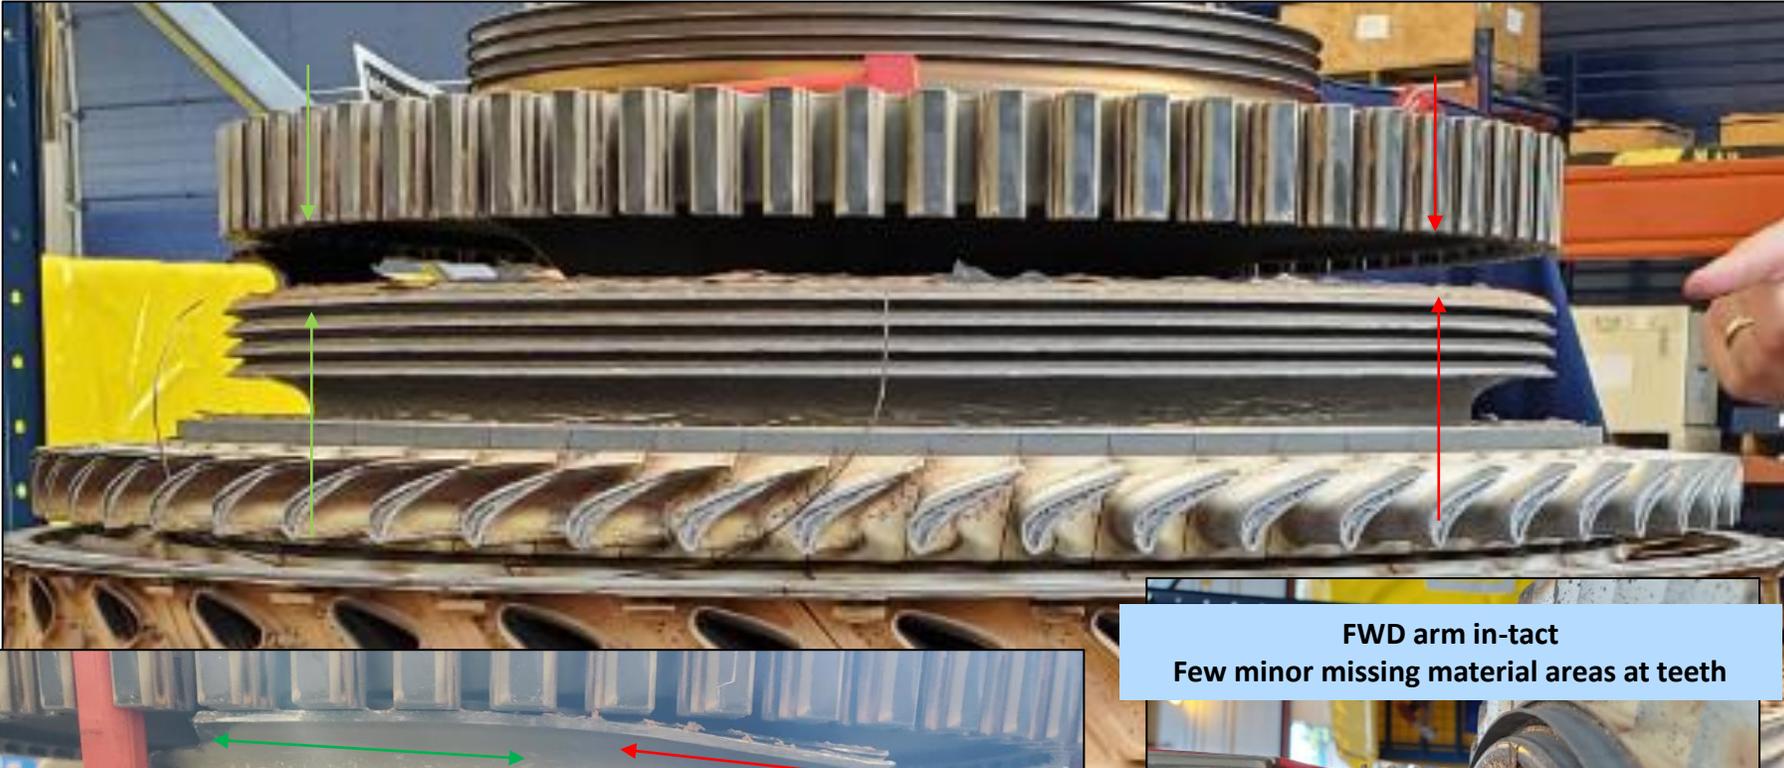
- Mid-seal squeeze differences noted in areas where aft arm missing

FWD arm in-tact  
Few minor missing material areas at teeth

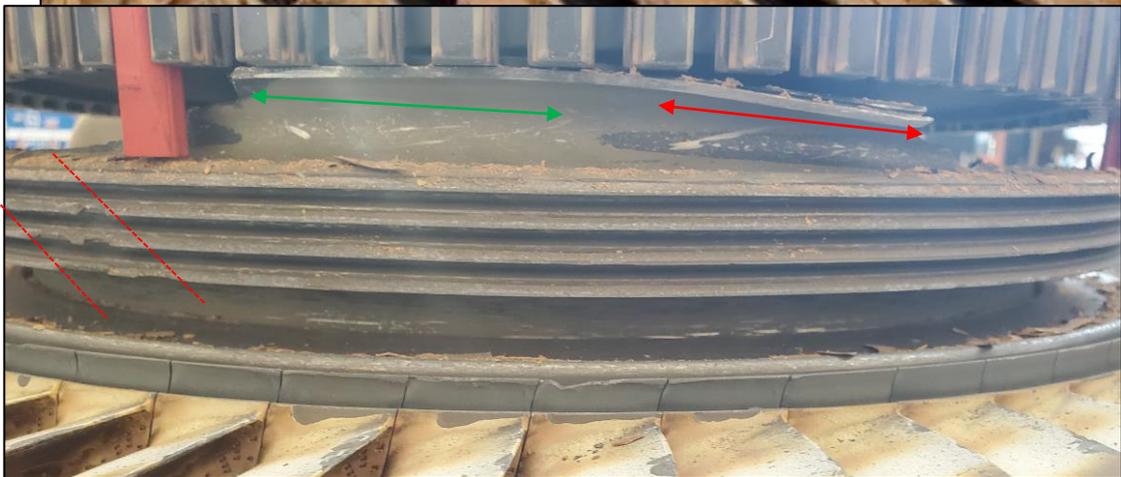
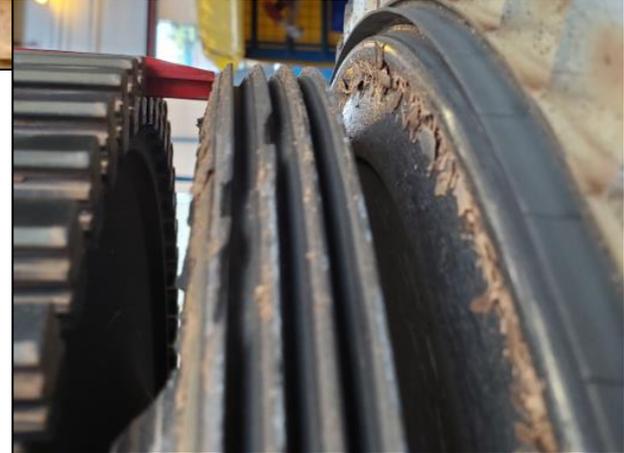
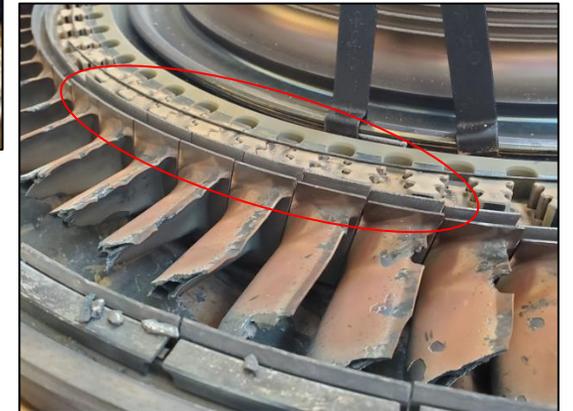
Axial position of S2B as expected in mid-seal intact aft arm

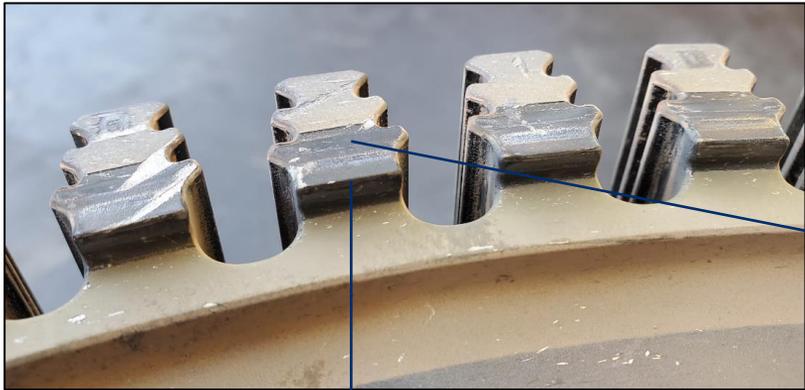
Rabbet area to be investigated in lab

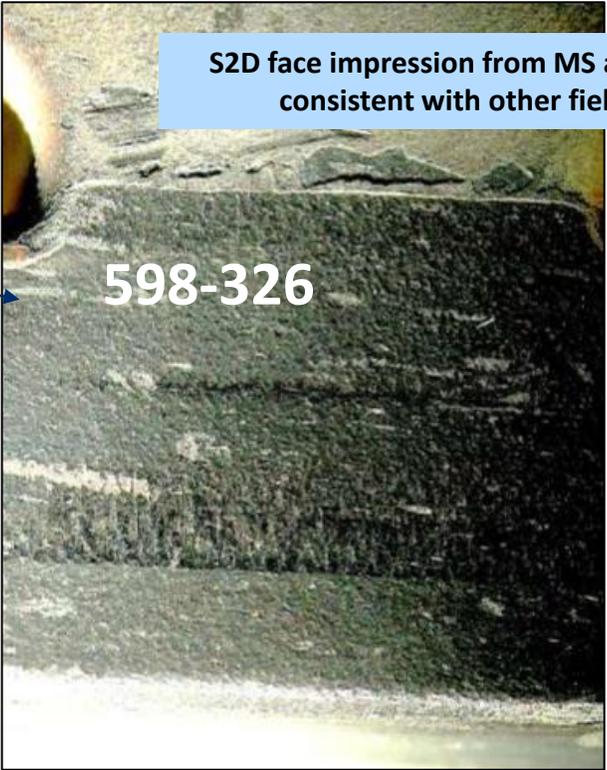
S2D face impression from MS aft axial face consistent with other field disks

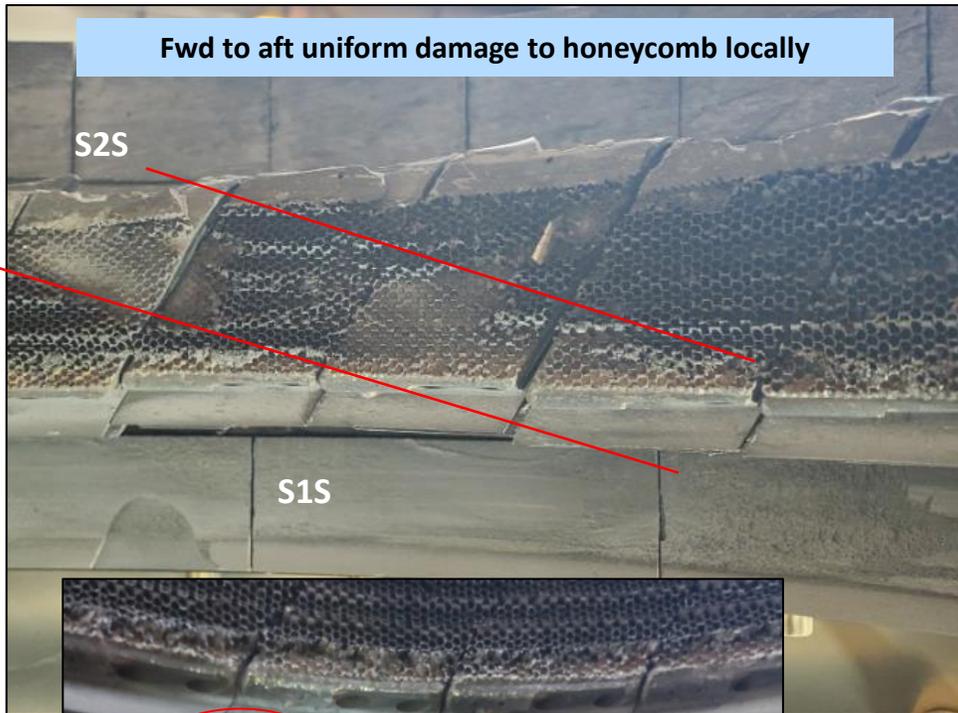
Fwd to aft uniform damage to honeycomb locally

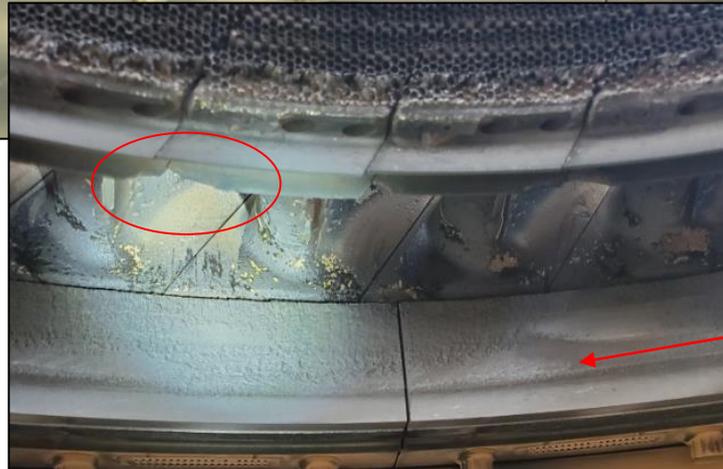
4 grooves in honeycomb, in general good condition  
FWD S2N purge holes clear of obstruction  
Aft purge holes clear where present

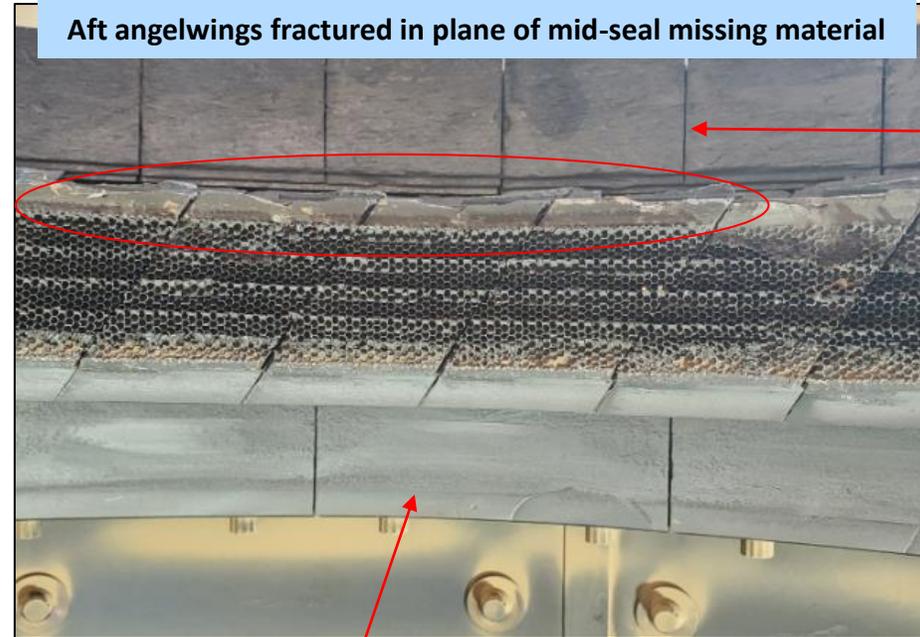
Aft angelwings fractured in plane of mid-seal missing material

S2S with flowpath sooting, no appreciable damage

S1S with minor missing EBC coating, heavy sooting on flowpath

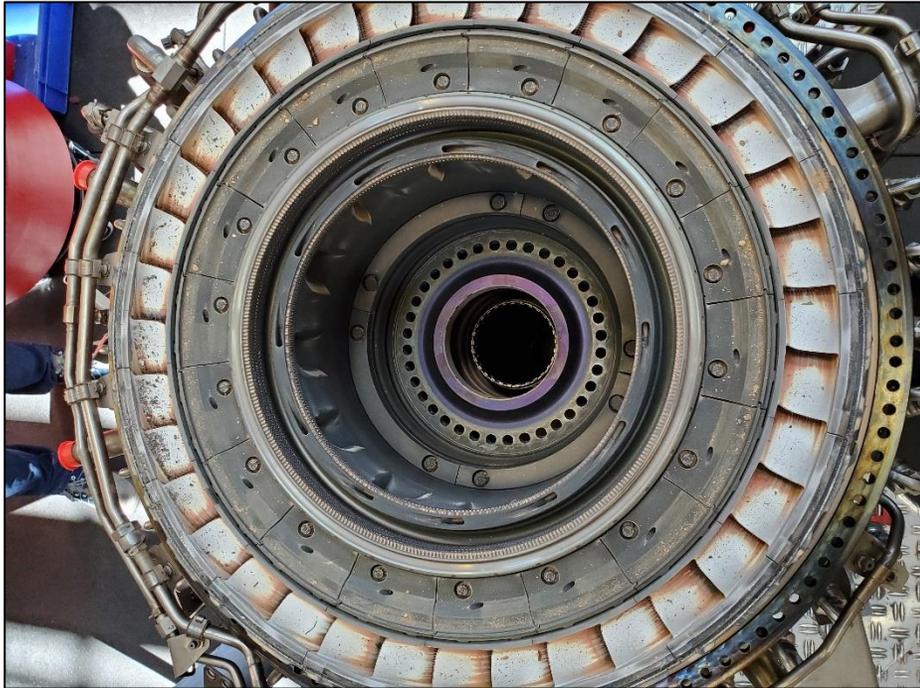
**S1N in good condition – 1 segment with convex panel crack**

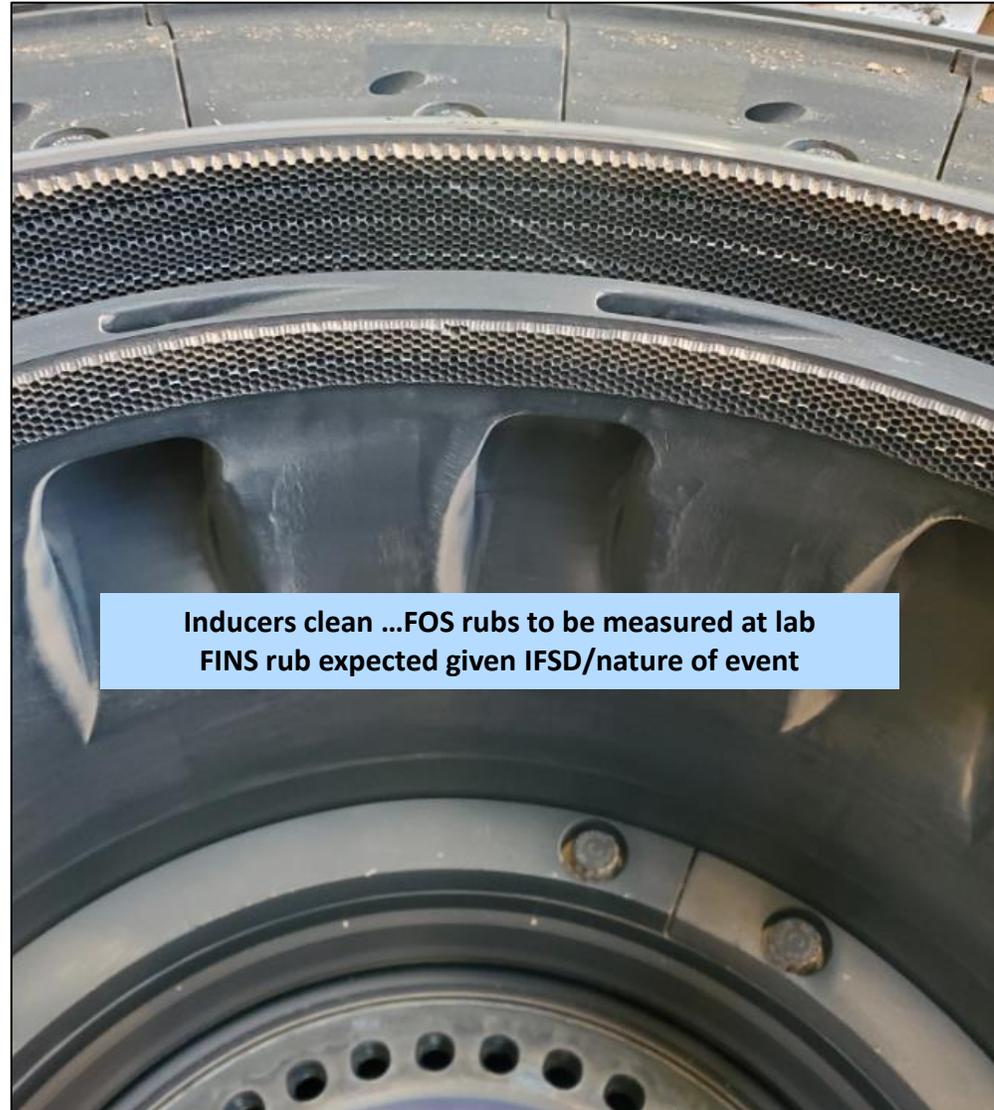
**Inducers clean ...FOS rubs to be measured at lab  
FINS rub expected given IFSD/nature of event**
