**FINAL INVESTIGATION REPORT ON  
AIR TURN BACK INCIDENT TO  
M/s AIR INDIA LTD AIRBUS A320-251N AIRCRAFT  
VT-EXM ON 19/05/2022 AT MUMBAI**

**GOVERNMENT OF INDIA  
O/o DIRECTOR AIR SAFETY, WESTERN REGION,  
NEW INTEGRATED OPERATIONAL OFFICE COMPLEX,  
SAHAR ROAD, VILE PARLE (EAST), MUMBAI-400099**

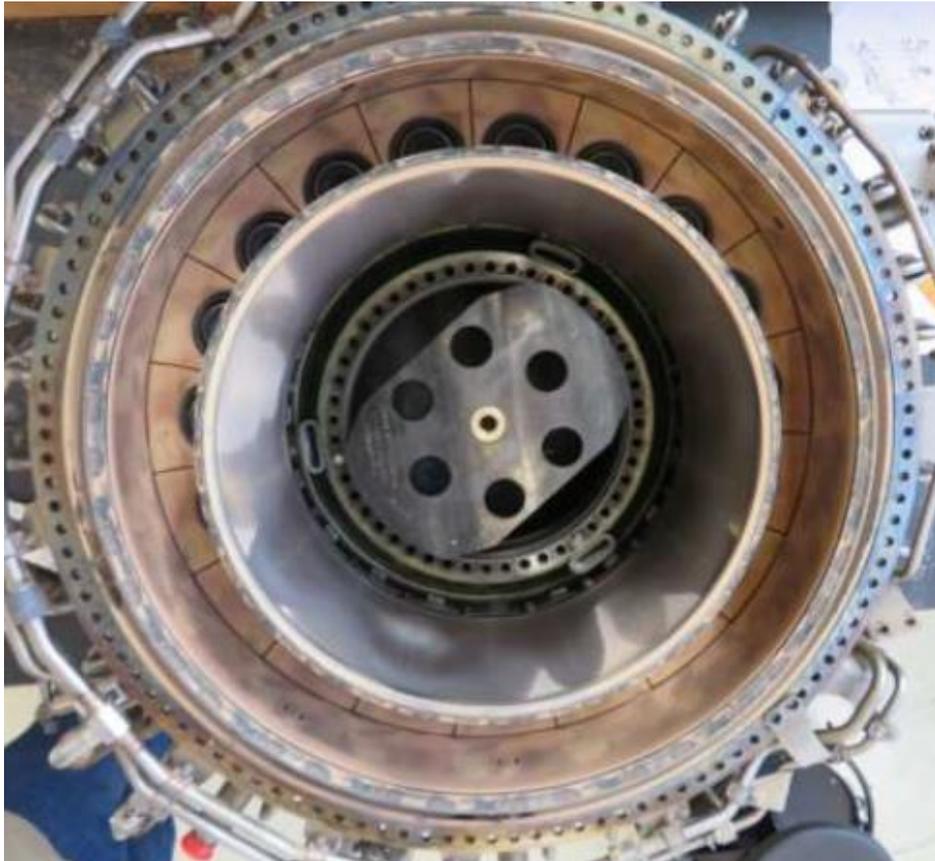
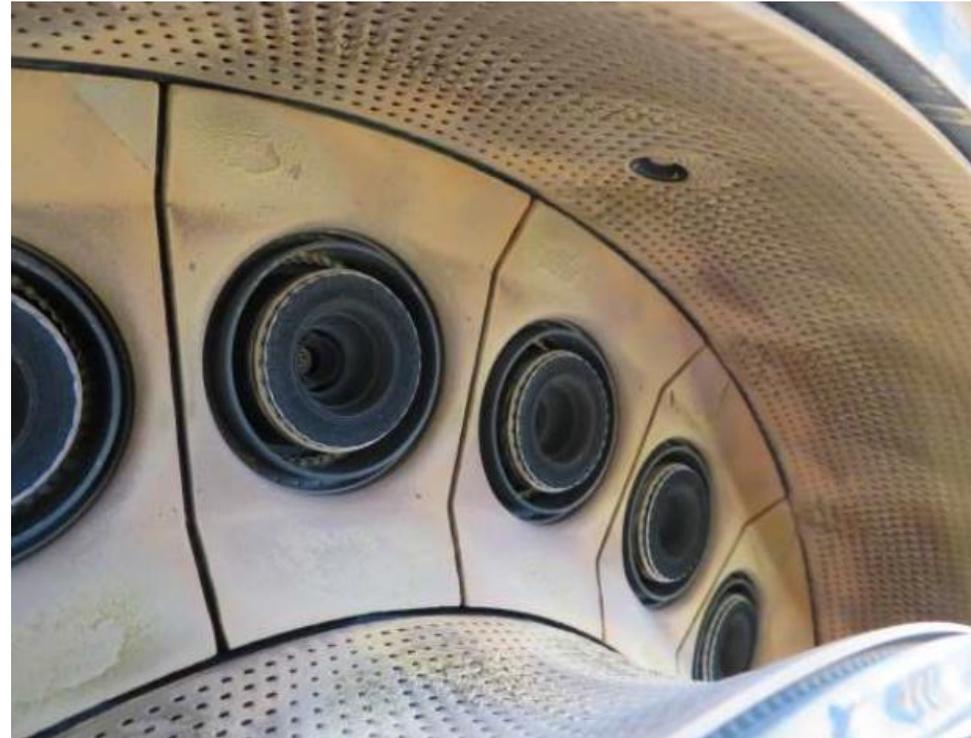
# 598-326 Teardown – Combustor Assembly

**Combustor in good condition, with sooting on FN aft heat shield**

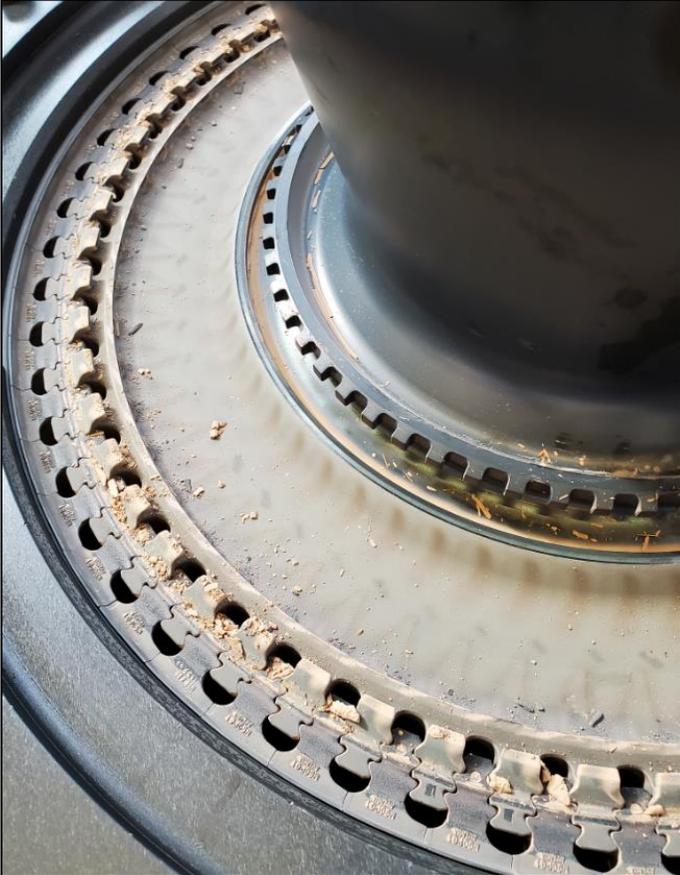
Evidence of dust buildup on FOS, less than MENA experience

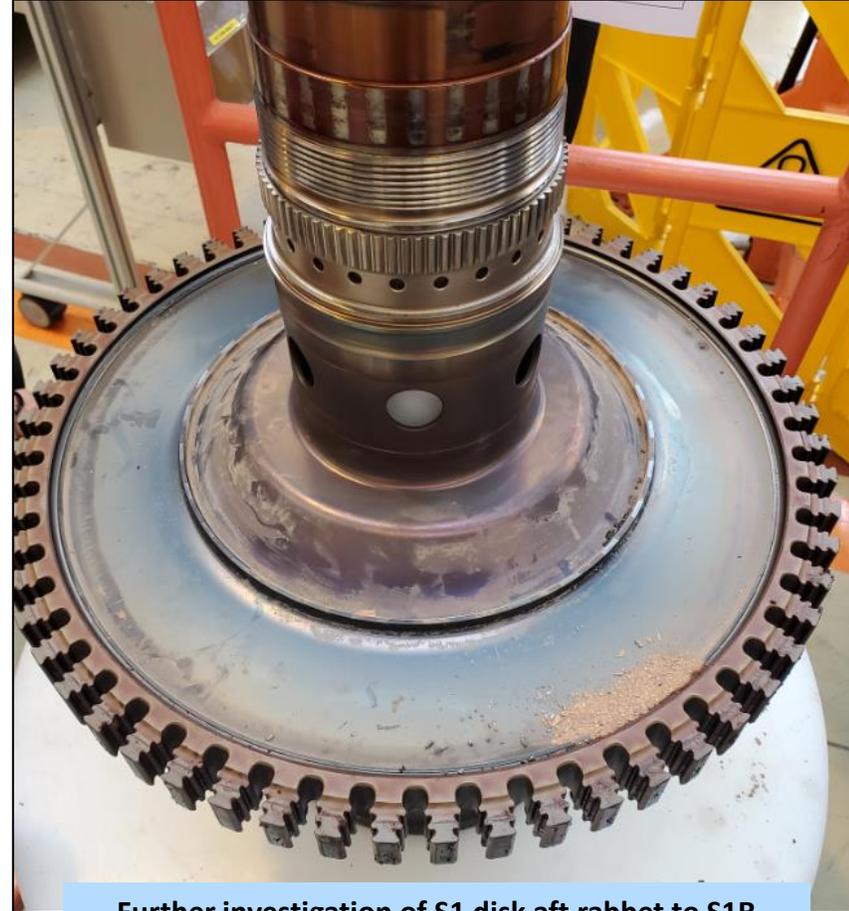
Further investigation of S1 disk aft rabbet to S1R collet at lab

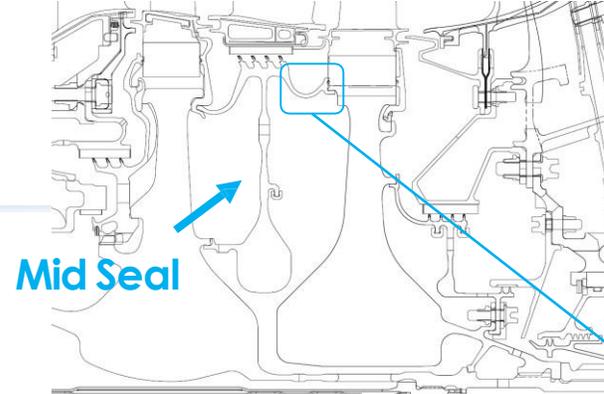
Approximate location of catenary arm fracture

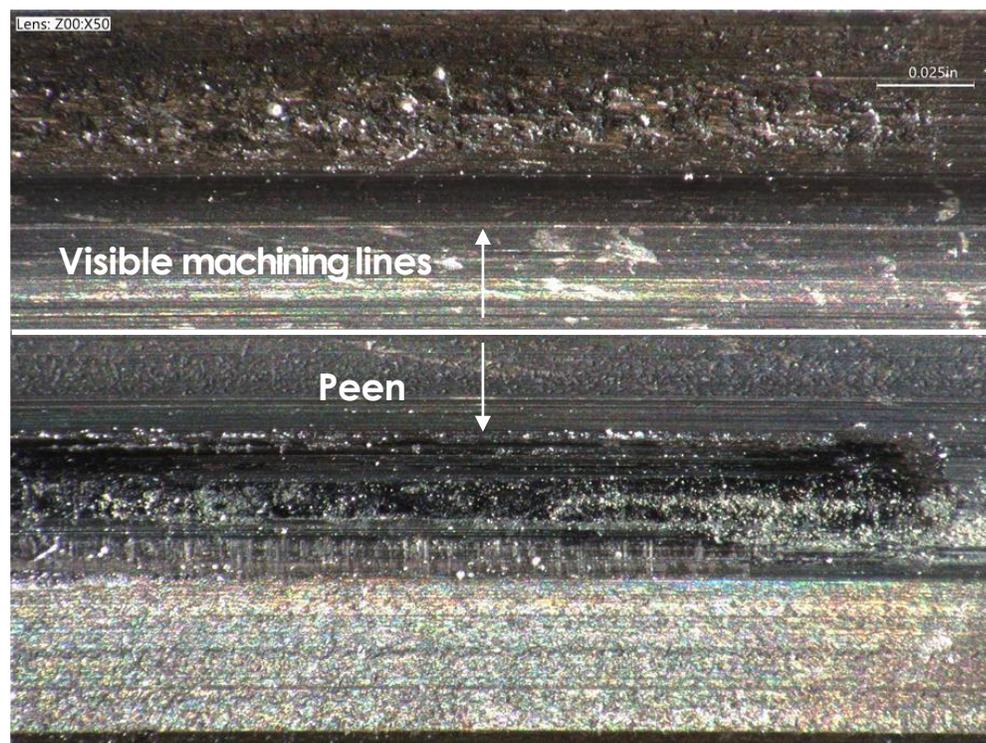
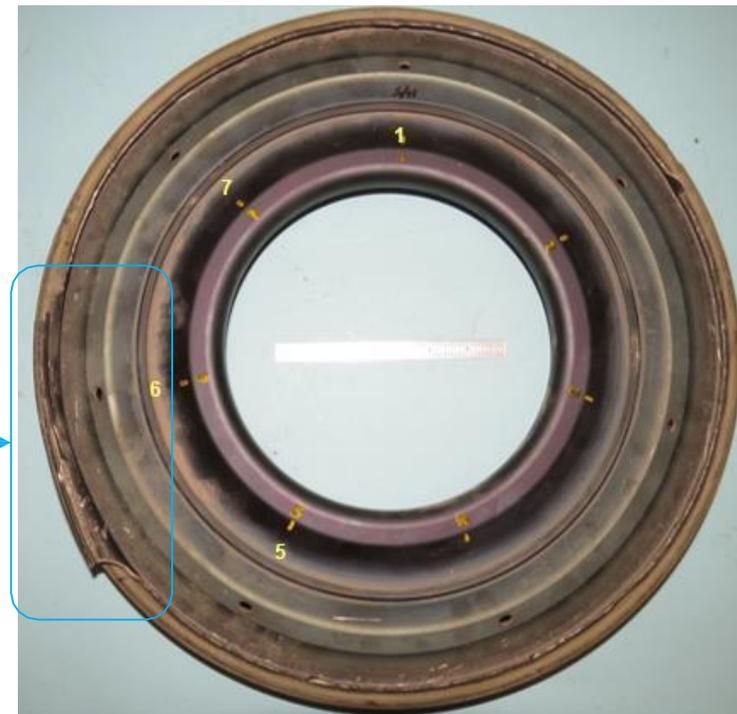
# 598-326 Mid Seal Metallurgical Evaluation

- ❑ No evidence of creep or overtemperature exposure (verified dimensionally)
- ❑ In remaining aft catenary arm ligament:
  1. Rabbet fillet has less visible shot-peened area with visible machining lines

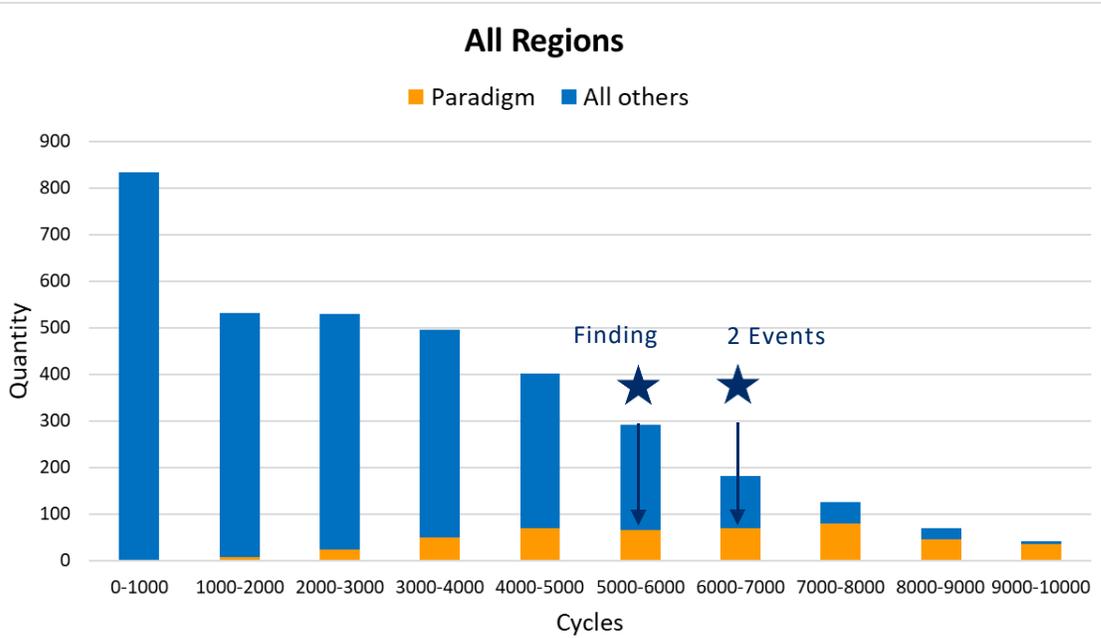
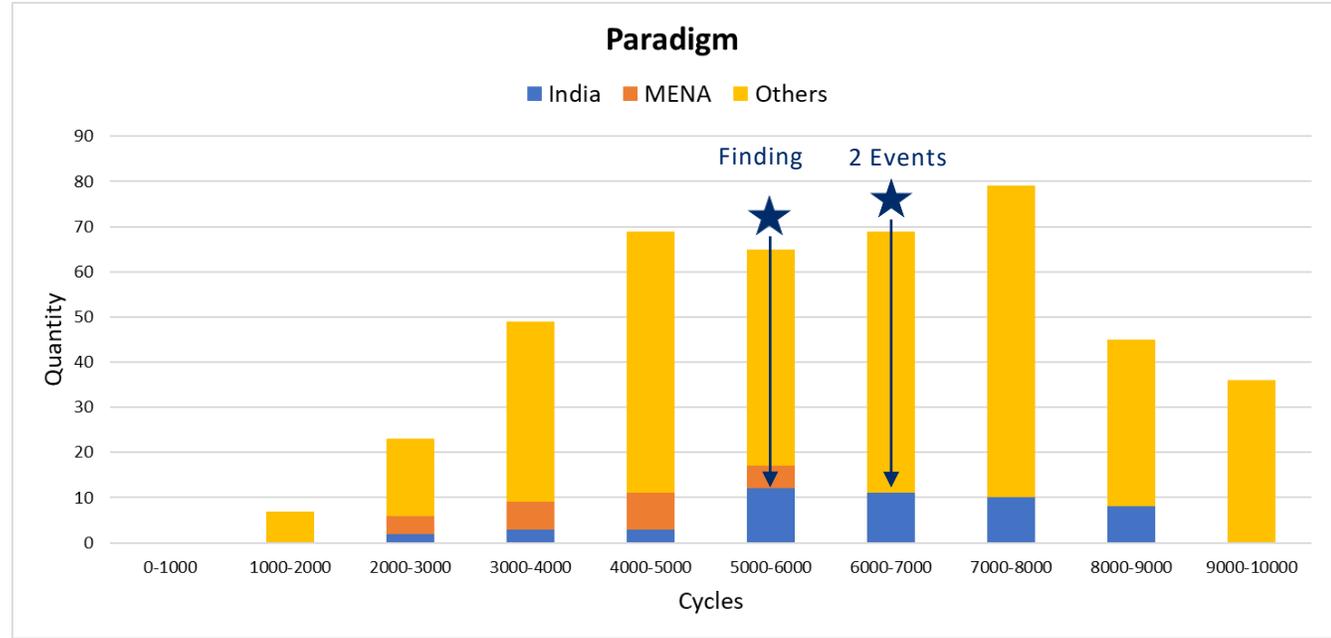
- Relatively high time parts, but not highest
  - Failure at ~6500 – 6800 CSN
  - -317 finding extrapolated to fail at ~6500 CSN
- Manufactured by same supplier (Paradigm)

All three mid seals manufactured from same supplier “Paradigm” and operated in India region

- (c) As 85% of the Paradigm (WES) parts have been inspected with inadequate peen coverage, OEM has planned the following corrective action:
  - To issue CAT 2B Service Bulletin 72-0525 recommending removal of all Paradigm mid seals (serial numbers starting with “WES”) from service.
