**FINAL INVESTIGATION REPORT ON
UN-COMMANDED IN-FLIGHT SHUT DOWN OF ENGINE #1
OF BOEING B787-8 AIRCRAFT VT-ANW
AT MUMBAI ON 04.08.2023**

**GOVERNMENT OF INDIA
O/o, DIRECTOR AIR SAFETY, WESTERN REGION,
NEW INTEGRATED OPERATIONAL OFFICE COMPLEX,
SAHAR ROAD, VILE PARLE (EAST), MUMBAI**

FINAL INVESTIGATION REPORT ON THE INCIDENT TO
M/s AIR INDIA, BOEING B787-8 AIRCRAFT VT-ANW ON 04.08.2023
AT MUMBAI

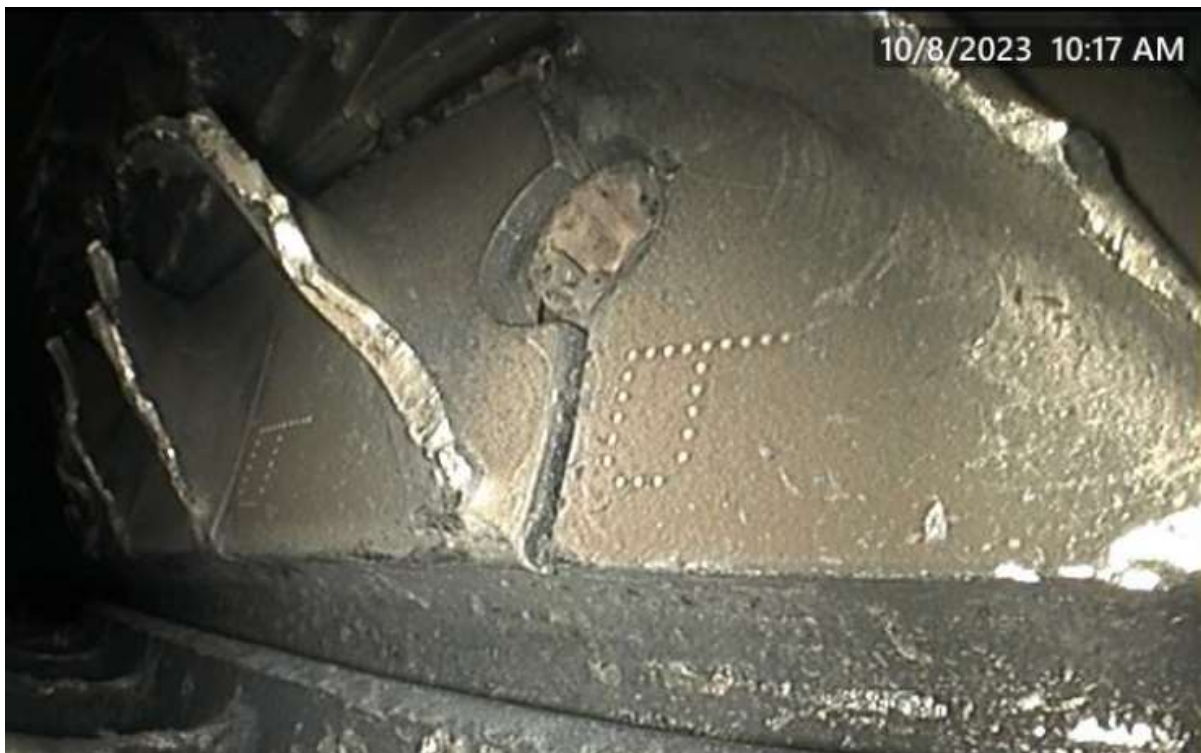
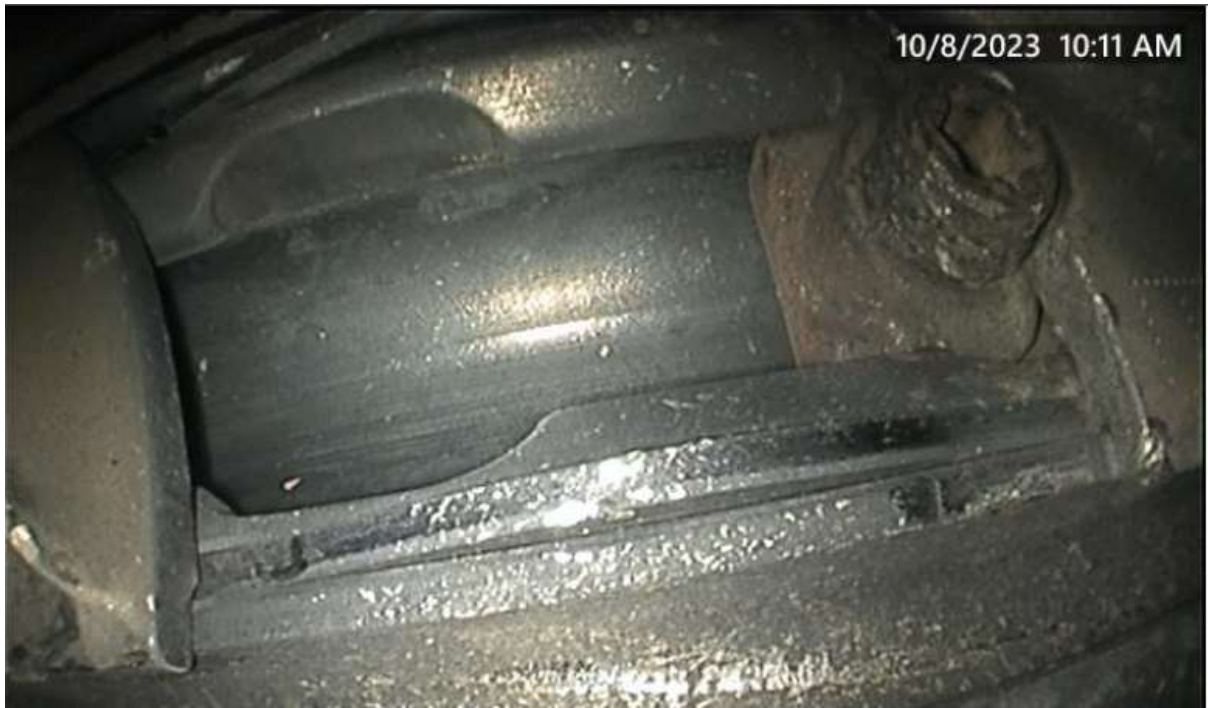
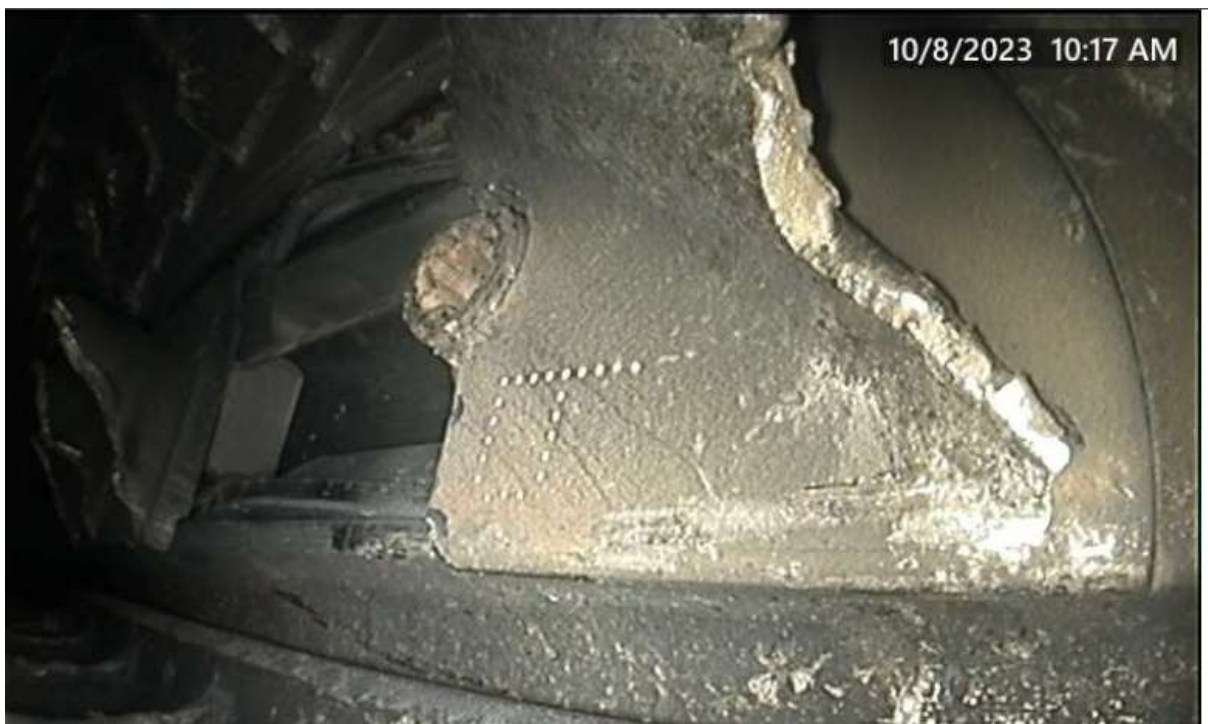
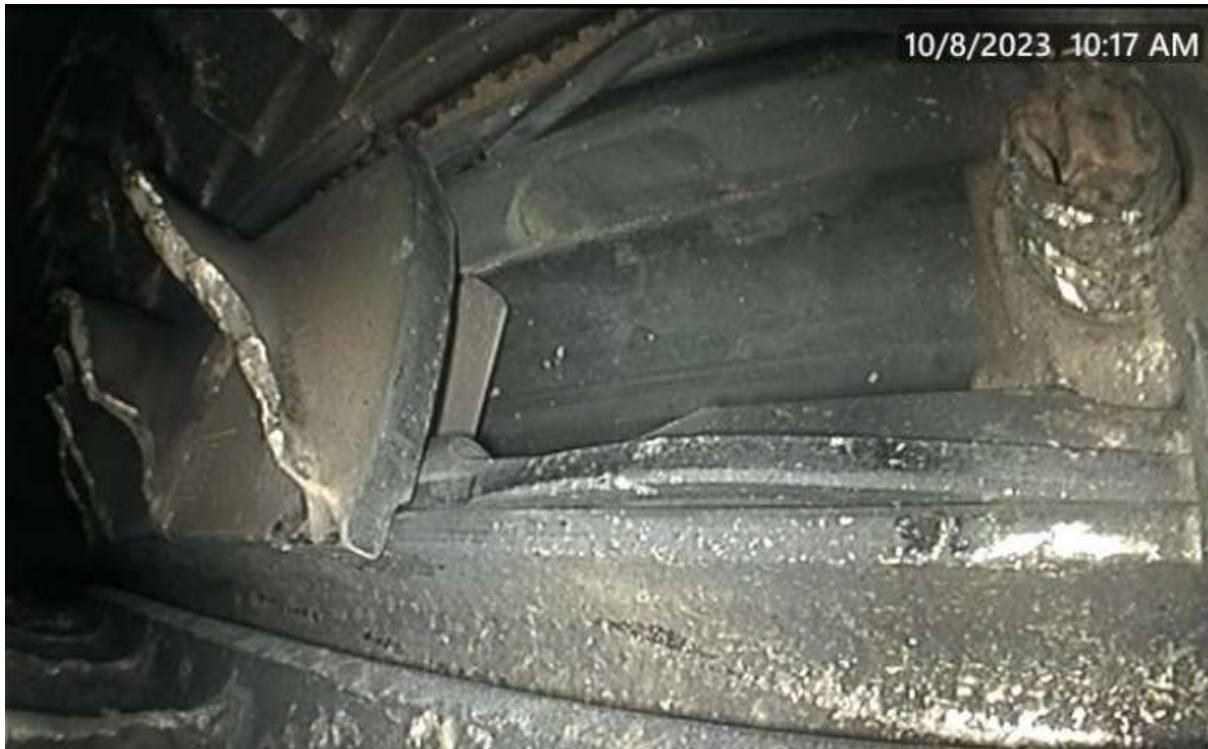
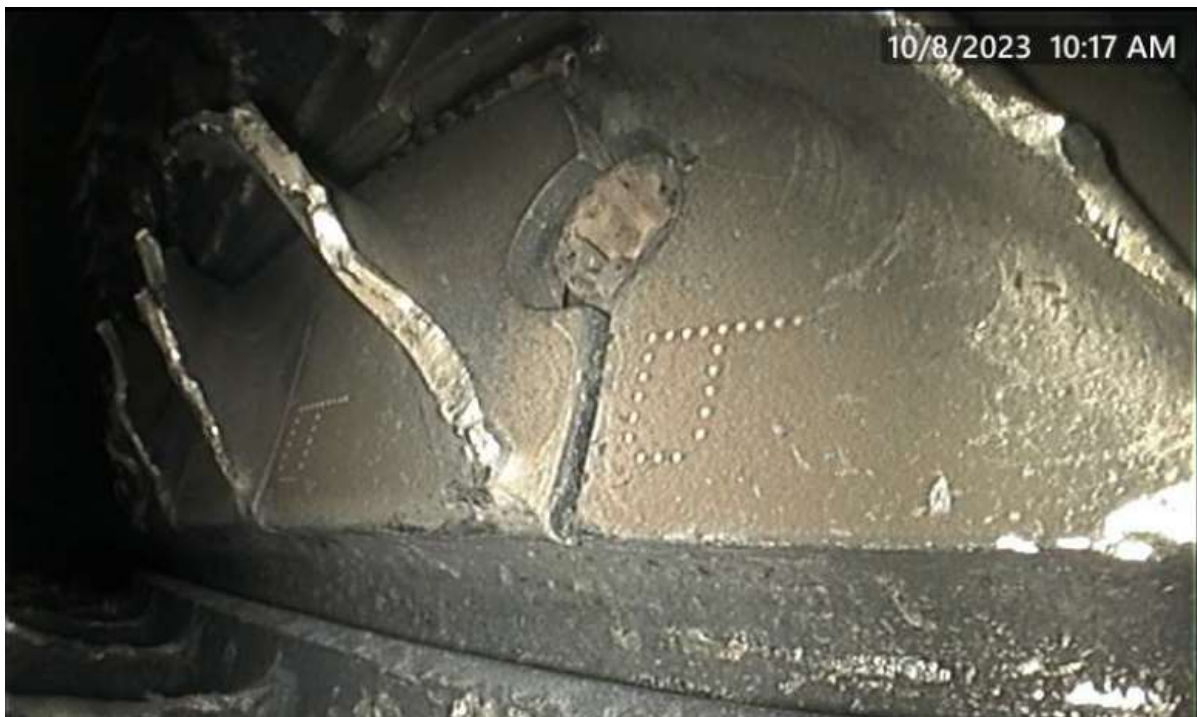
- Qty (1) HPC Stage 10 blades found liberated and missing between loading and locking slot, causing damage to all the blades. Both the locking and loading slot grub screws were found to be in place.
- All HPC Stage 9 blades were found with severe damage of missing material, bent, tear, dent and cracks on T/E.
- All HPT Stage 1 blades noticed with missing TBC, damage on L/E and convex area along with dents and missing material in L/E tip area.
- Quantity (1) HPC stage 10 blade found liberated and missing from the loading slot, causing damage to all blades, beyond AMM Limits.
- TBC material powder/ Metal powder was found on LPT stage 4,5 & 6 Blades, Tip shorted area/ concave side (Powder was found in loose condition).

Below are the images indicating the missing blade and other damages.

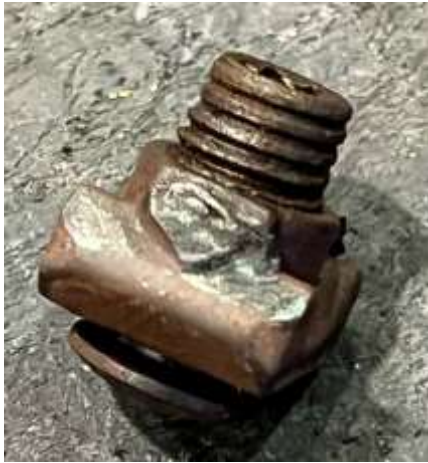
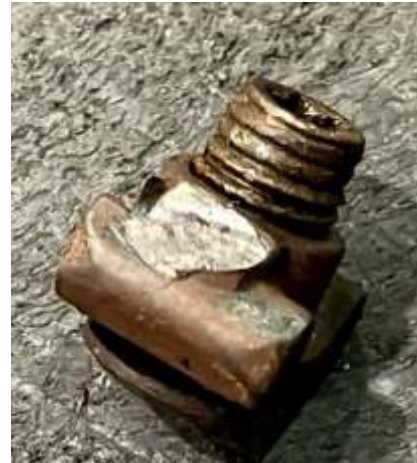
The root cause investigation for the release of HPC Stage 10 blade was conducted by the OEM and the disassembly investigation revealed that the LH locking lug was installed out of the lock slot and the RH locking lug was installed partially inside the lock slot and the improper installation of lugs caused the release of the blade.

Above are the pictures of the LH locking lugs which have experienced severe damage on upper lug shoulder indicating lug installed out of lock slot and not proper.

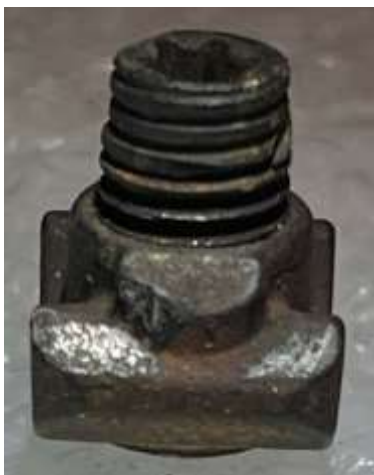
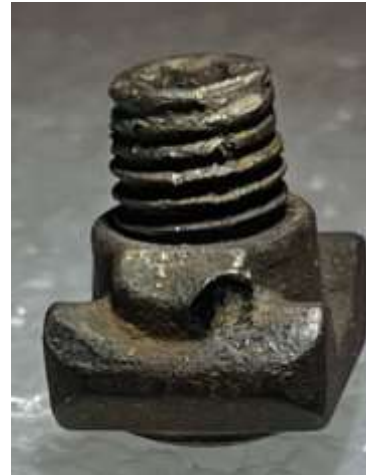
Above are the pictures of the RH locking lugs which have experienced abnormal wear on one side of the shoulder and pressure face indicating that the installation was partially inside the lock slot and not proper.
