INVESTIGATION REPORT ON TAIL STRIKE INCIDENT TO M/S INDIGO A-321 AIRCRAFT VT-ILR WHILE LANDING AT NETAJI SUBHASH INTERNATIONAL AIRPORT, KOLKATA ON 02.01.2023

INVESTIGATION REPORT ON TAIL STRIKE INCIDENT TO M/S INDIGO AIRLINE A-321 AIRCRAFT VT-ILR AT KOLKATA AIRPORT ON 02.01.2023

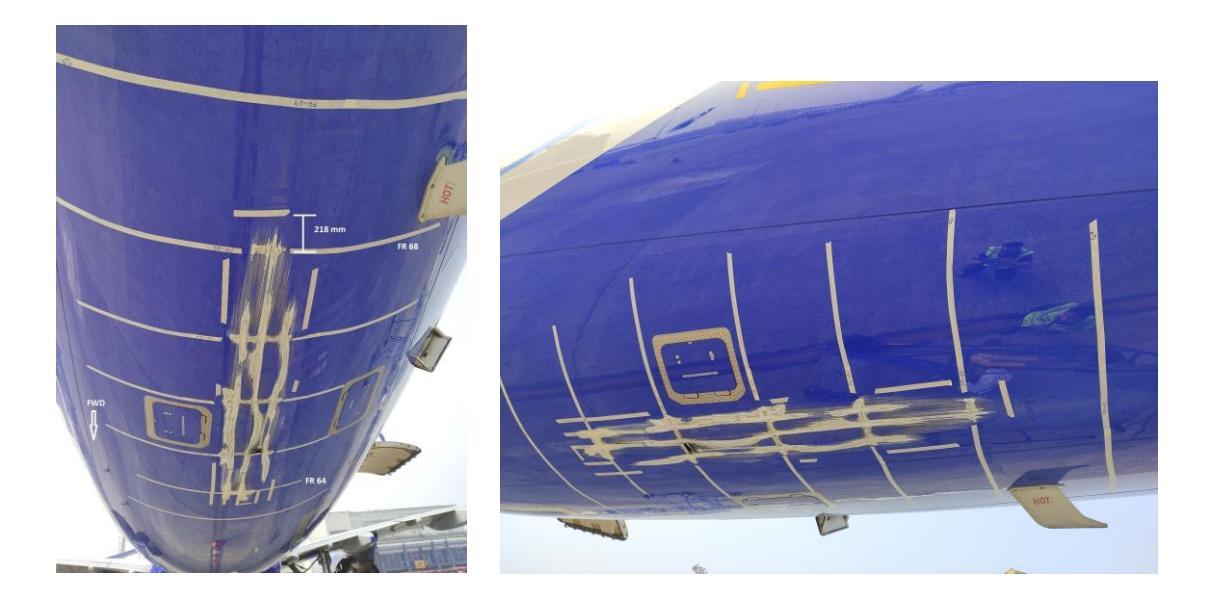
During the walk around inspection, damages observed on aft fuselage. During detailed inspection of the aircraft various internal and external structural damages, cracks, scratches, deformations were observed including the damage to the skin.

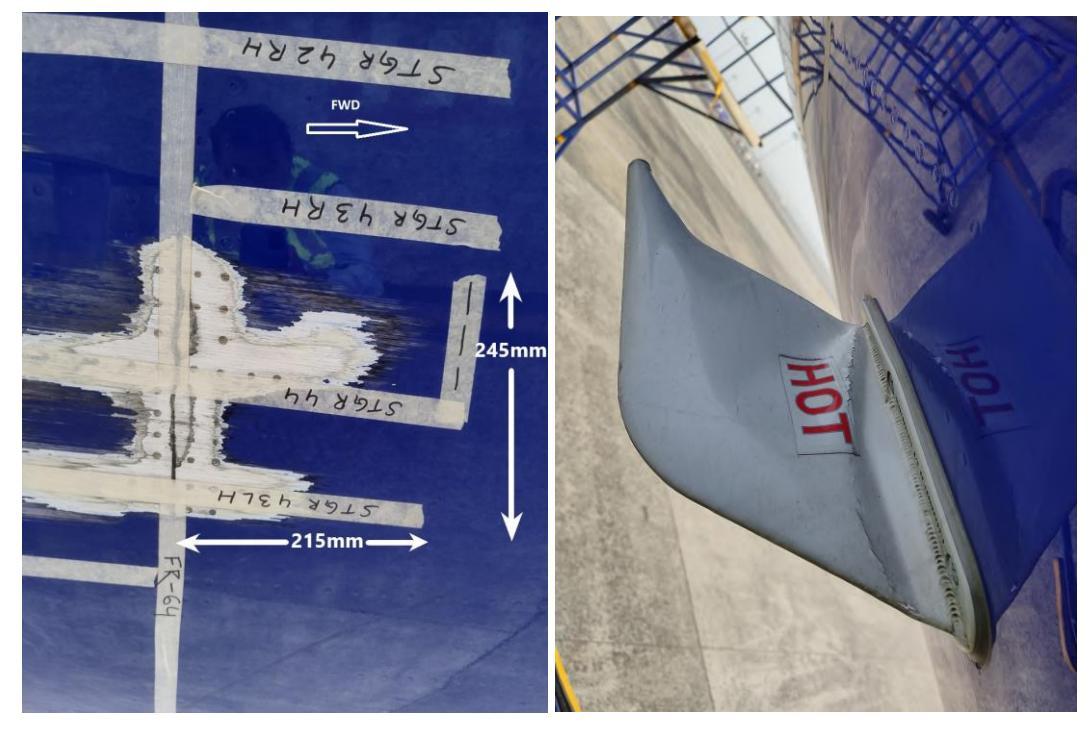
• Aft fuselage skin damage in between Frame 63 to 69 and between Stringer 42LH and Stringer 42RH.

Frame # 64, 65, 66, & 67, bottom chord at 6 O' clock location, have deep rubbing/ gouge marks.

- Frame # 65 depressed, torn and bottom attachment lug found missing in an area of 4 inches length between stringer 44 to stringer 43RH.
- Overall lower skin damage was observed of dimensions: max length 2540 mm and max width 390mm.
- Damage started from 350mm aft of Frame 63 upto 165mm forward of Frame 69.
- Skin teared at 06 locations below Frame 65, 66 & 67 with maximum dimension: length 95mm and width 85mm at frame 65.
- -Drain mast damaged (bent and cracked). No further damage observed on drain mast support structure.

All the damaged structural fittings, systems components, waste lines, hoses, drain mast, toilet system etc, were replaced/repaired as per Airbus approved procedures. Sections S17 and S18 lower shells and internal structure suffered several damages due to Tail Strike.

- S18 Lower equipped shell replacement done as per repair references
- S17 between FR63-64 flush skin repairs done as per repair references
- Embodiment deviations repaired as per repair references

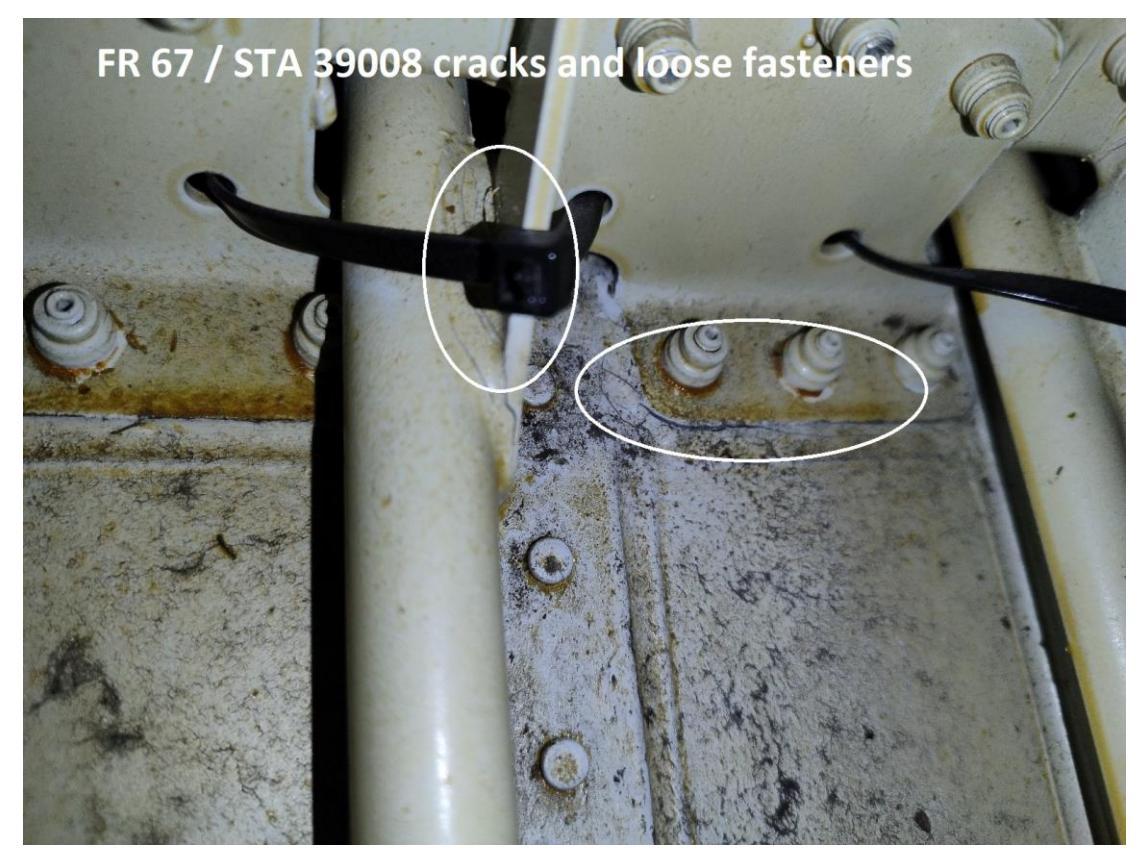
- Frame 65 damage and distorted between stringer 43RH to stringer 42LH.
- Rivets pulled off on frame 65 to stringer 43LH, stringer 44 and stringer 43 RH attachment clip.
- Rivets loose on frame 66 and frame 67 attachment between stringer 43LH and stringer 43RH.

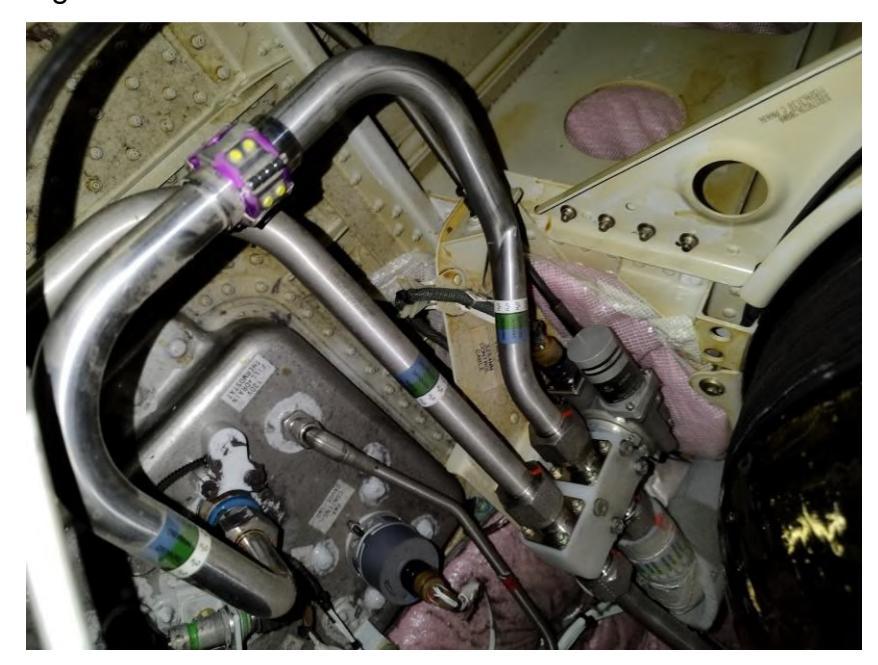
Sharp bend observed on water tank filling line (p/n: D3817021101600).
No further damage observed on water and waste tank mounting/attachment structure.

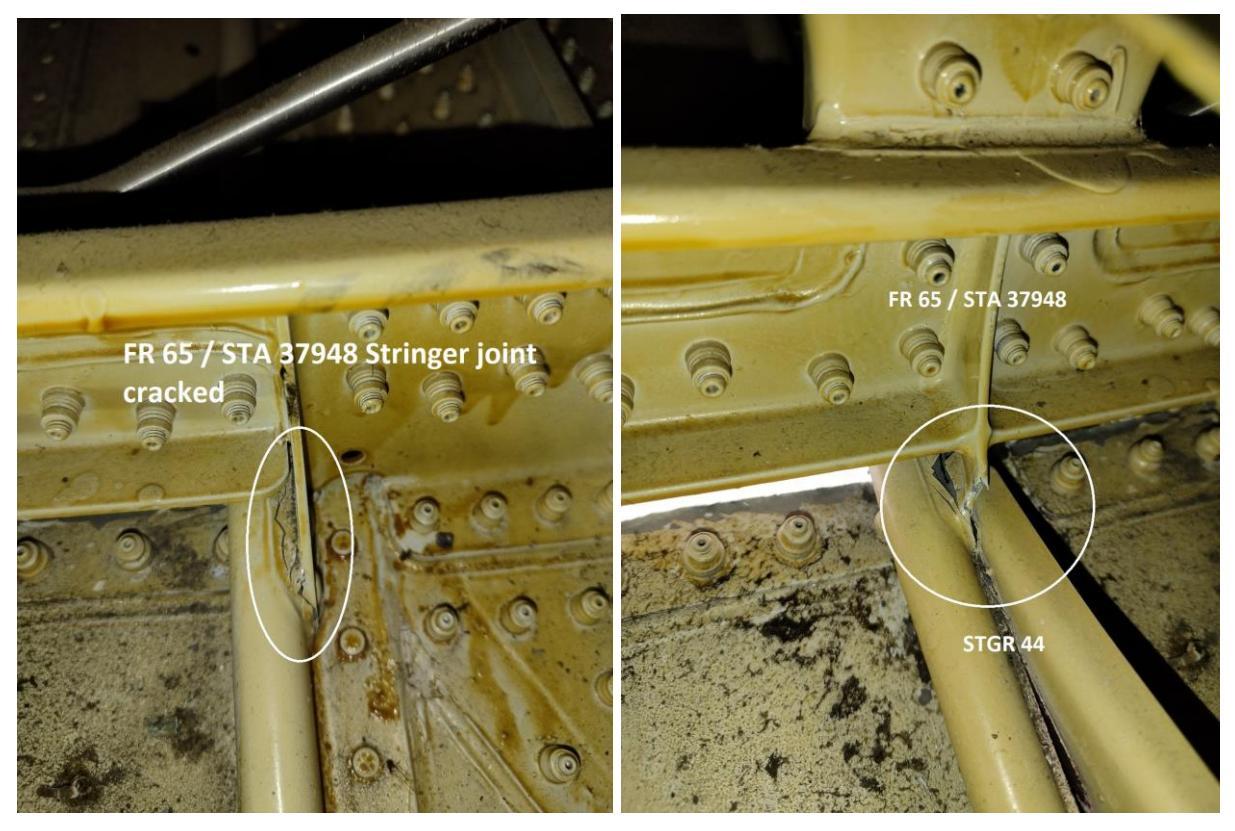
• Slight depression observed in skin panel between stringer 44 and stringer 43LH from frame 65 to 67.

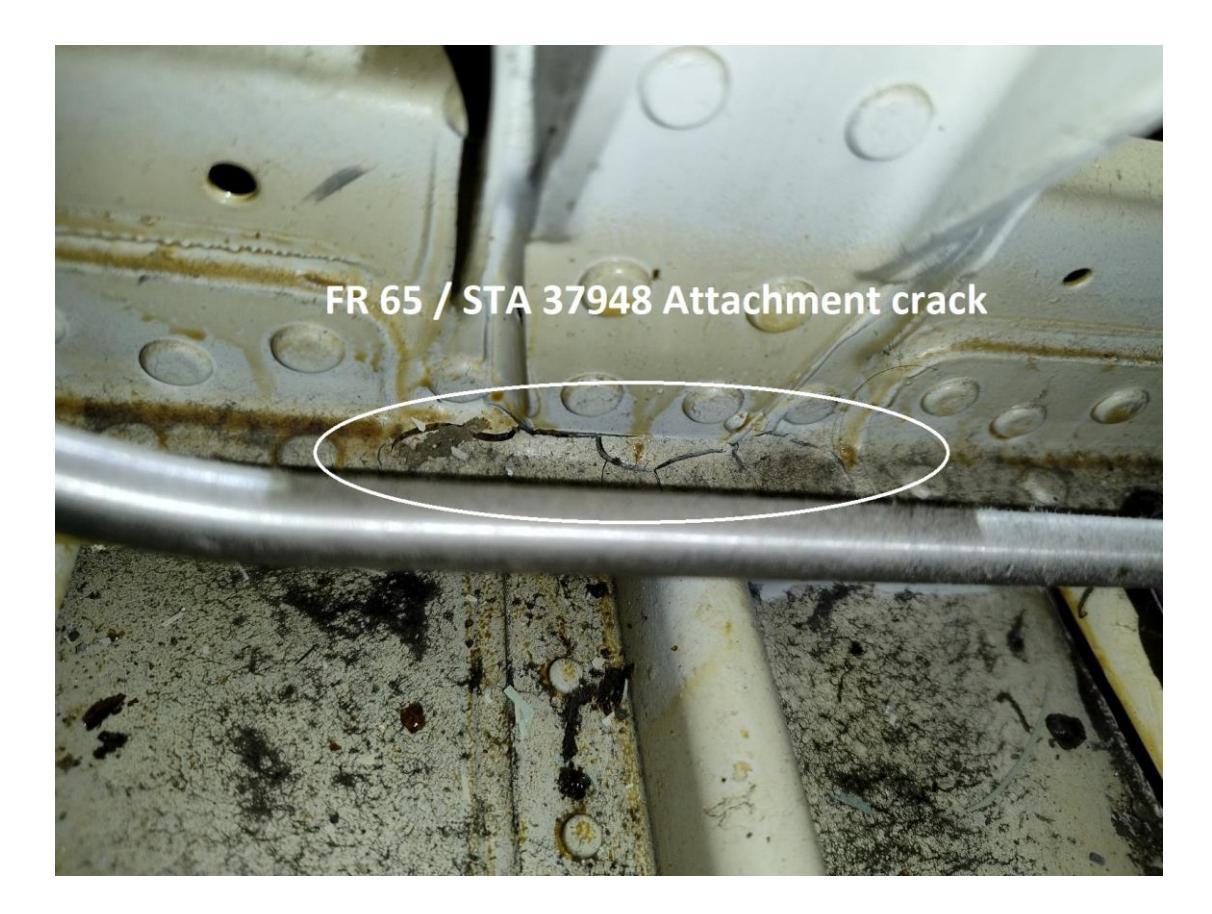
All the damages/cracks/deformations observed during the inspection were caused by the impact of aircraft due tail strike. No abnormality in the movement or unbalancing of flight controls was reported before the incident that can cause deviation in pitch or roll attitude of the aircraft. The MEL on 'Smoke Maintenance Msg' was revoked on 03.01.2023.

On completion of required maintenance and repair work, all the service panels and internal panels of aft cargo compartment were installed.
