**Government of India
Directorate General of Civil Aviation**

**INVESTIGATION REPORT ON AIR TURN BACK INCIDENT OF
M/S AIR INDIA A-319 AIRCRAFT VT-SCJ OPERATING FLIGHT
A1-776 ON 14.07.2023 AT MUMBAI**

On 14/07/2023, M/s Air India A-319-112 aircraft VT-SCJ was involved in an Air turn back incident while operating flight AI-776 sector Mumbai-Kolkata.

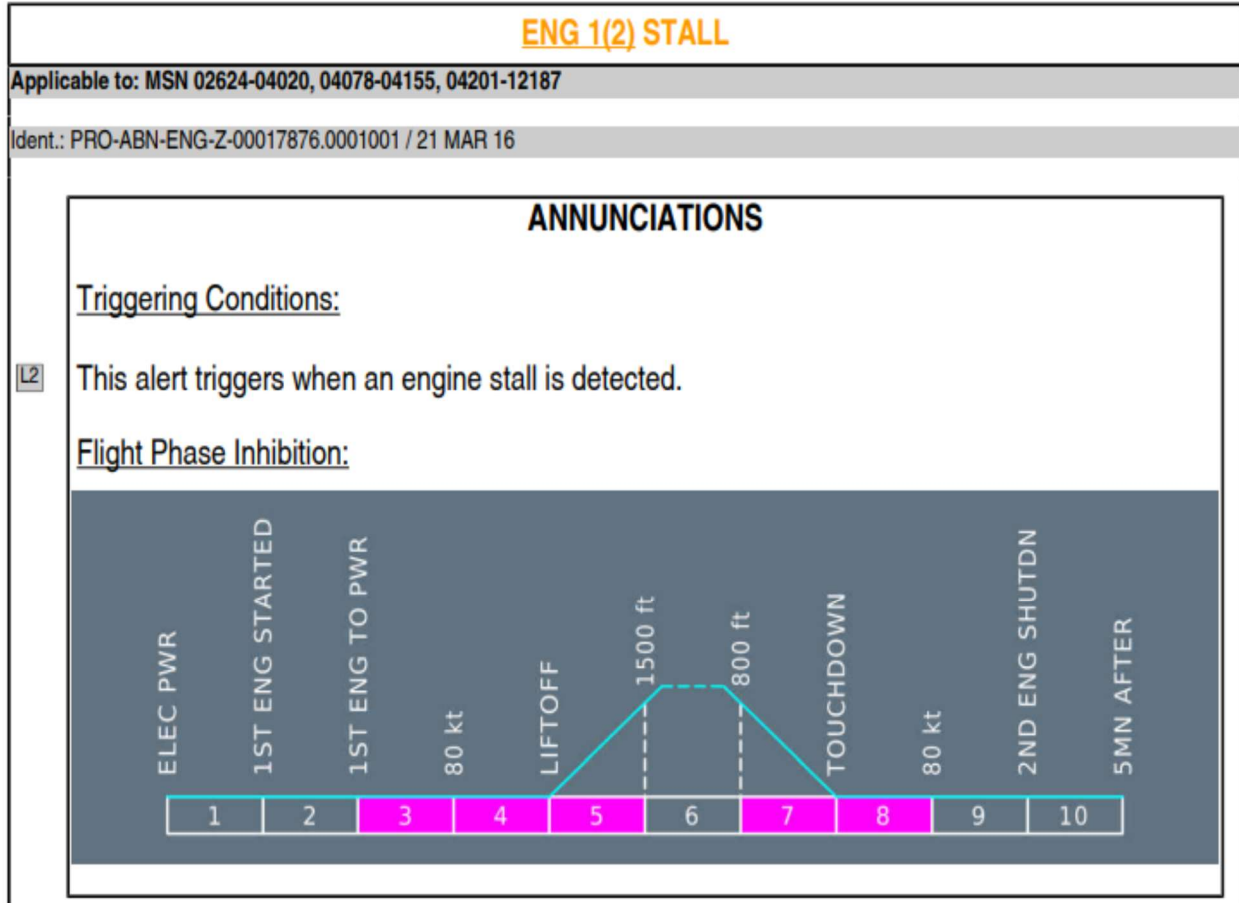
2. Airbus Feedback about Inhibition Logic:

Airbus feedback revealed following about ENG x STALL warning display inhibition logic:

- At FWC side, there is two types of inhibitions:
 - Logic inhibition which avoids computation of a message in the logic definition
 - And monitoring inhibition which is used after computation of message ensures proper message display only when necessary.
- As mentioned in the FCOM, the message "ENGINE x STALL" has a monitoring inhibition in flight phase (FP) 3-4-5-7 and 8.
