Final Investigation Report on Abnormal Runway Contact Incident to M/s. Srilankan Airlines A330-343 aircraft Regn. 4R-ALR at Cochin on 27/05/2018

Model : A330-343

Registration : 4R-ALR

13. Type of incident : Off Centre Landing – (ARC)

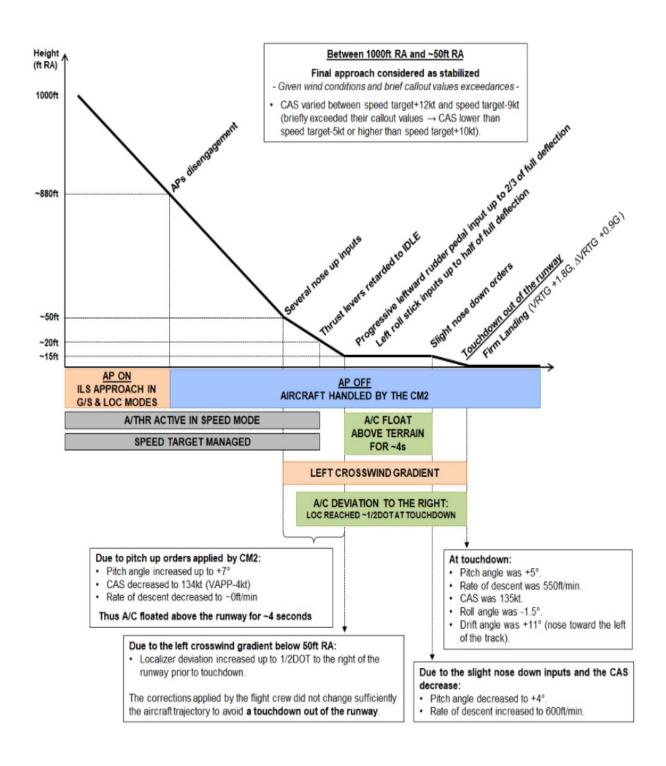
DFDR Data KEY POINTS

M/s. Airbus is of the opinion that the Aircraft lateral deviation to the right increased significantly in the last 50 ft has made the aircraft to finally touchdown out of the runway. The flight crew must consider to perform a go-around if the stability is not maintained until landing.

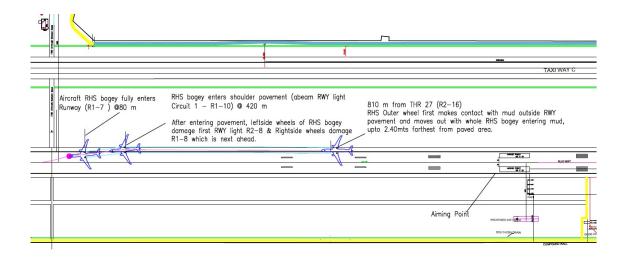
Fig.05A: Ground Markings left over by the aircraft on unpaved surface of Runway 27

Impact markings indicate that the aircraft's RH MLG made a touch down on the unpaved muddy surface (RH side of the runway 27) and longitudinally around 810 meters from the threshold of runway 27. After rolled out for a distance of approx. 420 metres in the same path, RH MLG entered the runway shoulder pavement area and damaged two runway edge lights (R 1-8 & R 2-8) at the entry point on its track.
