FINAL INVESTIGATION REPORT ON SMOKE IN PASSENGER CABIN
INCIDENT OF M/S SPICEJET DASH8 Q-400 AIRCRAFT VT-SUR ON
02/07/2022 AT DELHI

DIRECTORATE GENERAL OF CIVIL AVIATION
GOVERNMENT OF INDIA
NEW DELHI-110003

**FINAL INVESTIGATION REPORT ON SMOKE IN PASSENGER CABIN INCIDENT
OF M/S SPICEJET DASH8 Q400 AIRCRAFT VT-SUR AT DELHI ON 02/07/2022**

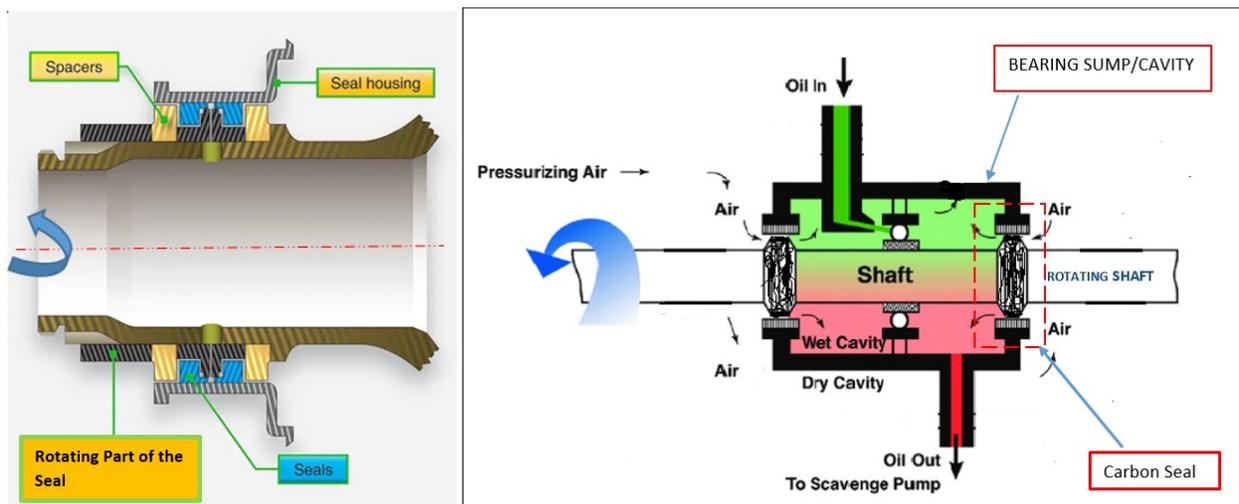
1.6.2.6 PW150A engine bearing sumps are designed with carbon seals on both ends of the sump and the No. 3 and 4 bearing cavity is sealed on each end using a double carbon seal ring. The typical carbon seals used for bearing No. 3 & 4 sump is made of two sections, a stationary section which is in build with carbon rubbing surface on its inner face and smooth metallic mating rotating surface. Rotating part gets snugly fitted over the rotor shaft and stationary carbon inner surface section immediately seats against the rotating mating surface when attach with bearing housing. Close rubbing surfaces between these sections provide a sealing surface to contain oil lubricant inside the sump. Regardless of sealing provided by carbon seals, lubricating oil under the influence of high temperature and pressure always tends to cross pass sealing surfaces and penetrate into normal airflow air. If lubricating oil is allowed to enter onto the gas path, oil loaded air might enter the aircraft air-conditioning system through bleed port P 2.2 and P2.7.

1.6.2.7 To seize the possibility of oil leakage through carbon seals seated in bearing sumps, high air pressure from the compressor is utilized to pressurize the air side surface of the carbon seal. In particular pressurized with P2.8 (HP compressor split vane impeller level) directed through internal passages in the inter-compressor case carbon seal at either end of bearing sump/cavity of PW150A Engine. **If carbon seals fail** or pressurization of bearing sumps does not work well for any reason, high pressure Engine lubrication oil from the bearing sump shall enter into the dry airside of the sump and contaminate the airflow.

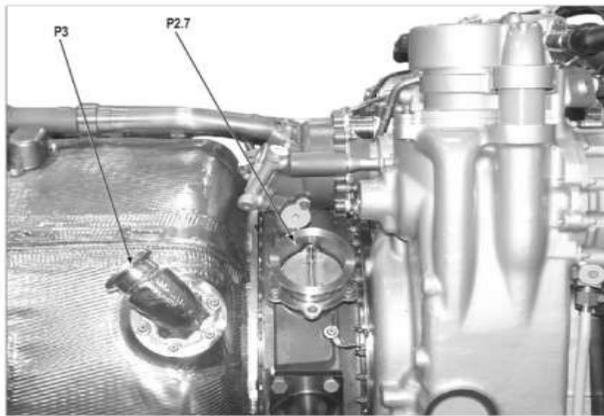
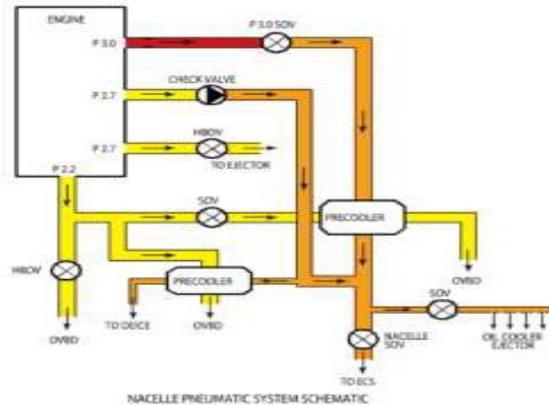
1.6.2.9 The engine provides air bleed extraction ports from both compressors, the low pressure (LP/P2.7) and the high pressure (HP/P3). As the two bleed ports are connected to the same duct, a P2.7 check valve is installed in the low pressure port to prevent back flow from the high pressure (P3) to the low pressure (P2.7). The Environment Control System (ECS) is supplied with low pressure air (P2.7). At low engine power, P3 port is allowed to supply air to feed the airframe system and at a predetermined pressure (P3) port gets closed and supply of required bleed taken over by the P2.7 port for Environment Control System (ECS)

1.6.2.10 Compressed bleed air ported from engine goes to Air conditioning pack for temperature and humidity control for passenger cabin and Cockpit. **If oil leaking from bearing sumps enters into the gas path, it will be carried into cabin /cockpit through engine bleed ports, airframe ducts and ECS to cabin and lead to smoke and odour** depending upon quantity of contamination.
