**Final Investigation Report of Engine In-Flight Shutdown Incident to M/s. AIX  
Connect Pvt Ltd Aircraft VT-VTZ (I5-1563) After Takeoff from Kolkata on  
08.01.2024.**

**O/o Director General of Civil Aviation  
Air Safety Directorate,  
New Delhi– 110003**

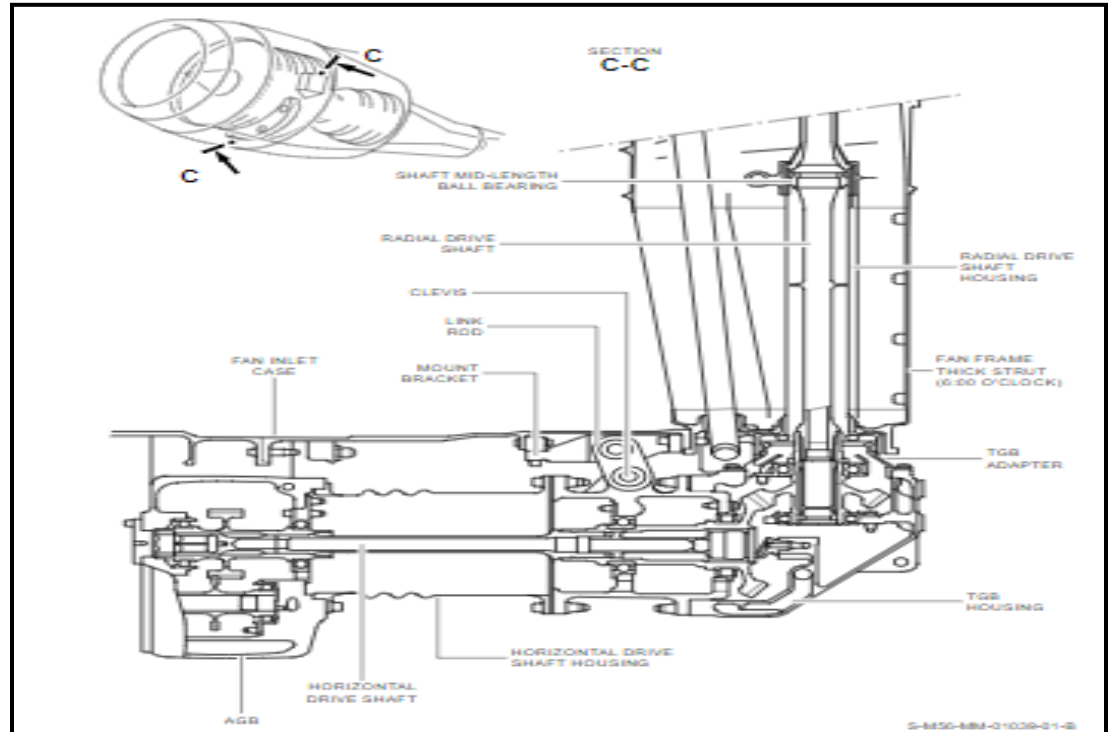
- 1.6.3.2. Post arrival engine 1 oil level was found at 13 QTZ. Fan frame strut # 07 was damaged along with radial drive shaft outer casing. No faults were detected in operational test of FADEC 1A & 1B with engine non motoring.

- 1.6.3.5. **Damages observed along with strut:** Fan duct panel @05:30 position corner area crack-adjacent right to the damaged strut. Aft acoustic panel liner stuck with damaged strut @6:30 position.

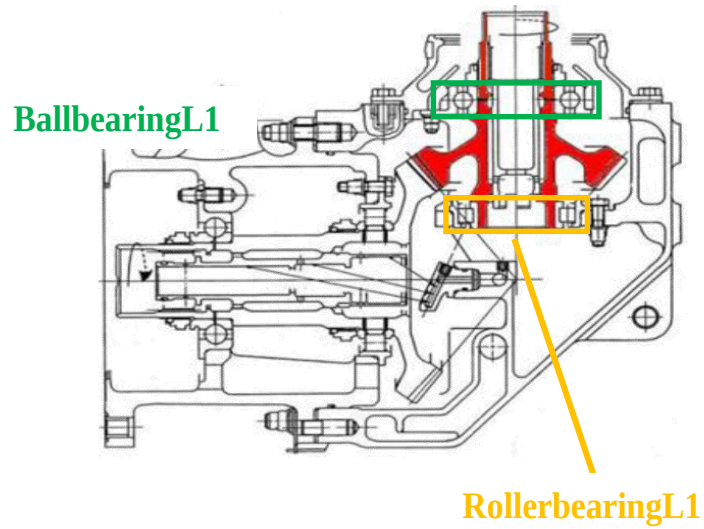
- L1 roller bearing failure
- L1 ball bearing failure
- L1 and RDS orbiting
  - ✓ L1 gear shaft wear
  - ✓ RDS roller bearing
  - ✓ RDS Inner Housing
  - ✓ RDS shroud torn
  - ✓ Fan Frame Strut damaged
- RDS destruction by a RDS blockage in the TGB Housing
- Engine stop, IFSD
