**FINAL INVESTIGATION REPORT ON
UN-COMMANDED IN-FLIGHT SHUT DOWN OF ENGINE #1
OF BOEING B787-8 AIRCRAFT VT-ANW
AT MUMBAI ON 04.08.2023**

**GOVERNMENT OF INDIA
O/o, DIRECTOR AIR SAFETY, WESTERN REGION,
NEW INTEGRATED OPERATIONAL OFFICE COMPLEX,
SAHAR ROAD, VILE PARLE (EAST), MUMBAI**

FINAL INVESTIGATION REPORT ON THE INCIDENT TO
M/s AIR INDIA, BOEING B787-8 AIRCRAFT VT-ANW ON 04.08.2023
AT MUMBAI

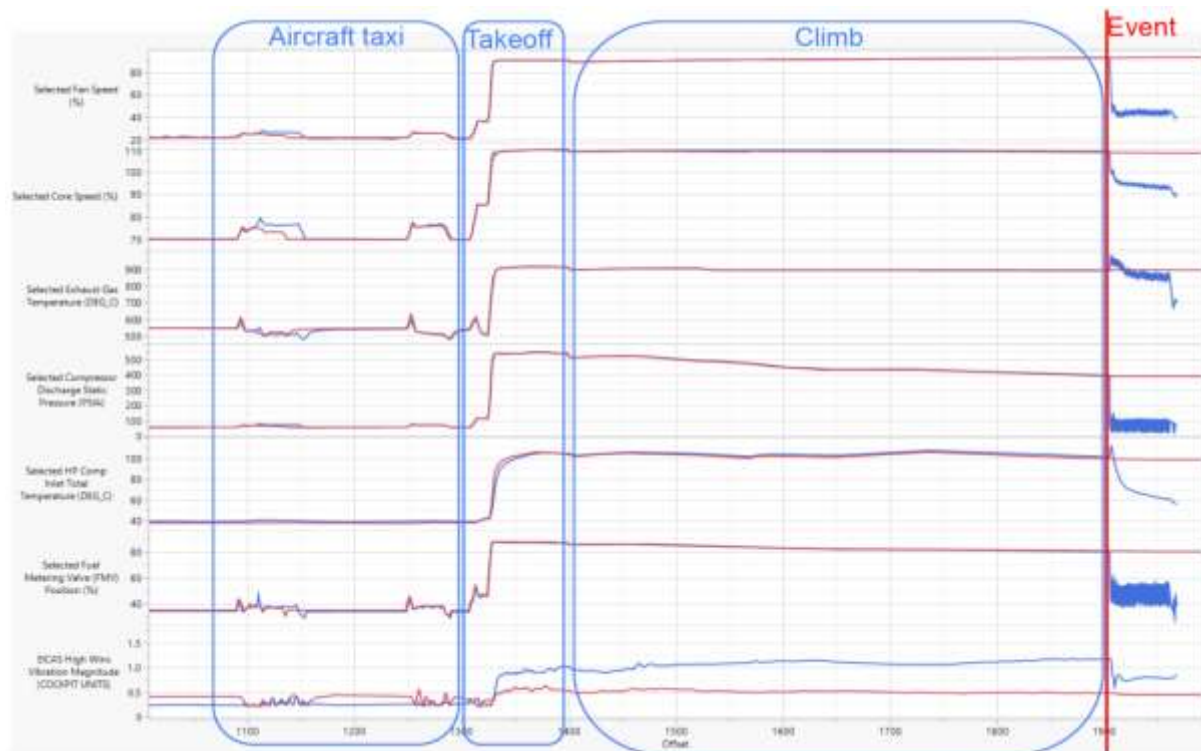
As provided by the OEM, the FDR Data comparison of both the engines indicate that both the engines were operating normal until the In-Flight Shut Down event occurred

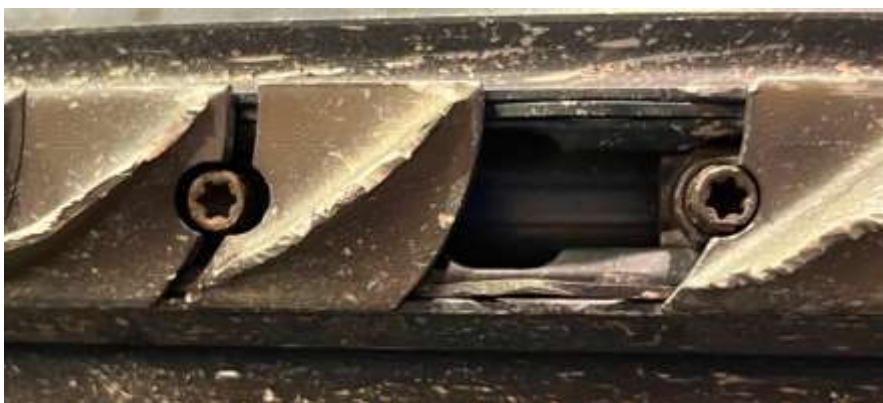
The root cause investigation for the release of HPC Stage 10 blade was conducted by the OEM and the disassembly investigation revealed that the LH locking lug was installed out of the lock slot and the RH locking lug was installed partially inside the lock slot and the improper installation of lugs caused the release of the blade.

Above are the pictures of the LH locking lugs which have experienced severe damage on upper lug shoulder indicating lug installed out of lock slot and not proper.

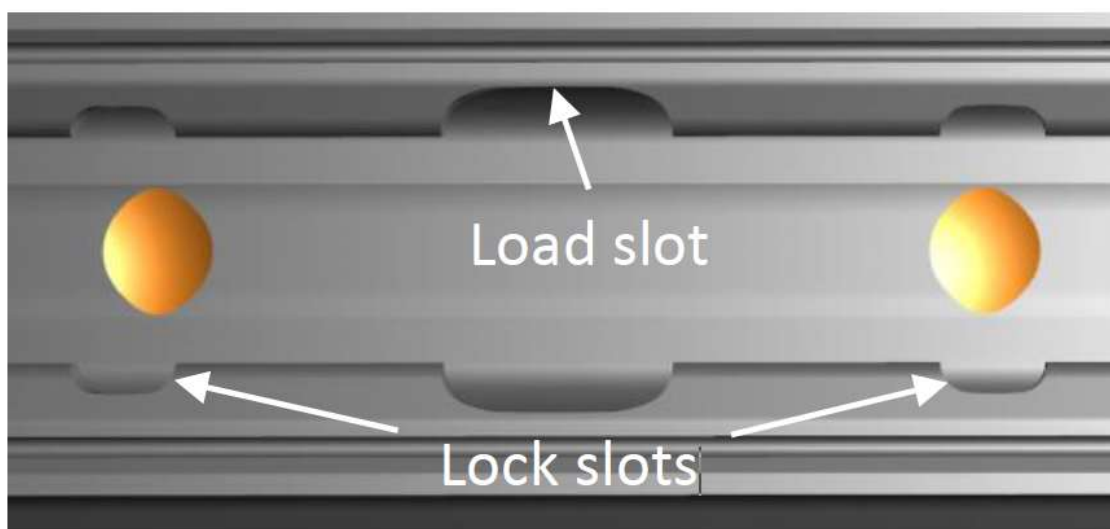
There are two locking lugs for each stage and these locking lugs secure the blades in a circumferential fashion to prevent blade release from the load slot.

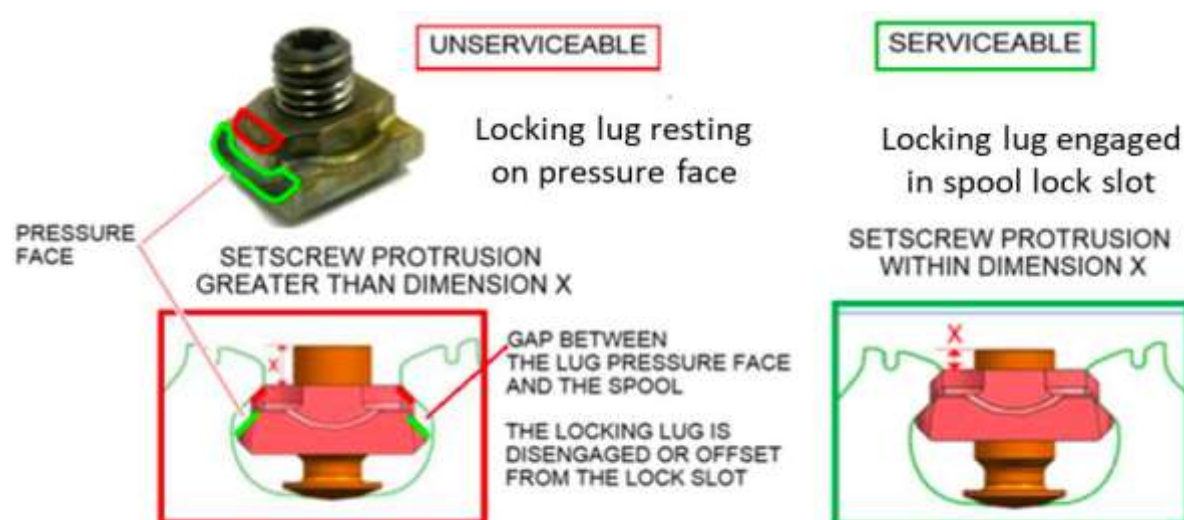
During installation a set screw placed on top of lug is torqued, raising the locking lug into the locking slot in the spool.
