INVESTIGATION REPORT ON INCIDENT TO M/S SPICEJET BOEING 737-8 AIRCRAFT VT-MXE ON 09.12.2021 AT MUMBAI

DIRECTORATE GENERAL OF CIVIL AVIATION GOVERNMENT OF INDIA NEW DELHI

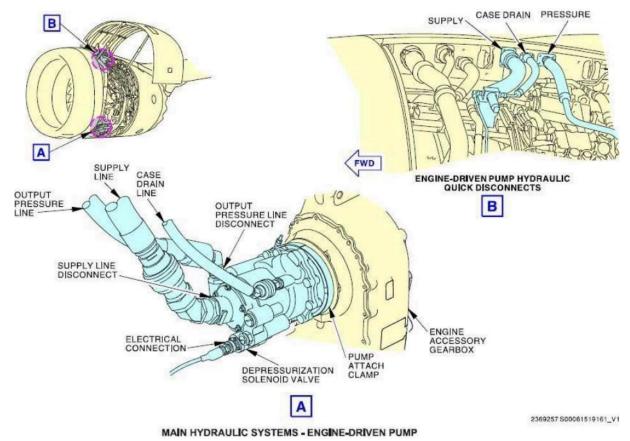
Figure 2

During the discharge stroke of each piston, hydraulic fluid is forced out of the piston cylinder bores and into the output pressure line. Some of the supply fluid in the pump becomes case drain fluid. The case drain fluid cools and lubricates the pump before it goes to the heat exchanger and reservoir through the case drain connection.

A pressure compensator in the pump maintains a preset pressure by control of the fluid flow out of the pump in response to changes in system demands. The pump operates in the pressurized or depressurized mode. In the depressurized mode, the pump is isolated from the hydraulic system and runs at a zero output flow. The solenoid operated depressurization valve controls the pressurized or depressurized modes of the pump. Both EDPs are rated at 36 gallons per minute (136 litres per minute) at 3000 pounds per square inch (20,684 kilopascals).

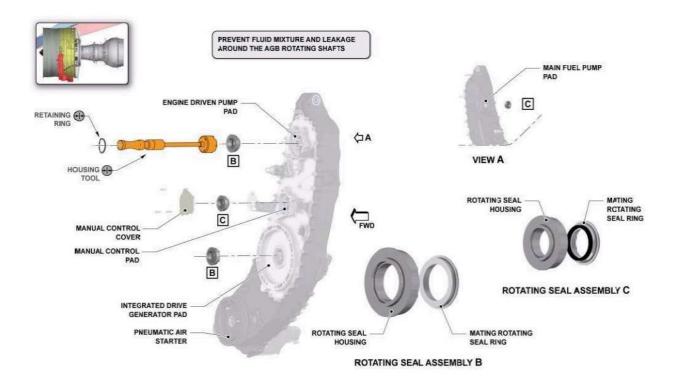
Accessory Gearbox Rotating Seals - General Figure 3

There are 4 different rotating seals installed on the Accessory Gearbox (Refer Figure 3).

Purpose:- The AGB rotating seals prevent fluid mixture and leakage around the AGB rotating shafts.

Interfaces:- The rotating seals are the interface between the gears, the shafts and the AGB housing and front cover. They are kept in position by retainer rings.
