**FINAL INVESTIGATION REPORT ON  
AIR TURN BACK INCIDENT TO  
M/s AIR INDIA LTD AIRBUS A320-251N AIRCRAFT  
VT-EXM ON 19/05/2022 AT MUMBAI**

**GOVERNMENT OF INDIA  
O/o DIRECTOR AIR SAFETY, WESTERN REGION,  
NEW INTEGRATED OPERATIONAL OFFICE COMPLEX,  
SAHAR ROAD, VILE PARLE (EAST), MUMBAI-400099**

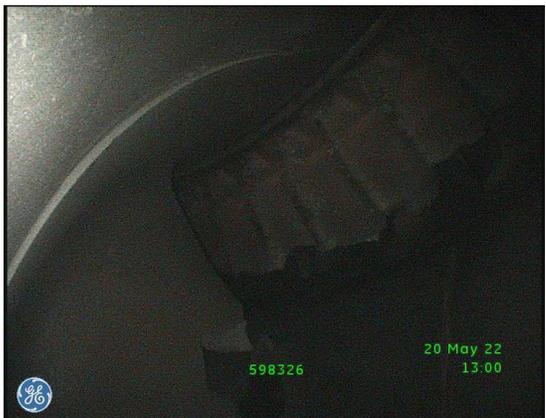
Image# 5 HPT Stage2 blade trailing edge

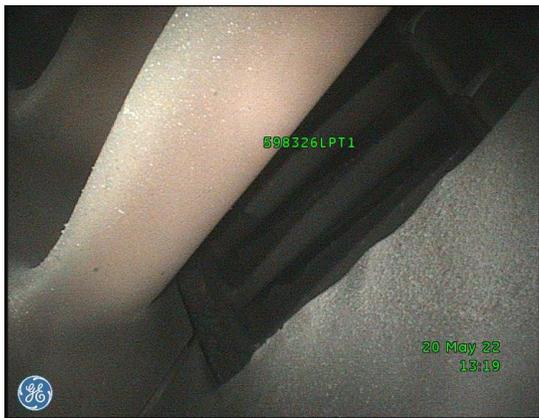
Image# 6 LPT Stage1

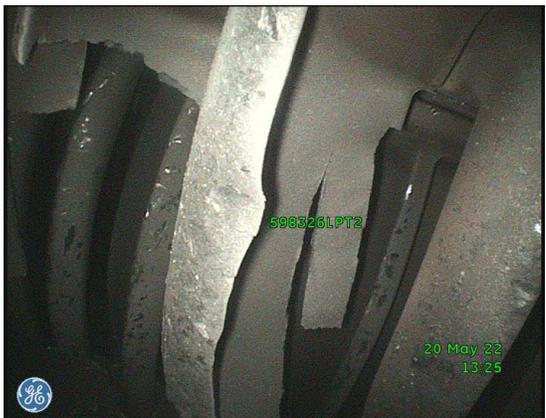
Image# 7 LPT Stage2

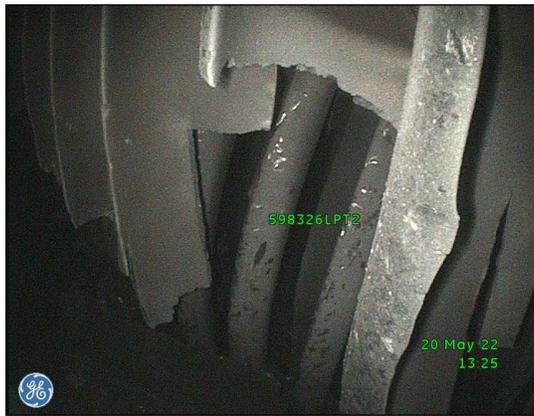
Image# 8 LPT Stage2

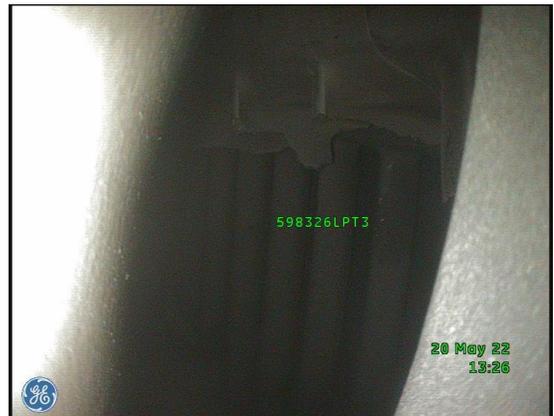
Image# 9 LPT Stage3

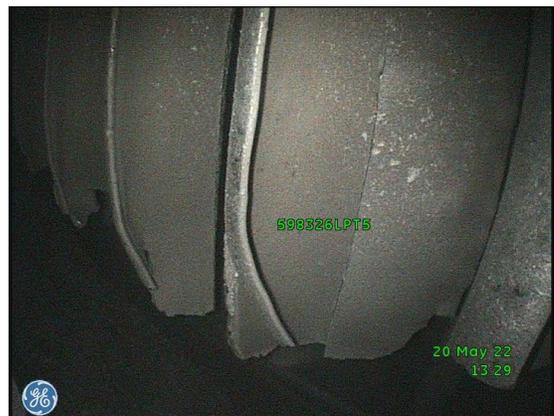
Image# 11 LPT Stage5

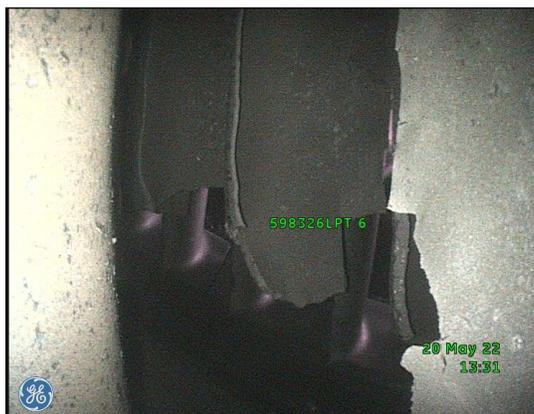
Image# 12 LPT Stage6

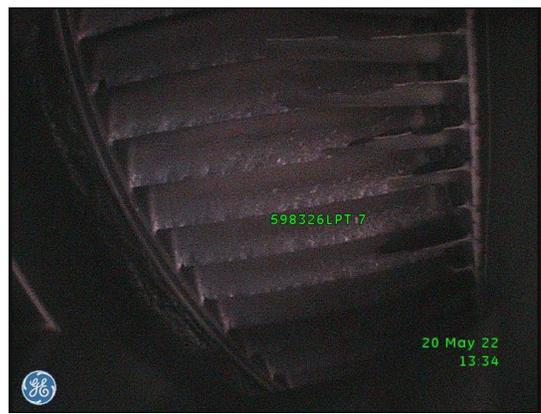
Image# 13 LPT Stage7

During physical inspection by AME (Cat 'B1' license holder) on arrival, it was observed that last two stages of LPT & LPT NGVs found damaged/ missing material. Boroscope inspection was carried out the incident involved engine as per M/s CFM International (Engine OEM) recommendations and the results were shared with M/s CFM International. Visual evidence of HPT rotor interstage seal material loss of the aft catenary arm was confirmed from the inspection reports.

Subsequently, the involved engine was removed for further investigation and a serviceable engine (Sl. No.: 599055) was installed on the aircraft on 09.06.2022. Inspection after a major engine failure was carried out on VT-EXM as per the advice of M/s Airbus. SSCVR and SSFDR were also replaced and the aircraft was released to service on 10.06.2022. The aircraft VT-EXM operated AI- 627 (Mumbai- Nagpur) on 10.06.2022 after completing the rectification action.

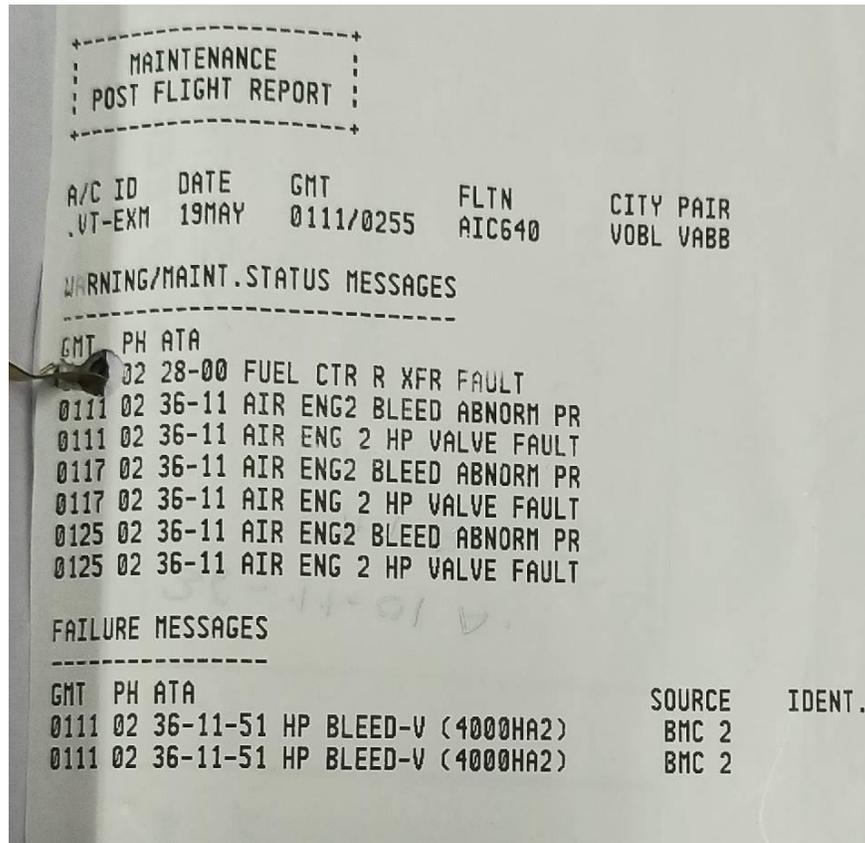
Image# 14 Maintenance Post Flight Report (PFR) of AI-640 of 19/05/2022

Aircraft had encountered a defect with regard to Eng# 2 bleed system in the previous sector (AI-640) during taxi out wherein crew had carried out operational procedure for 'MEL 36-11-01A - Engine Bleed Air Supply System (non- EDTO flights)' and continued flight. Subsequently, no abnormalities were observed in incoming flight AI-640. Crew reported in Pilot Defect Report that- 'AIR ENG2 BLEED ABNORMAL PR ECAM DURING TAXI IN BLR. RESET CARRIED OUT. MEL 36-11-01A OPS PROC CARRIED OUT'.

Maintenance Post Flight Report (PFR) of AI-640 of 19/05/2022 reflected following warning/ maintenance status messages:

As part of rectification, AME invoked MEL 36-11-01A Cat 'B' for 'ENG2 Bleed Air Supply System' at Mumbai.

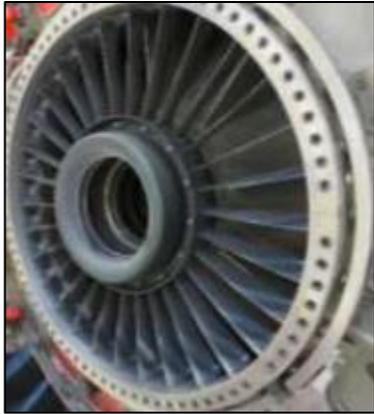
Minor deposits at IG

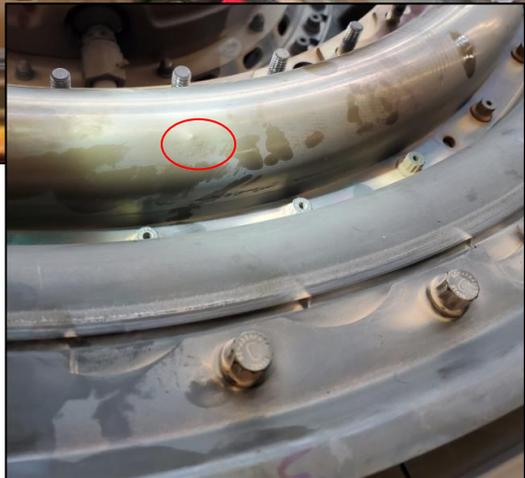
Typical condition at #4R
